X-RAY ANALYSIS OF THE NARBONNE HOUSE

David M. Hart, Designer
Topsfield, Mass.

In addition, an X-ray analysis was carried out to determine certain structural conditions hidden from view. Specifically, the examination was made in hopes of finding evidence in three areas. First, the existence and configuration of exterior wall bracing; second, the possibility of finding original window framing; third, the possibility of evidence between the two house frames that would indicate whether the south frame once had an exterior wall. The equipment used was Picker Corporation's Portashot System, which is a portable X-ray generator and Polaroid film and processing unit for on-the-job analysis of results.

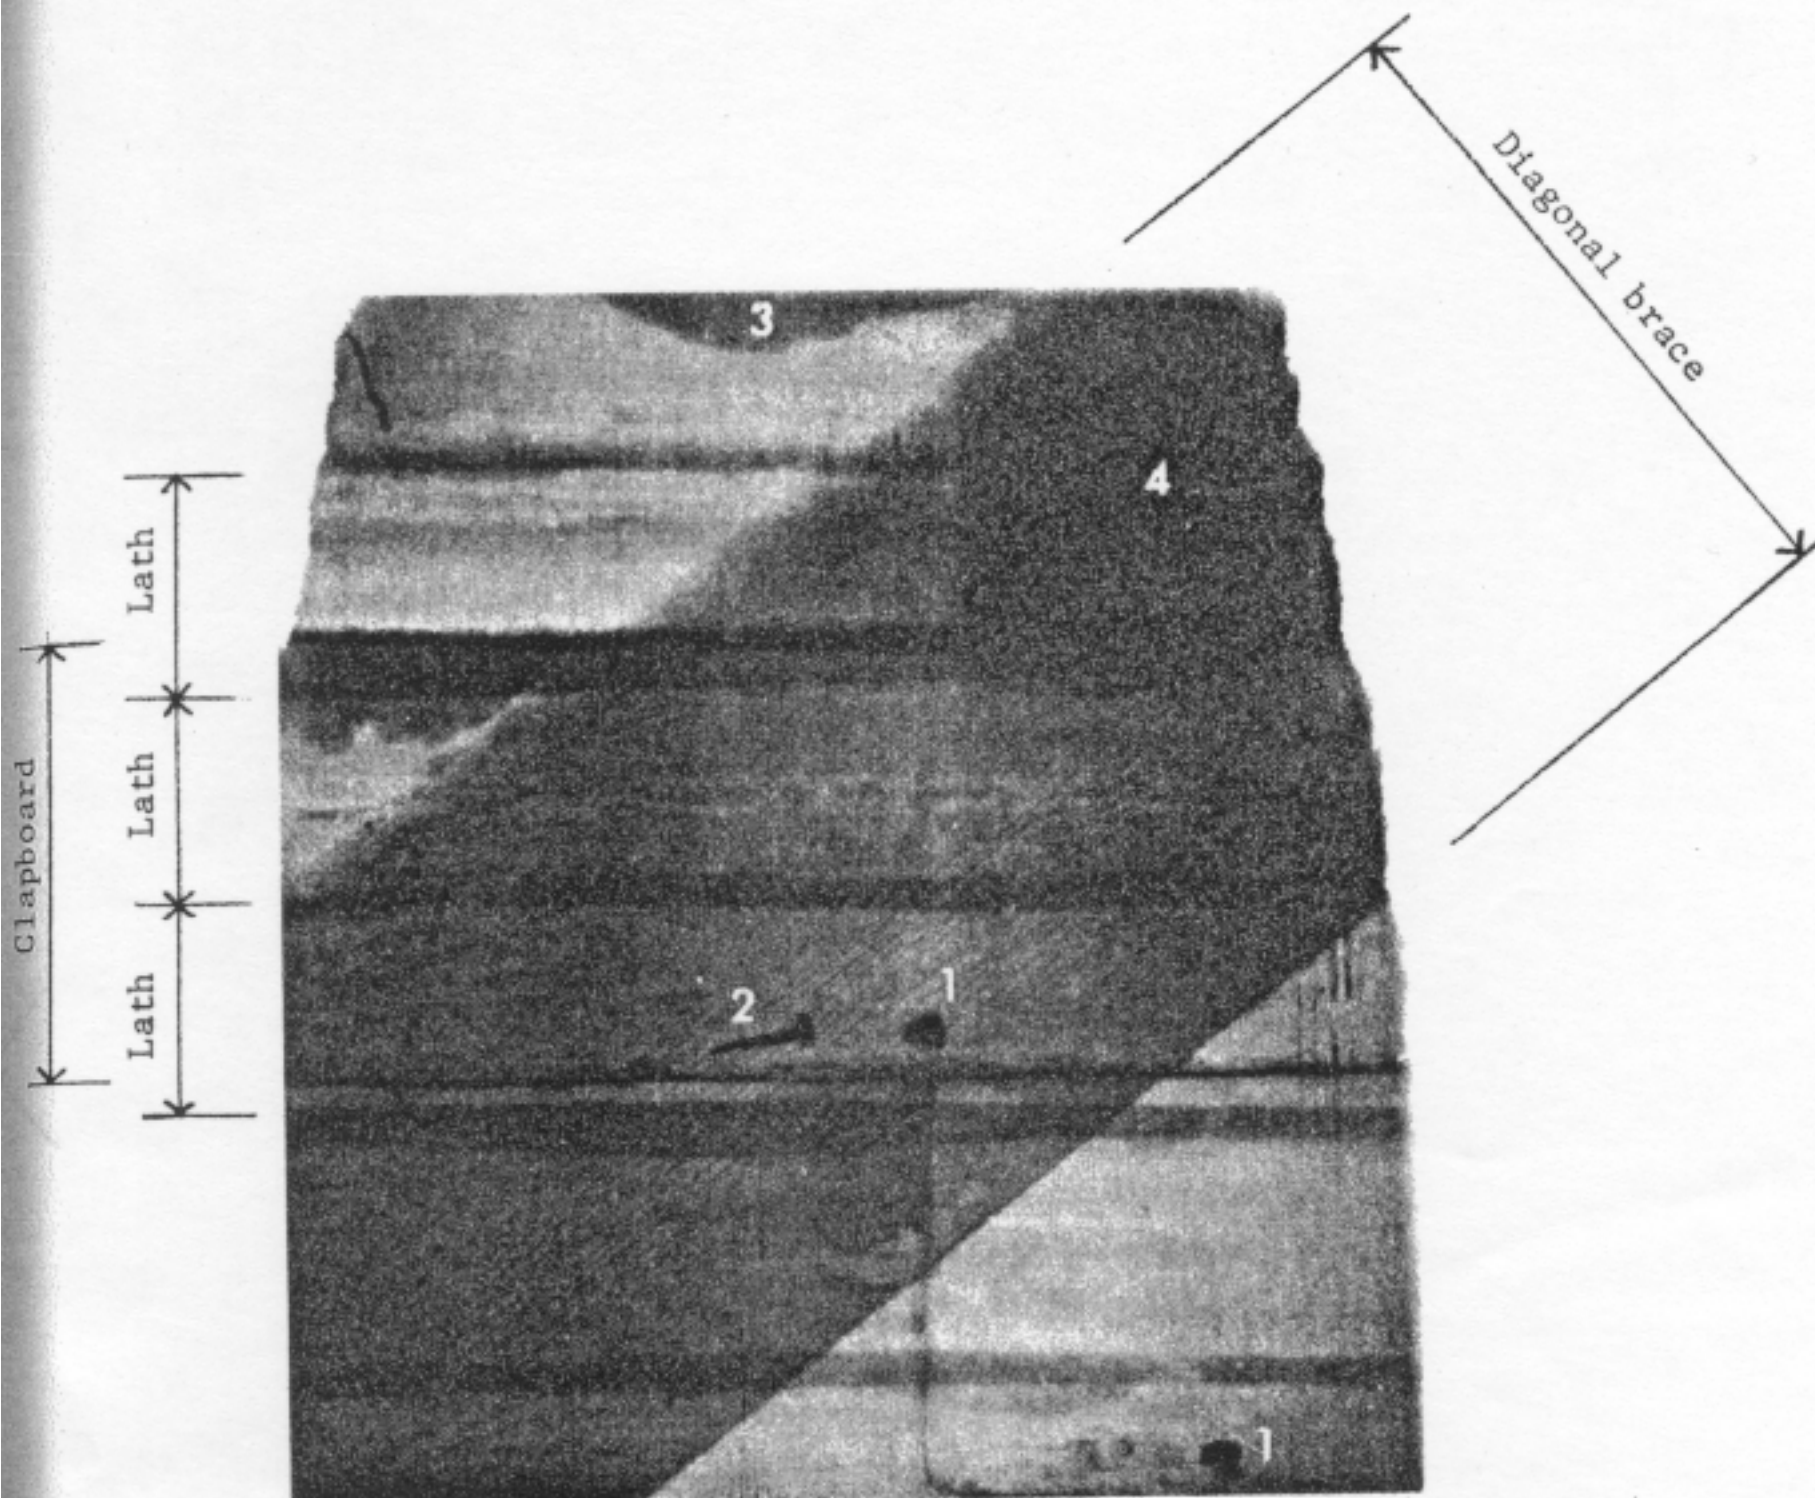
The first part of the investigation was the determination of the wall bracing and its configuration. For historical purposes, it was desired to know if the corner braces "rose" or "fell" inside the walls, at both the first and second floor levels. By visual analysis one could not determine the bracing. Furthermore, by tapping the walls and examining the ridges in the plaster, one would be led to believe that the braces rose. Interestingly enough, the X-rays revealed just the opposite case: the braces fell in all instances (see Fig. 6 and 7).

- 1) Braces showed no sign of structural failure, rot or decay;
- 2) Even though nogging was visually present in the east wall at the second floor level, it was not apparent in the west, north or first floor east walls;
- 3) Cut nails used to attach the clapboards to the studs are clearly seen;
- 4) Irregularly-shaped split lath is seen, as well as the hand-wrought nails used to attach the lath to the studs.

Fig. 6 Narbonne House, Salem, Mass.
 X-ray of brace located in area of Fig. 5.

- Key to X-ray:
1. Clapboard nails
 2. Wrought nail
 3. Plaster "key"
 4. Dark area, probably a mortise filled with debris, "unidentified."

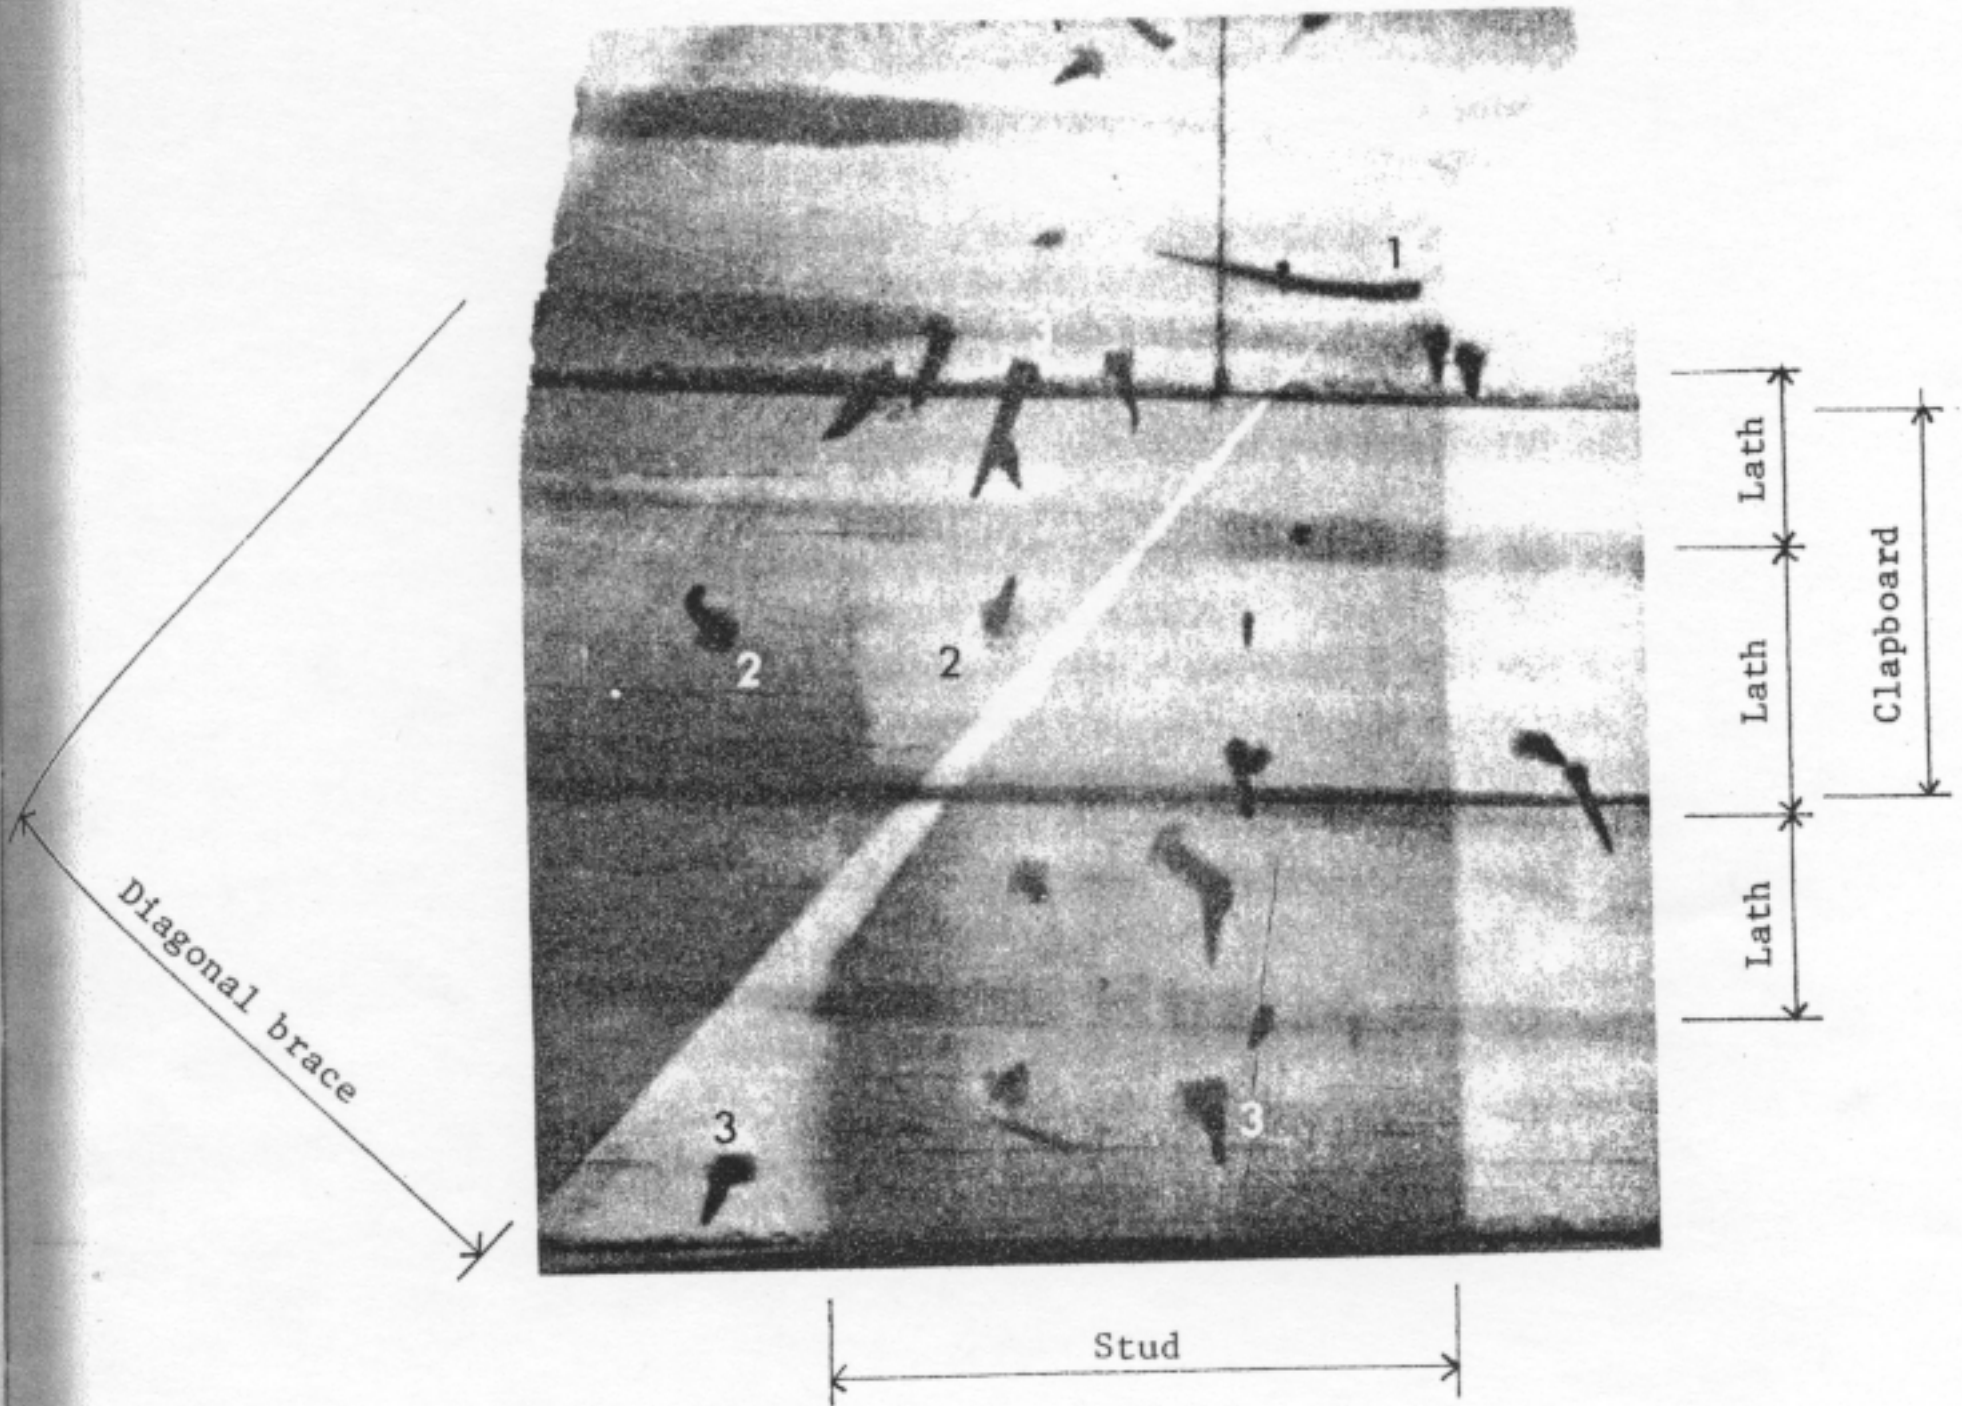
Fig. 7 Narbonne House, Salem, Mass.
 X-ray of brace (with stud portion at bottom), located in
 West wall, first floor.

- Key to X-ray:
1. Nail used to attach stud to diagonal brace
 2. Lath nails, wrought
 3. Clapboard nails, cut
 4. Butt-end of modern clapboard

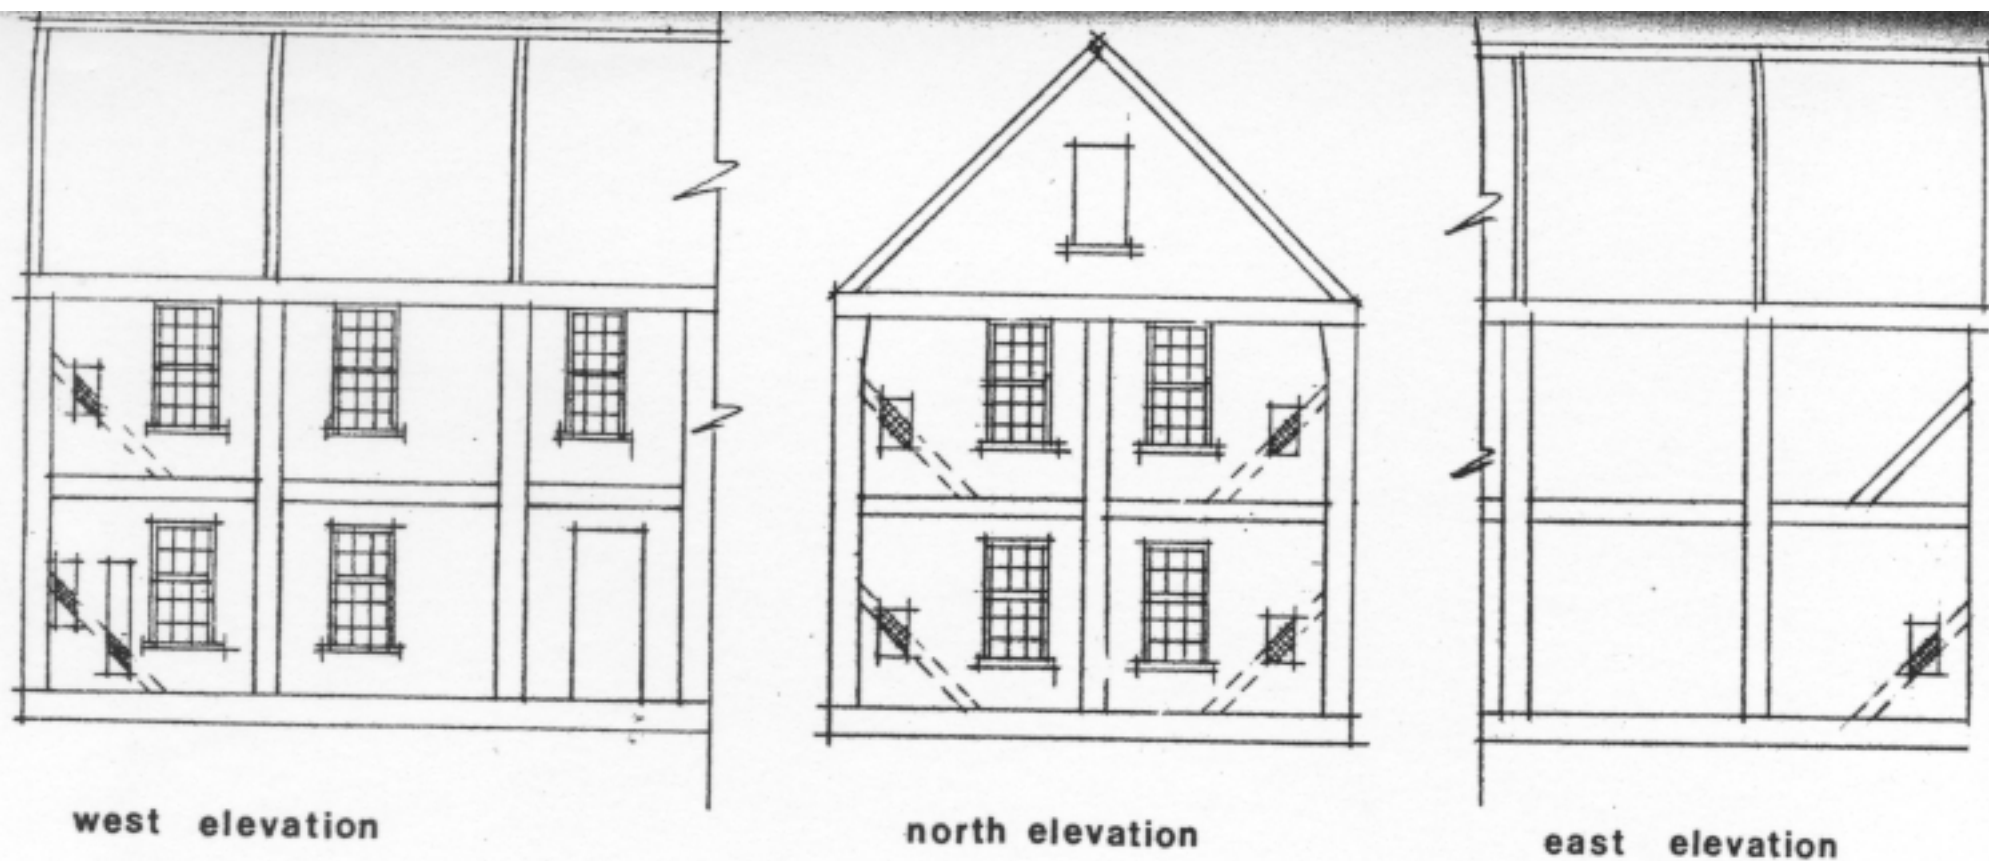
Fig. 8 (Left) Composite drawing; cross-hatched areas are those in which brace evidence was obtained by X-ray.

Fig. 9 (Center) Composite drawing, showing brace evidence in North wall.

Fig. 10 (Right) Composite drawing, showing brace evidence in East wall, second floor brace was determined visually.

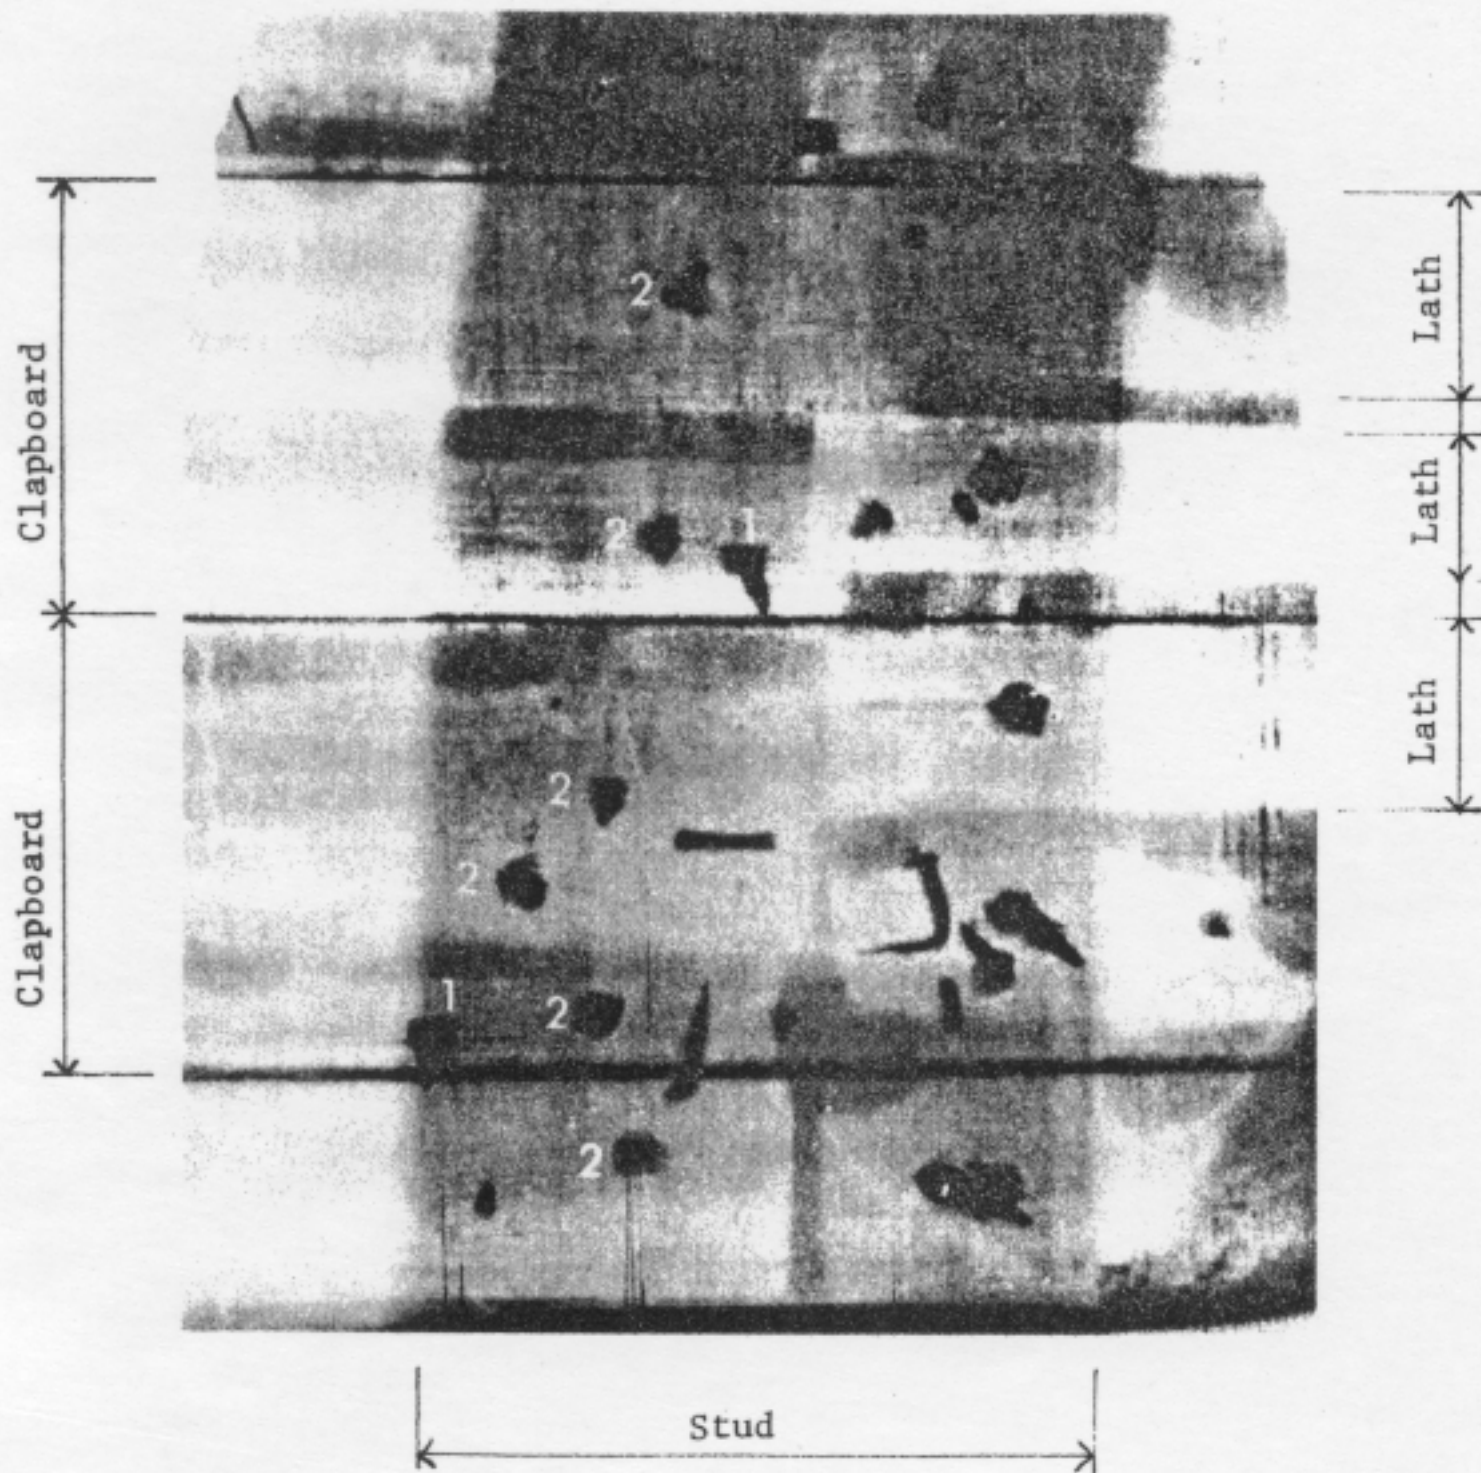
Fig. 11 Narbonne House, Salem, Mass.
 X-ray of stud, examined for possible notch used for original window frame. Lath configuration and wrought nails used for attachment are clearly seen. Cut nails can be seen, which attach clapboards.
 Key to X-ray: 1. Clapboard nails, cut
 2. Lath nails, wrought
 There are a few stray nails and broken nails in the stud.

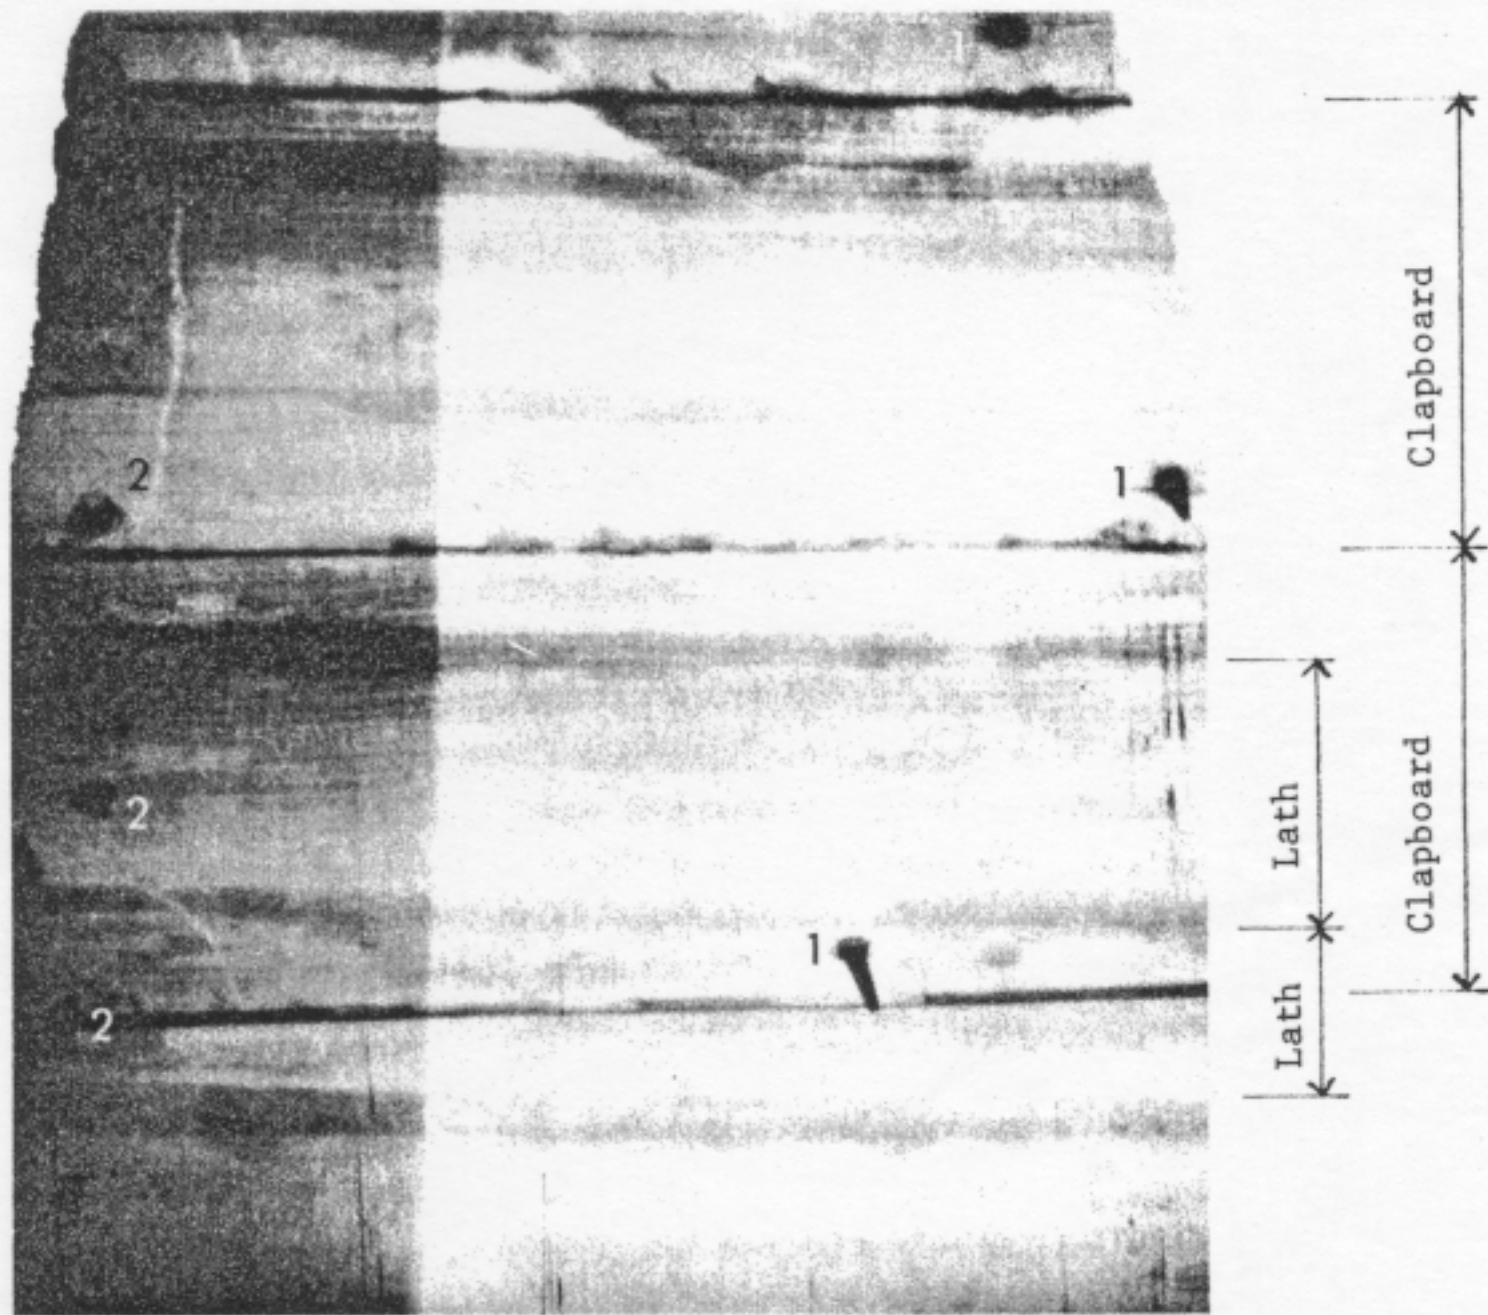
Fig. 12 Narbonne House, Salem, Mass.
 X-ray of post, examined for possible notch used for original window frame. Cut nail used to attach clapboard to sheathing can be seen in lower right-hand corner.

Key to X-ray: 1. Clapboard nails, cut
 2. Lath nails, wrought

There are a few stray nails and broken nails in post.

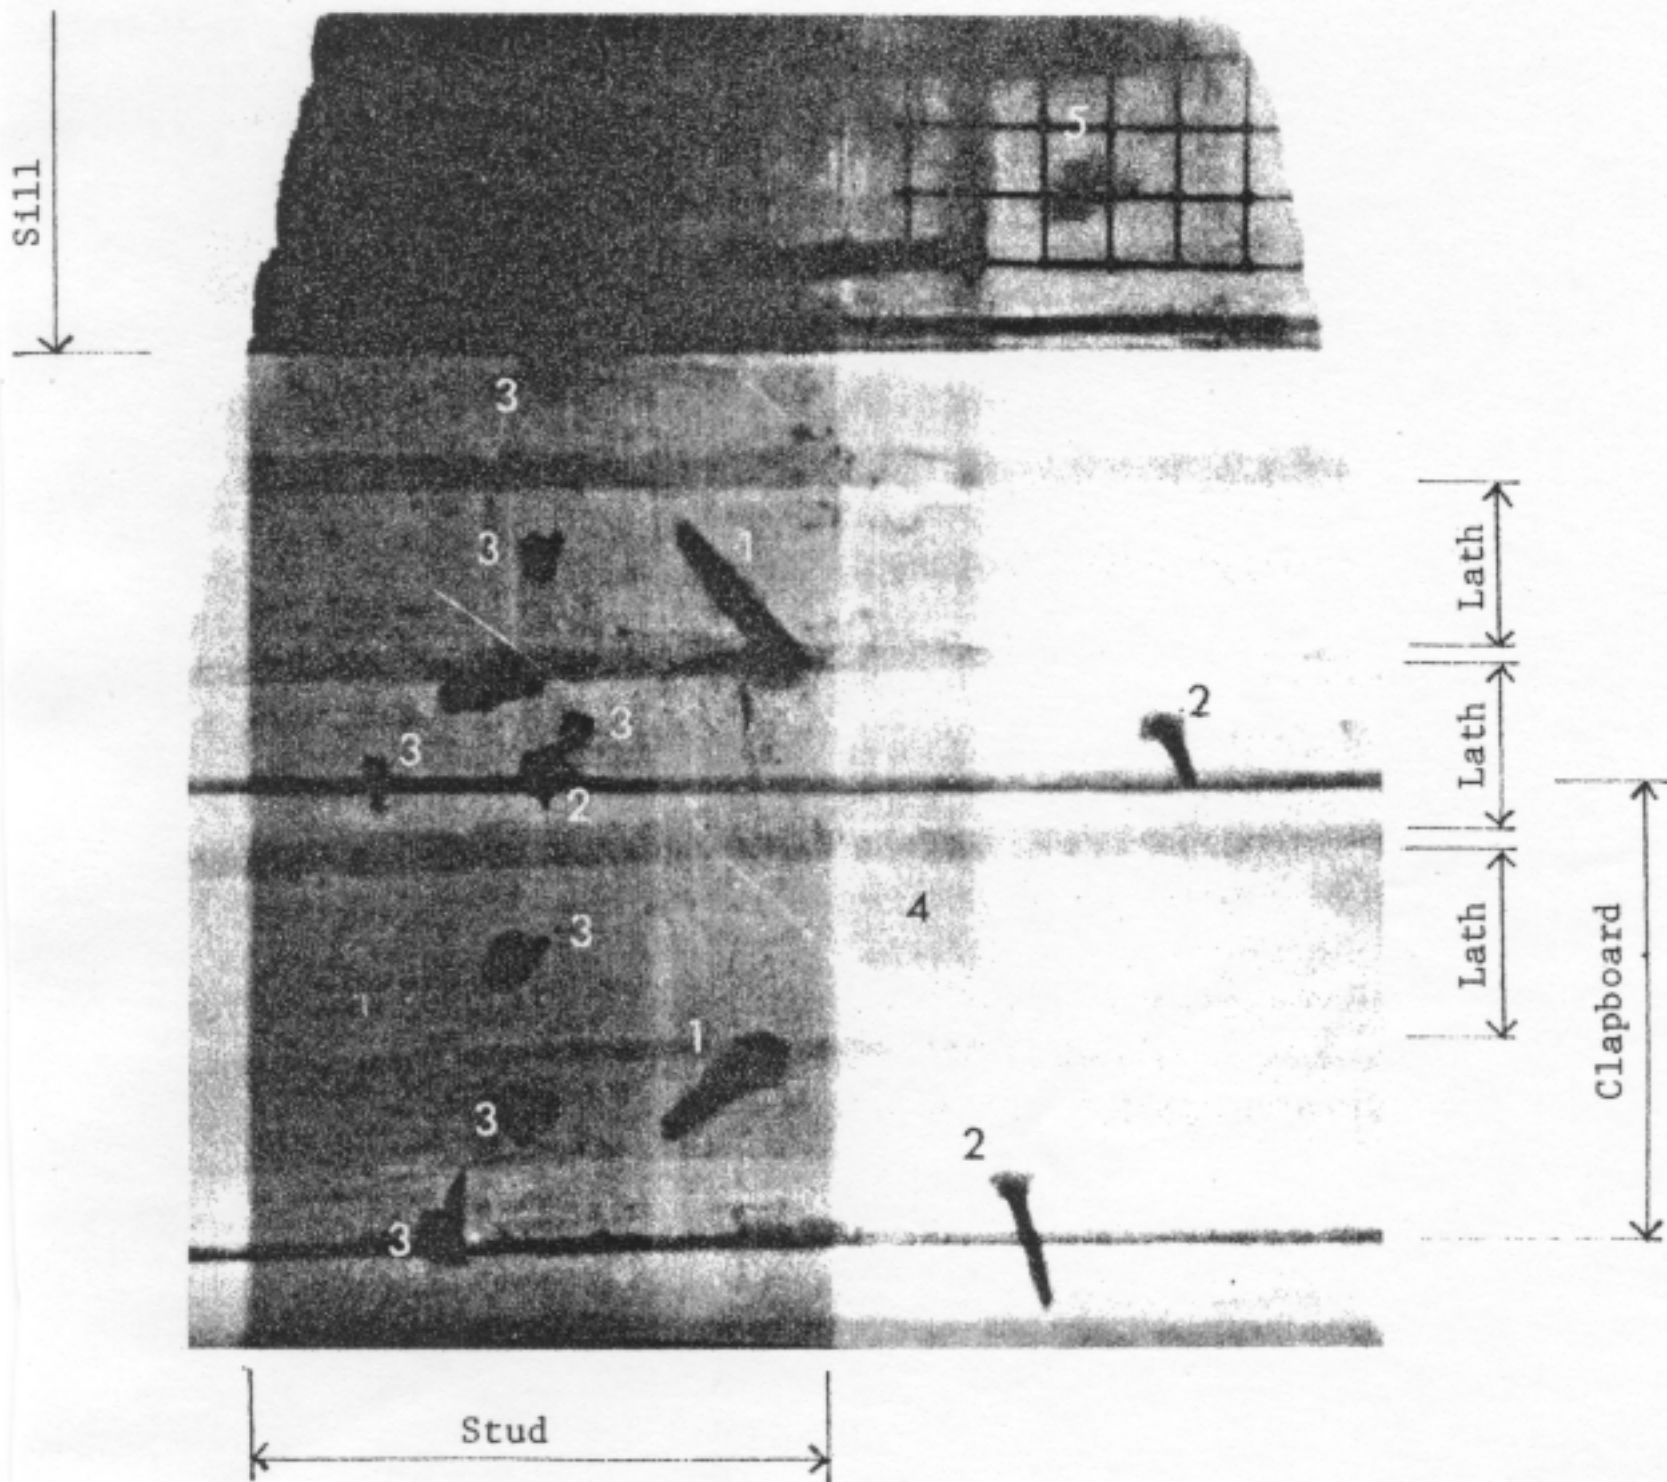
Next, the window itself was examined by X-ray, particularly around the lower corner of each side (see Fig. 13-17). Here again, there was no evidence of either a window frame that could date to the original, or any evidence of notches in the surrounding sheathing that would indicate an earlier frame. The possibility of the early frame being used as a base for the present frame is not entirely discounted, however, as there could be additional evidence that is obstructed, or not clear to us at this time.

Fig. 14 Narbonne House, Salem, Mass.
 X-ray of present window frame, lower left sill.
 Key to X-ray: 1. Sheathing nails
 2. Clapboard nails
 3. Lath nails, wrought
 4. Wood block nailed to stud
 5. Protective wire cloth over window

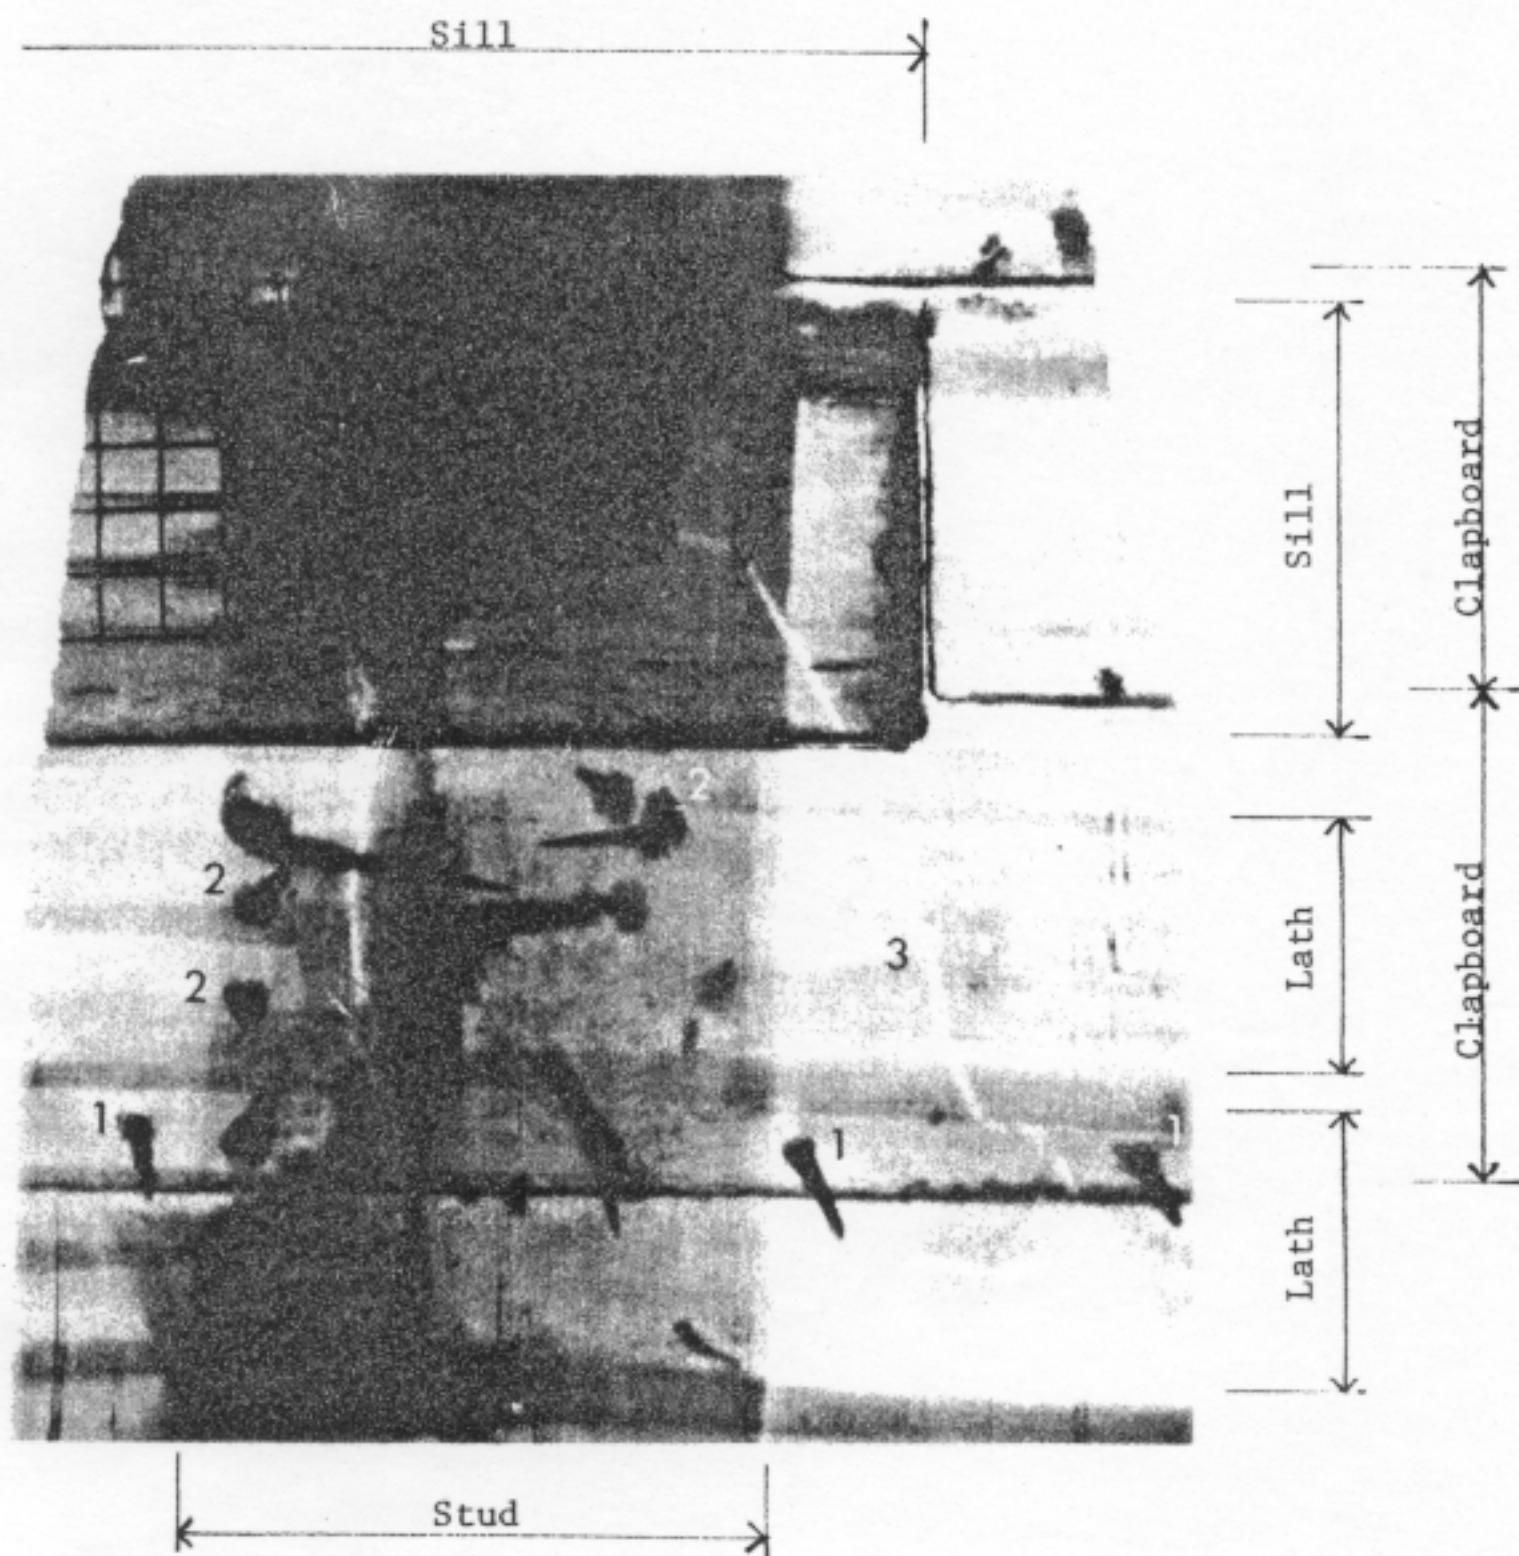
Fig. 15 Narbonne House, Salem, Mass.
 X-ray of present window frame, lower right sill.
 Key to X-ray: 1. Clapboard nail, cut
 2. Lath nails, wrought
 3. Plaster crack

There are quite a few broken nails and unused nails in the stud, adding to the confusion.

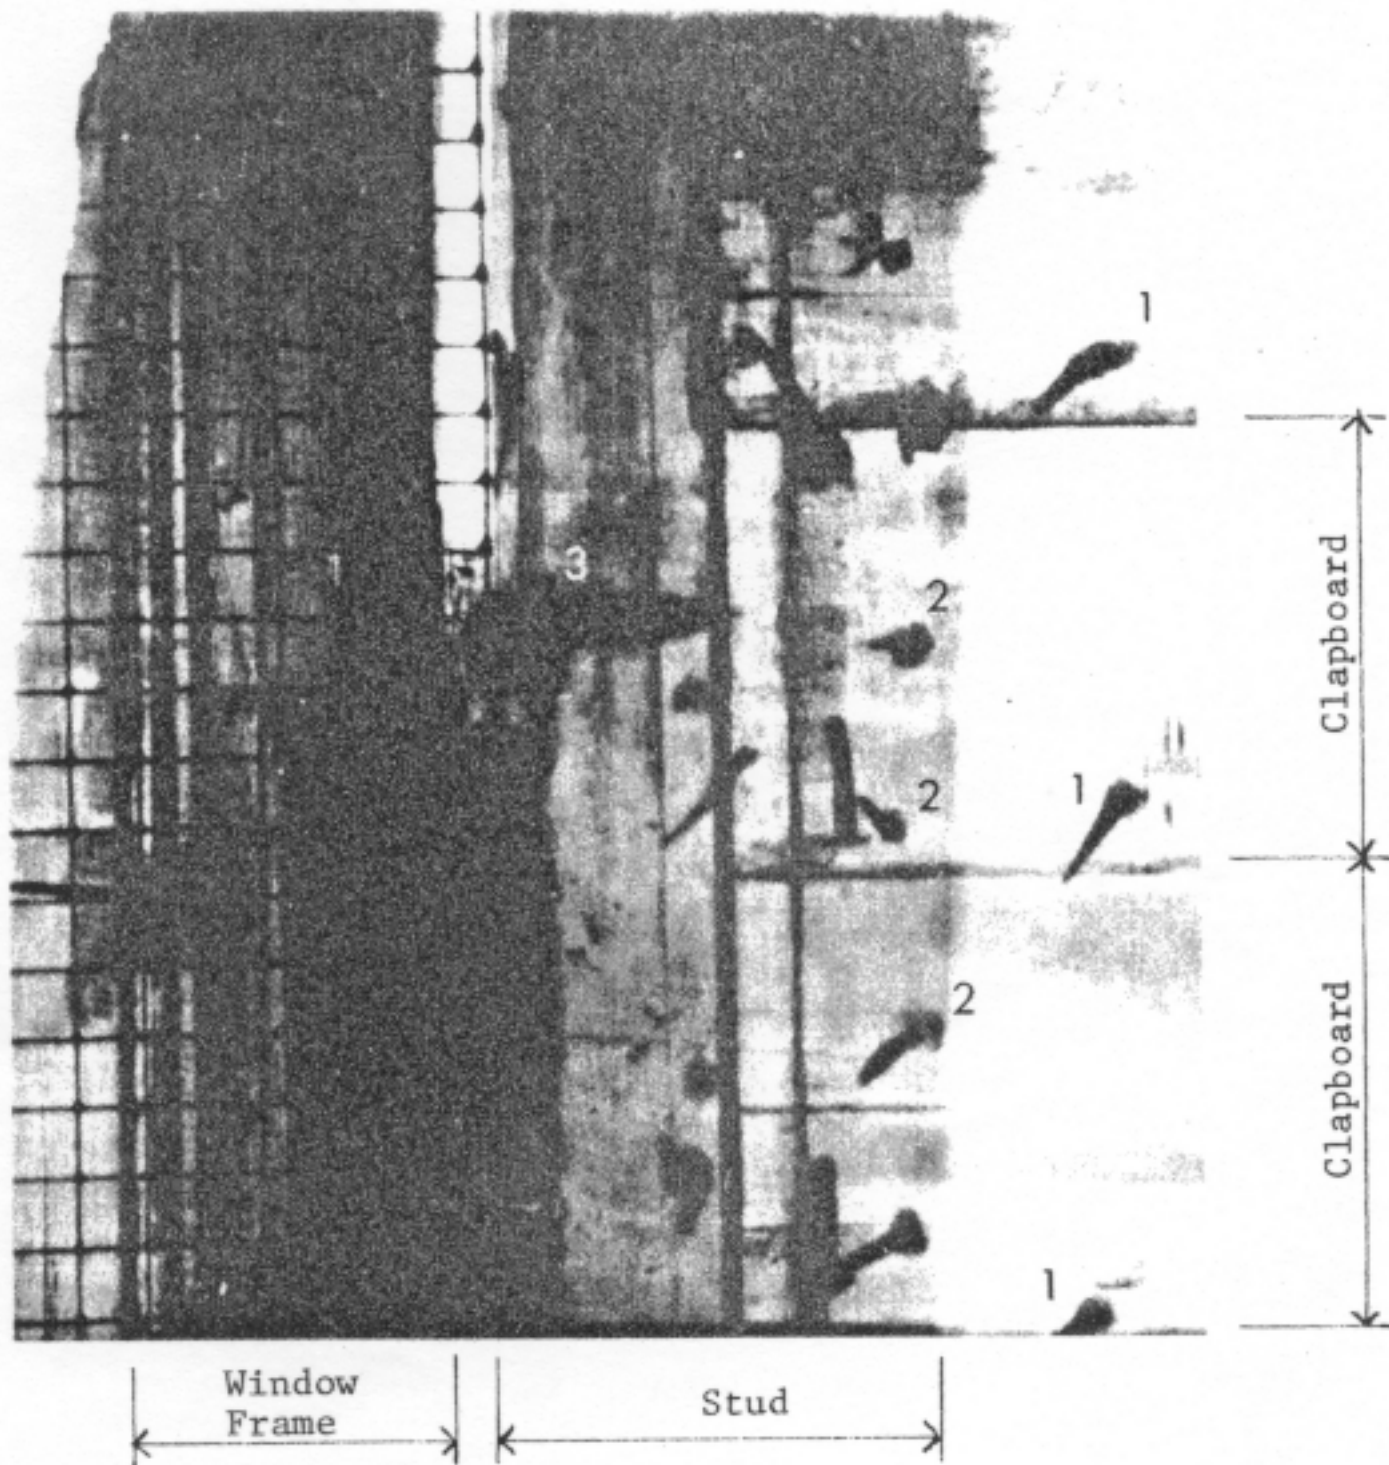
Fig. 16 Narbonne House, Salem, Mass.
 X-ray of present window frame, upper right, showing stud to which frame is attached.

Key to X-ray: 1. Clapboard nails, cut
 2. Lath nails, wrought
 3. Sash lock

There are a few stray nails and broken nails in the stud.

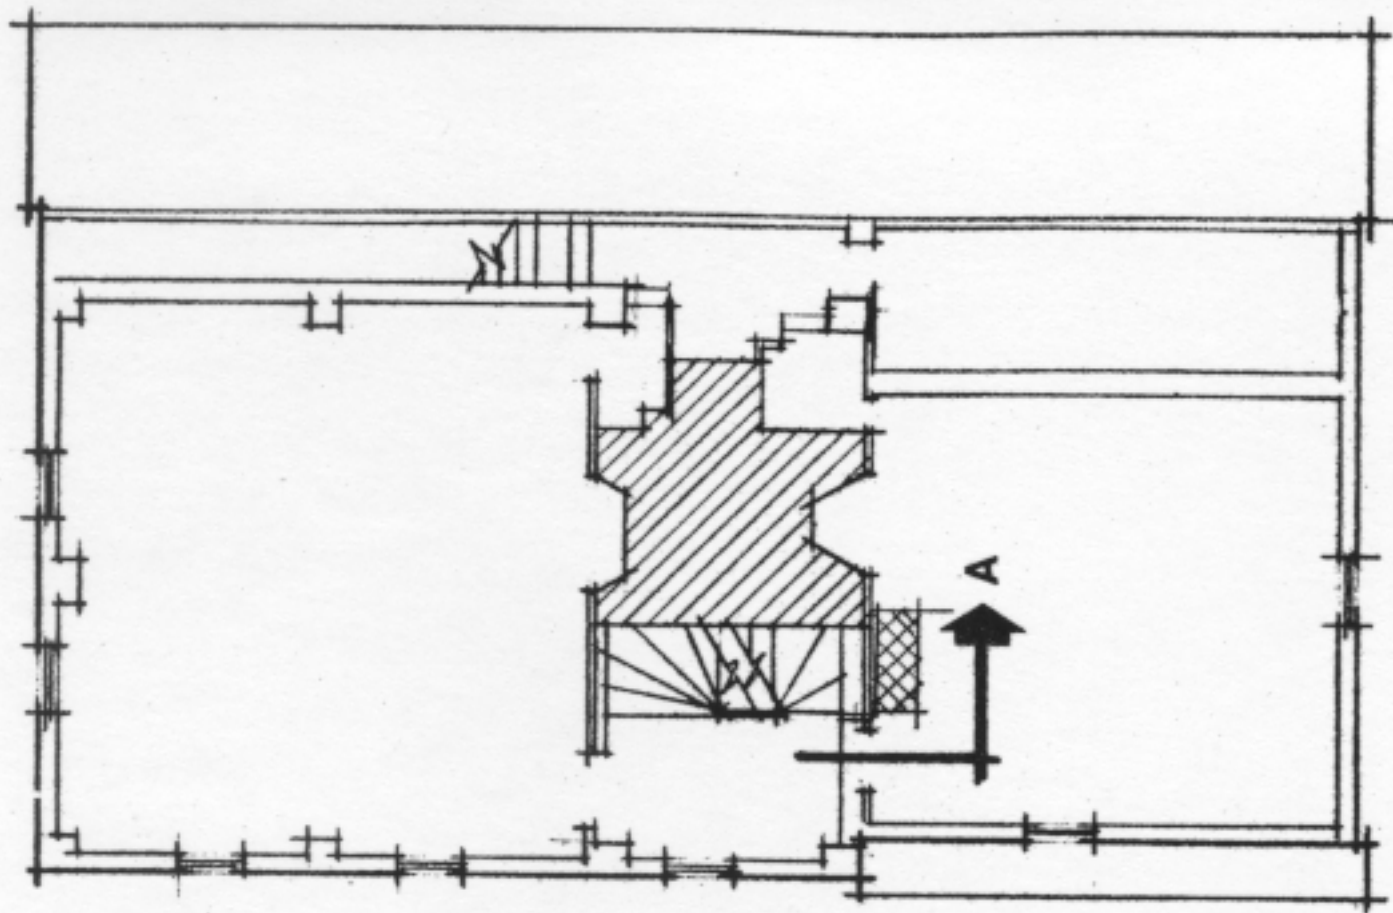
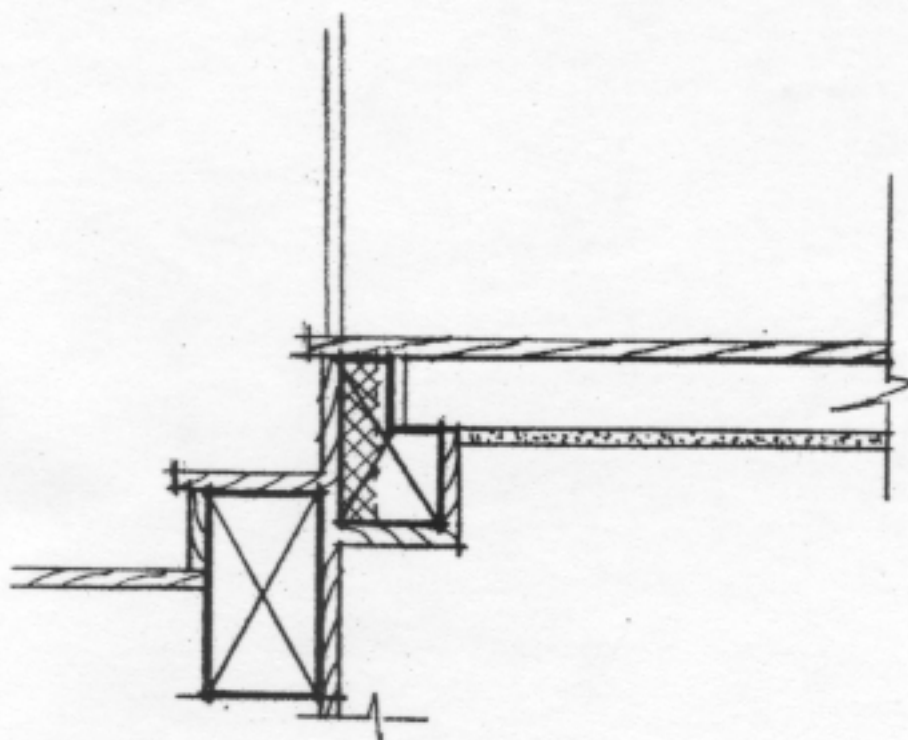
Evidence does exist that indicates that the present addition was once a separate structure, and was butted up against the north portion. One way to gather evidence of this was to examine the area between the frames, particularly the girts (see Fig. 19). If there was once an exterior wall, then stud mortices would probably be found. Actually, stud mortices were found in the north portion's frame by visual means, so examination by X-ray was limited to the south portion's girt. Fortunately for us, the girt in the south portion extended into the room below, thereby giving us a clear shot through the member. The unfortunate part is graphically shown in Fig. 22, which shows that the area we are most interested in has probably been previously removed by persons unknown. We are therefore frustrated in our attempts to obtain evidence that this was once an exterior wall. However, there are quite a few other interesting factors that came to light in this part of the investigation, and they are worthy of comment:

Fig. 19 Floor plan showing cross-hatched area examined for stud mortices. Section illustrates cut-away portion determined in gambrel girt.
