X-RAY ANALYSIS OF THE NARBONNE HOUSE

David M. Hart, Designer
Topsfield, Mass.

In addition, an X-ray analysis was carried out to determine certain structural conditions hidden from view. Specifically, the examination was made in hopes of finding evidence in three areas. First, the existence and configuration of exterior wall bracing; second, the possibility of finding original window framing; third, the possibility of evidence between the two house frames that would indicate whether the south frame once had an exterior wall. The equipment used was Picker Corporation's Portashot System, which is a portable X-ray generator and Polaroid film and processing unit for on-the-job analysis of results.

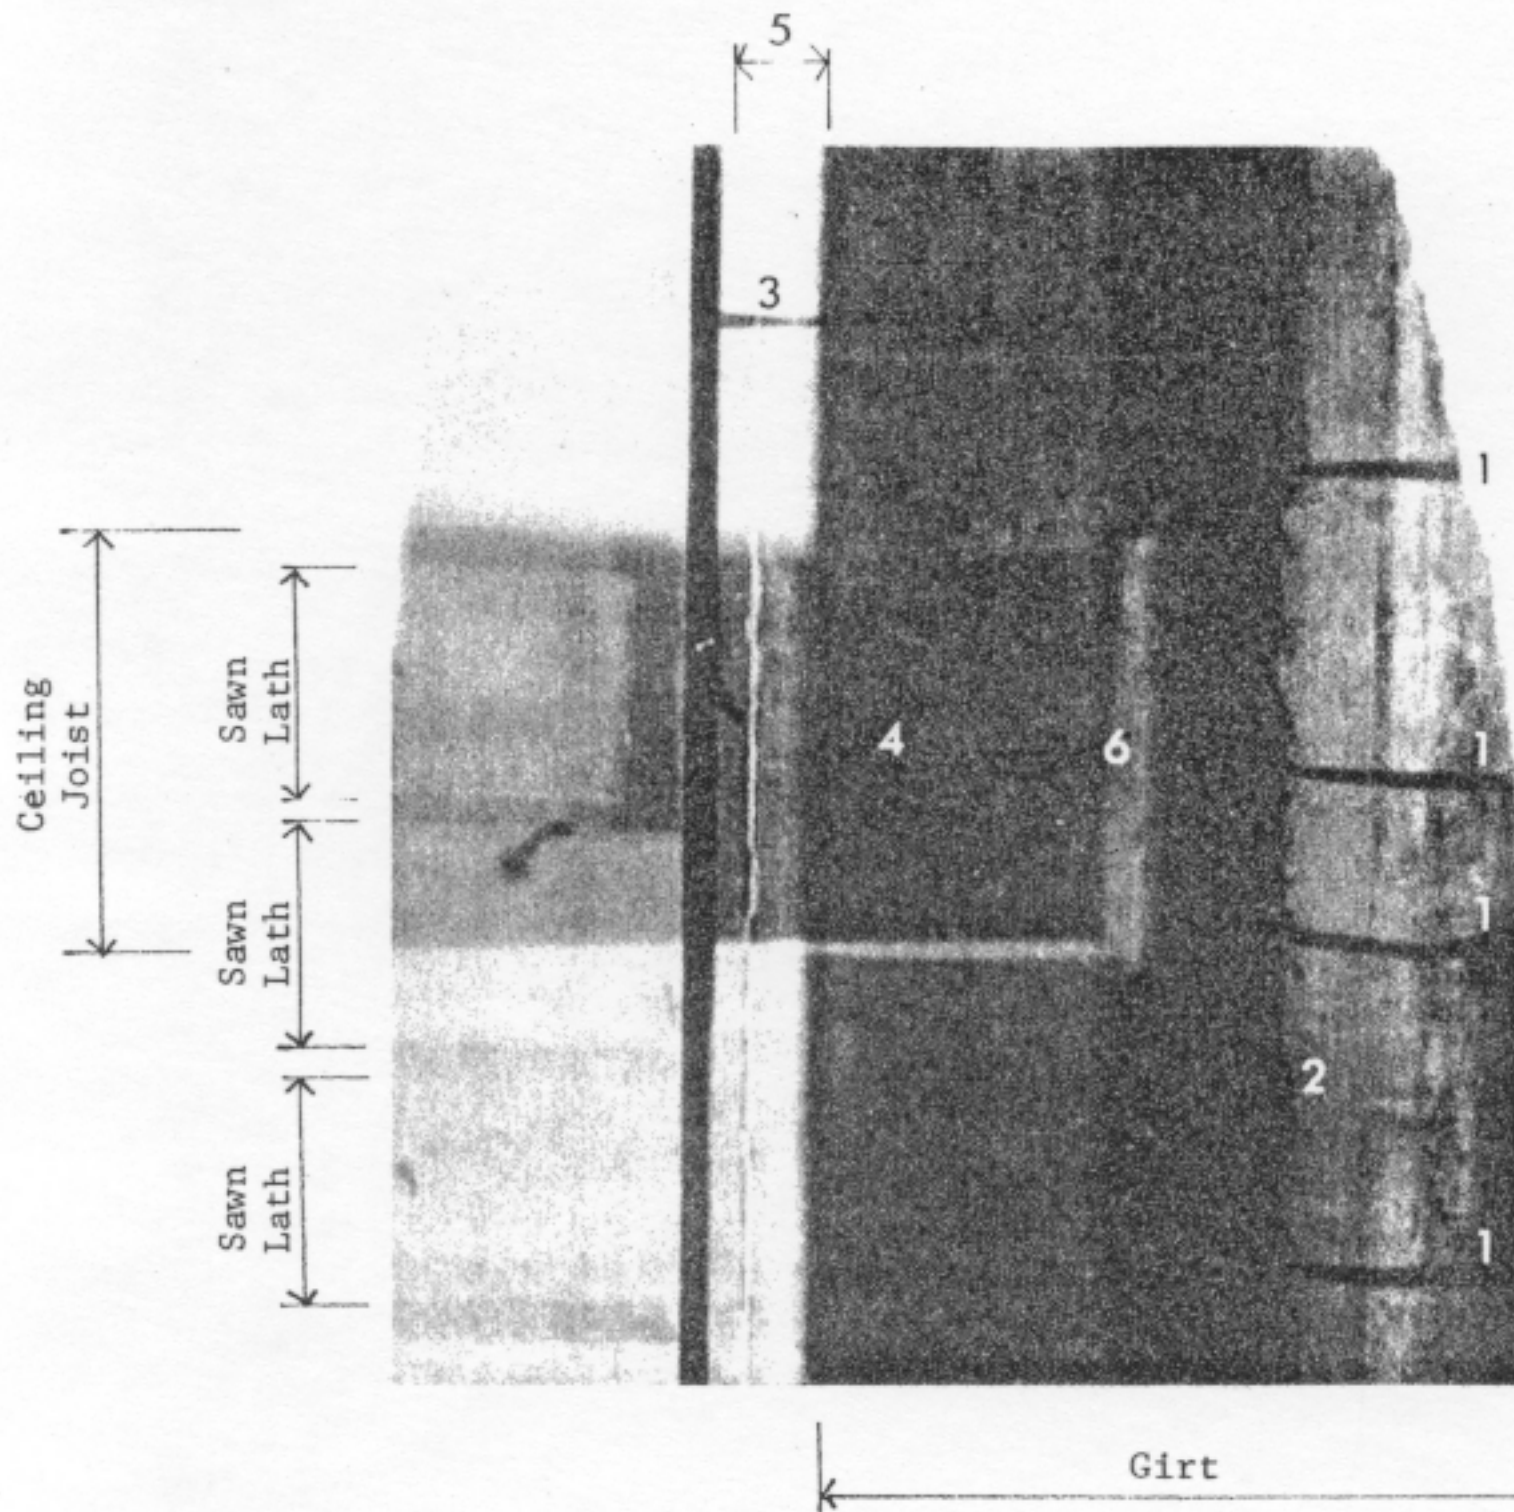
- 1) The joist and mortice shape, and configuration can be clearly seen. Their condition seems to be excellent;
- 2) It can be seen that there are a few large cut nails in the cut-away portion of the girt. As these probably do not date earlier than 1790, it is interesting to speculate if these are part of the work that joined the two frames together;
- 3) The lath in the ceiling is intriguing, as first of all, from its regular shape, it would appear to be sawn along both surfaces. Therefore it would date probably no earlier than 1820. The nails used to hold the lath to a furring

Fig. 22 Narbonne House, Salem, Mass.
 X-ray of areas shown in (20) and (21). Area cut away is seen on right side of X-ray; some large cut spikes also appear in this area. Ceiling joist and mortice are clearly seen.

- Key to X-ray:
- 1. Cut nails
 - 2. Cut-away area of girt
 - 3. Casing nail, wrought
 - 4. Nail, with head flattened
 - 5. Moulding attached to casing
 - 6. Joist mortice
