X-RAY INVESTIGATION OF BUILDINGS

David M. Hart, Designer, Topsfield, Mass.

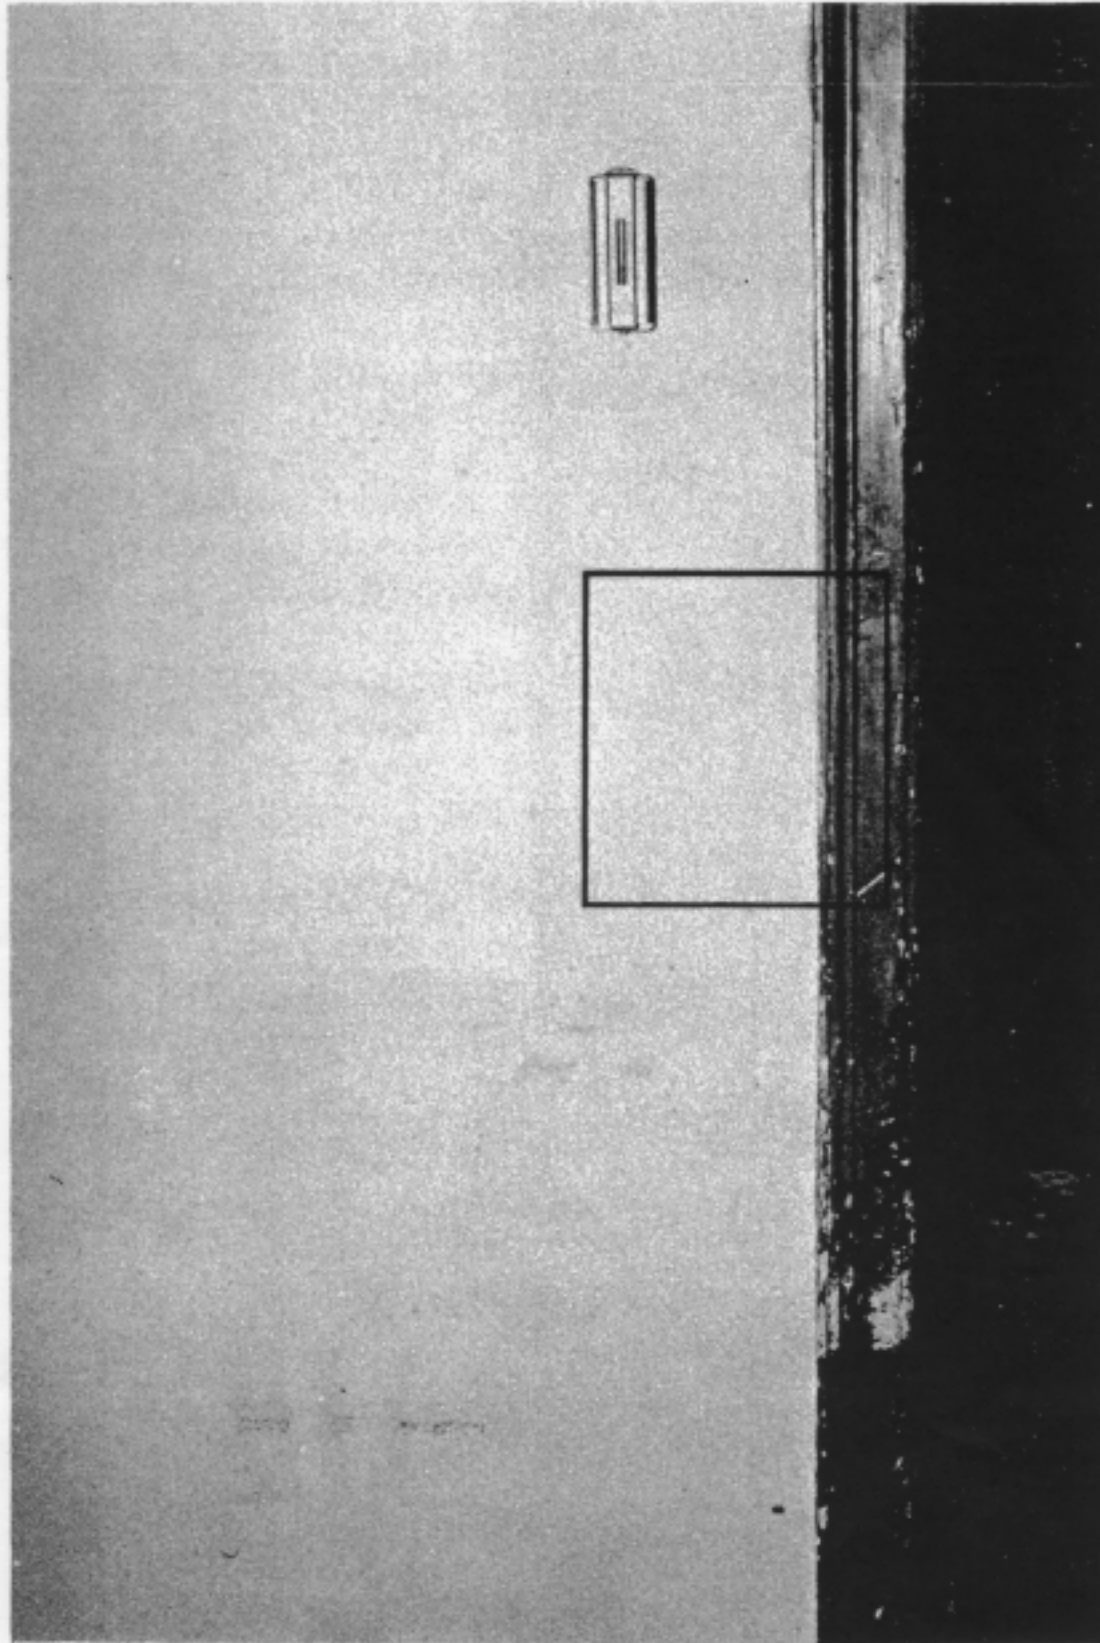
The first example is from the Dexter-Treadwell House, Topsfield, Mass. (c. 1741). This is an internal wall, plastered on one side and panelled on the other. The X-ray reveals stud wall construction, with early, hand-split lath, forged nails, and a recent thermostat cord (Figures 2 and 3).

Fig. 2 Dexter-Treadwell House, Topsfield, Mass. (c. 1741). Rectangle drawn on photo near edge of door opening indicates area of X-ray seen in Figure 3. Note thermostat above.

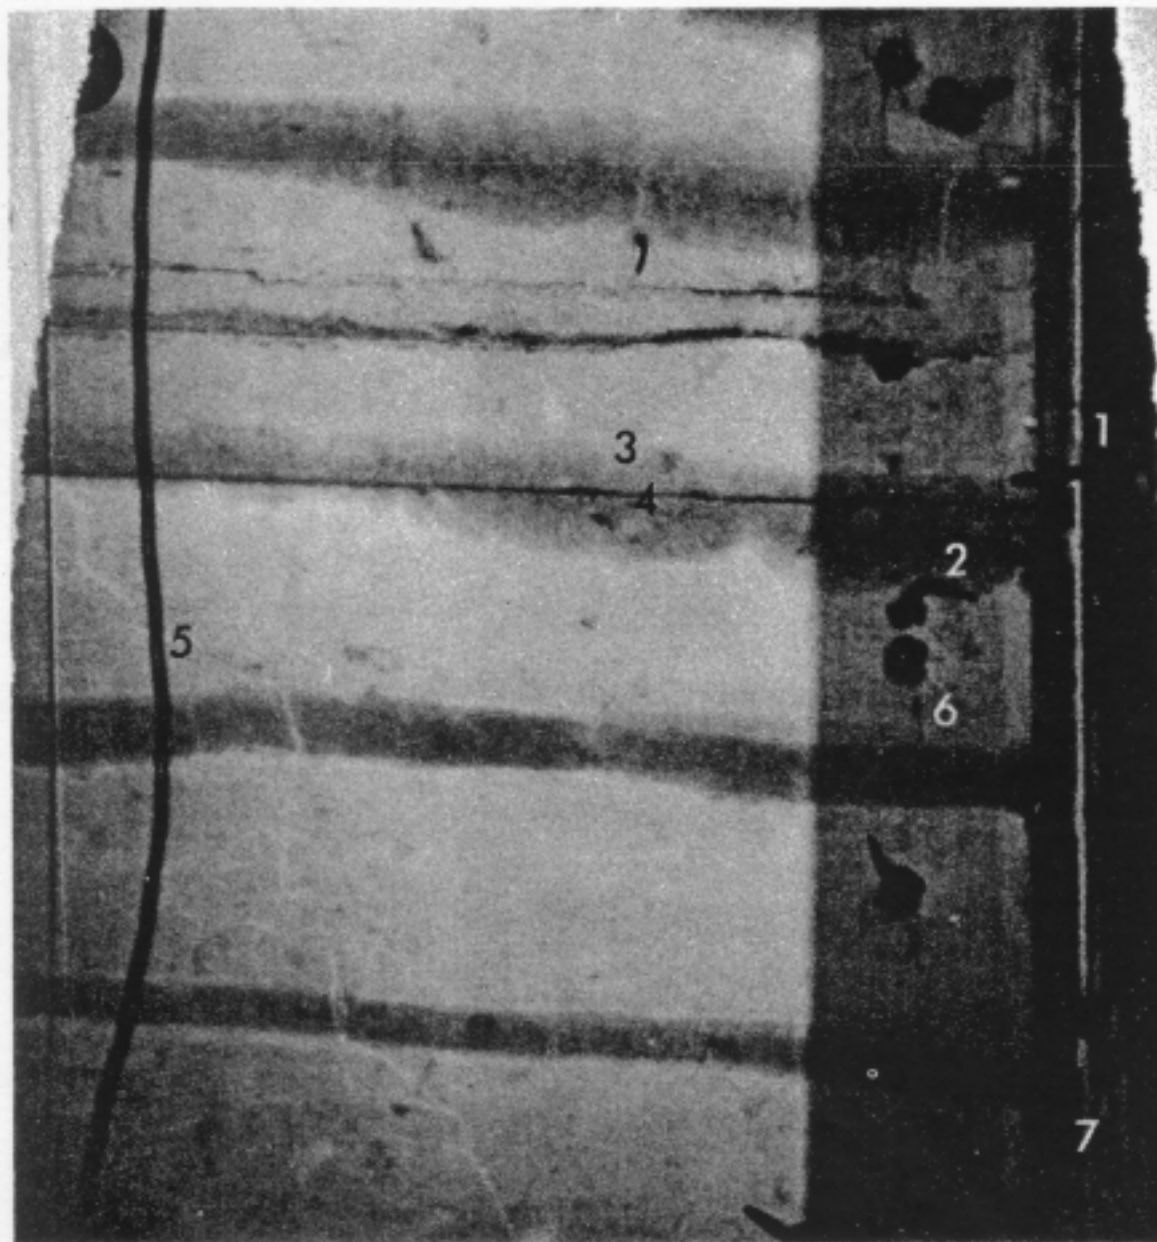
Fig. 3 Dexter-Treadwell House, Topsfield, Mass.

- Key to X-ray:
1. Possible wire nail, on trim
 2. Wrought nails
 3. Hand-riven lath
 4. Plaster Key
 5. Thermostat wire
 6. Wide stud (or door post)
 7. Door backband moulding

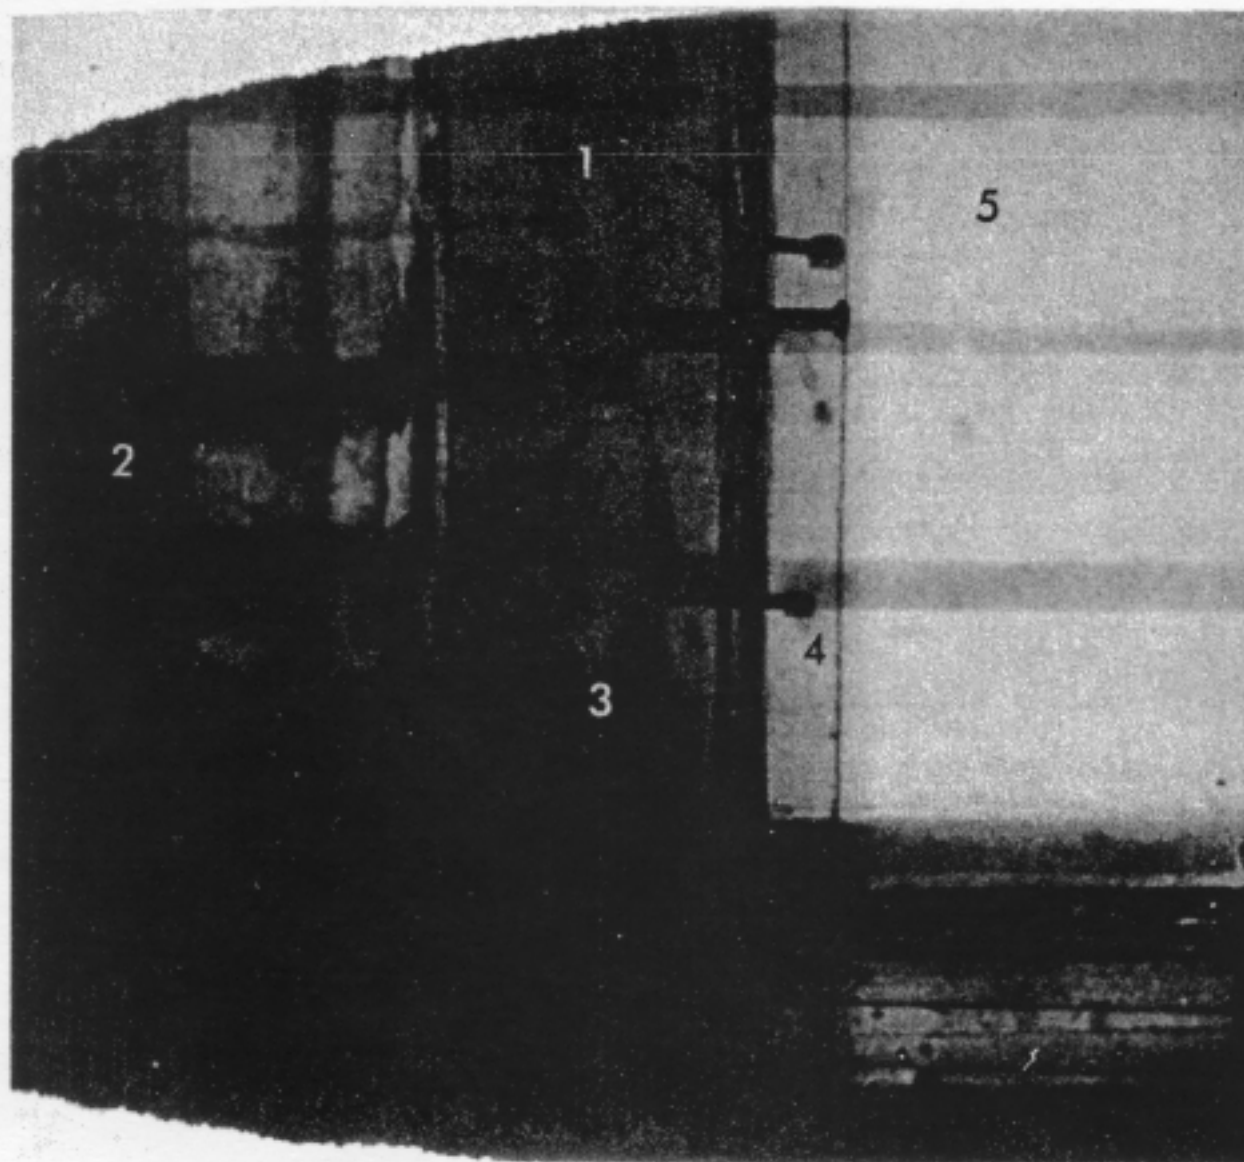
Fig. 5 House of the Seven Gables, Salem, Mass.

The next example is taken through a ceiling in the House of the Seven Gables (John Turner House, 1679) Salem, Mass. There is a prominent crack in the plastered ceiling, which suggests a structural failure (Figure 4). The X-ray reveals a joist directly above the crack, which is being displaced downward by a partition. This would seem to account for the crack. In addition, evidence is seen of new,

regular width lath to the right of the joist, and old, hand-split lath to the left. This indicates the area of recent work on the ceiling (Figure 5).

Key to X-ray: 1. Wrought nail
2. Hand-riven lath
3. Joist
4. Cut nail
5. Sawn lath

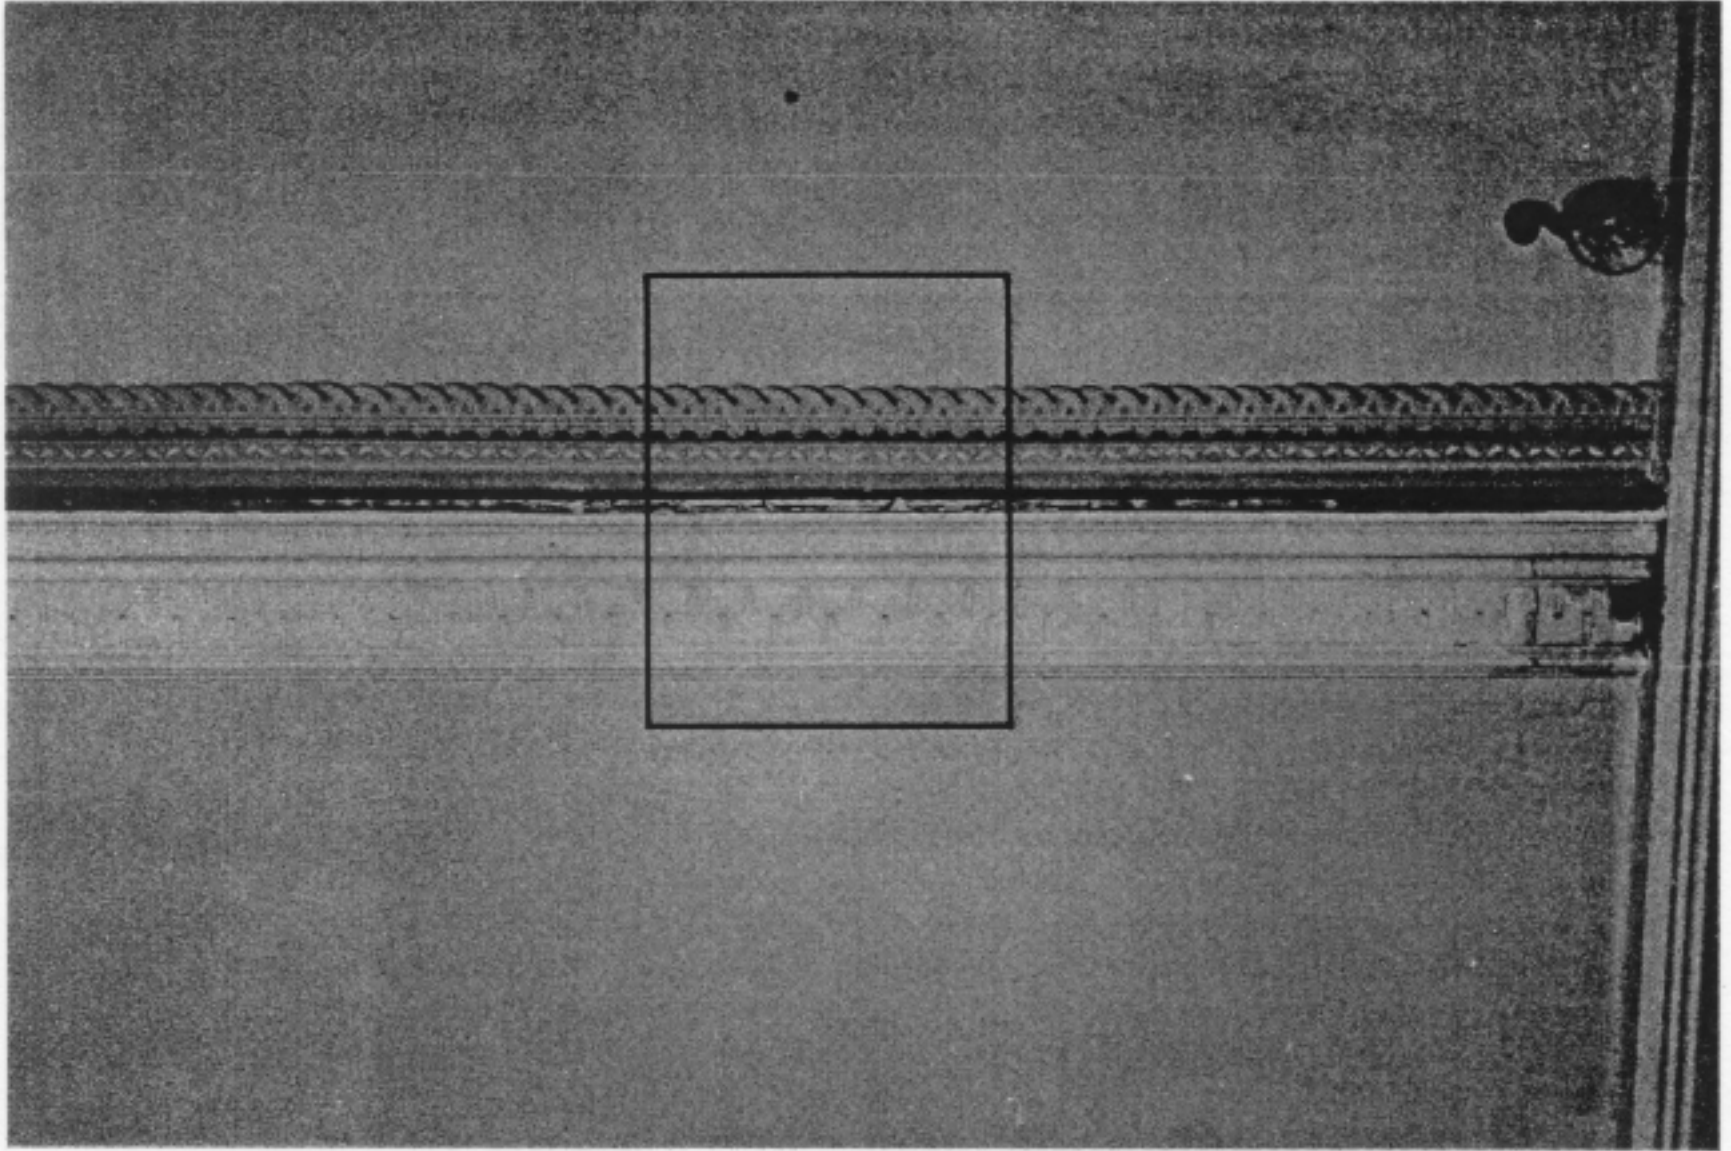
The third example is from the Harrison-Gray-Otis House, Boston, Mass. (1796), headquarters of the Society for the Preservation of New England Antiquities. The photograph shows one side of an internal wall (Figure 6). Both sides have plaster above a chair rail. This side is plastered below its elaborate rail, while the other side (not illustrated) has wood panelling below. The X-ray reveals items hidden in the wall. Lath and plaster are seen, as well as possible plank wall construction. Carved ornament details on one of the chair rails is evident; numerous coats of paint conceal them from view on the surface (Figure 7).

Fig. 6 Harrison Gray Otis House, Boston, Mass. Rectangle drawn across photo of chair rail indicates area of X-ray seen in Figure 7.

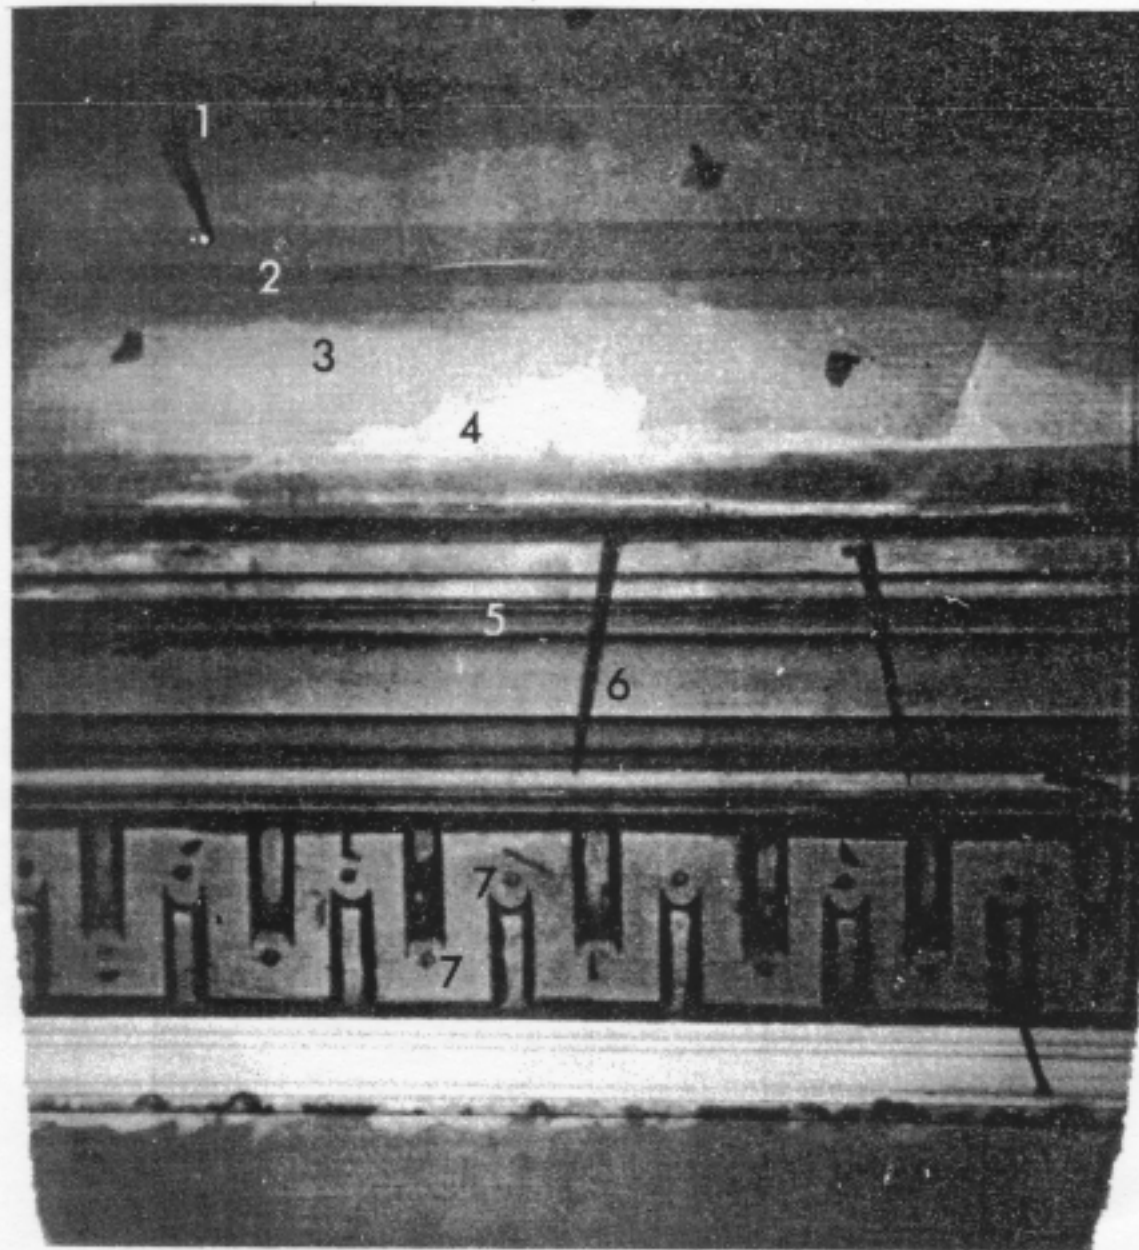
Fig. 7 Harrison Gray Otis House, Boston, Mass.
Key to X-ray: 1. Wrought nails
2. Plaster Key
3. Lath
4. Lead paint chipped away
5. Chair rail
6. Possible cut nails
7. "I" dentil drill holes not visible on surface due to paint build-up

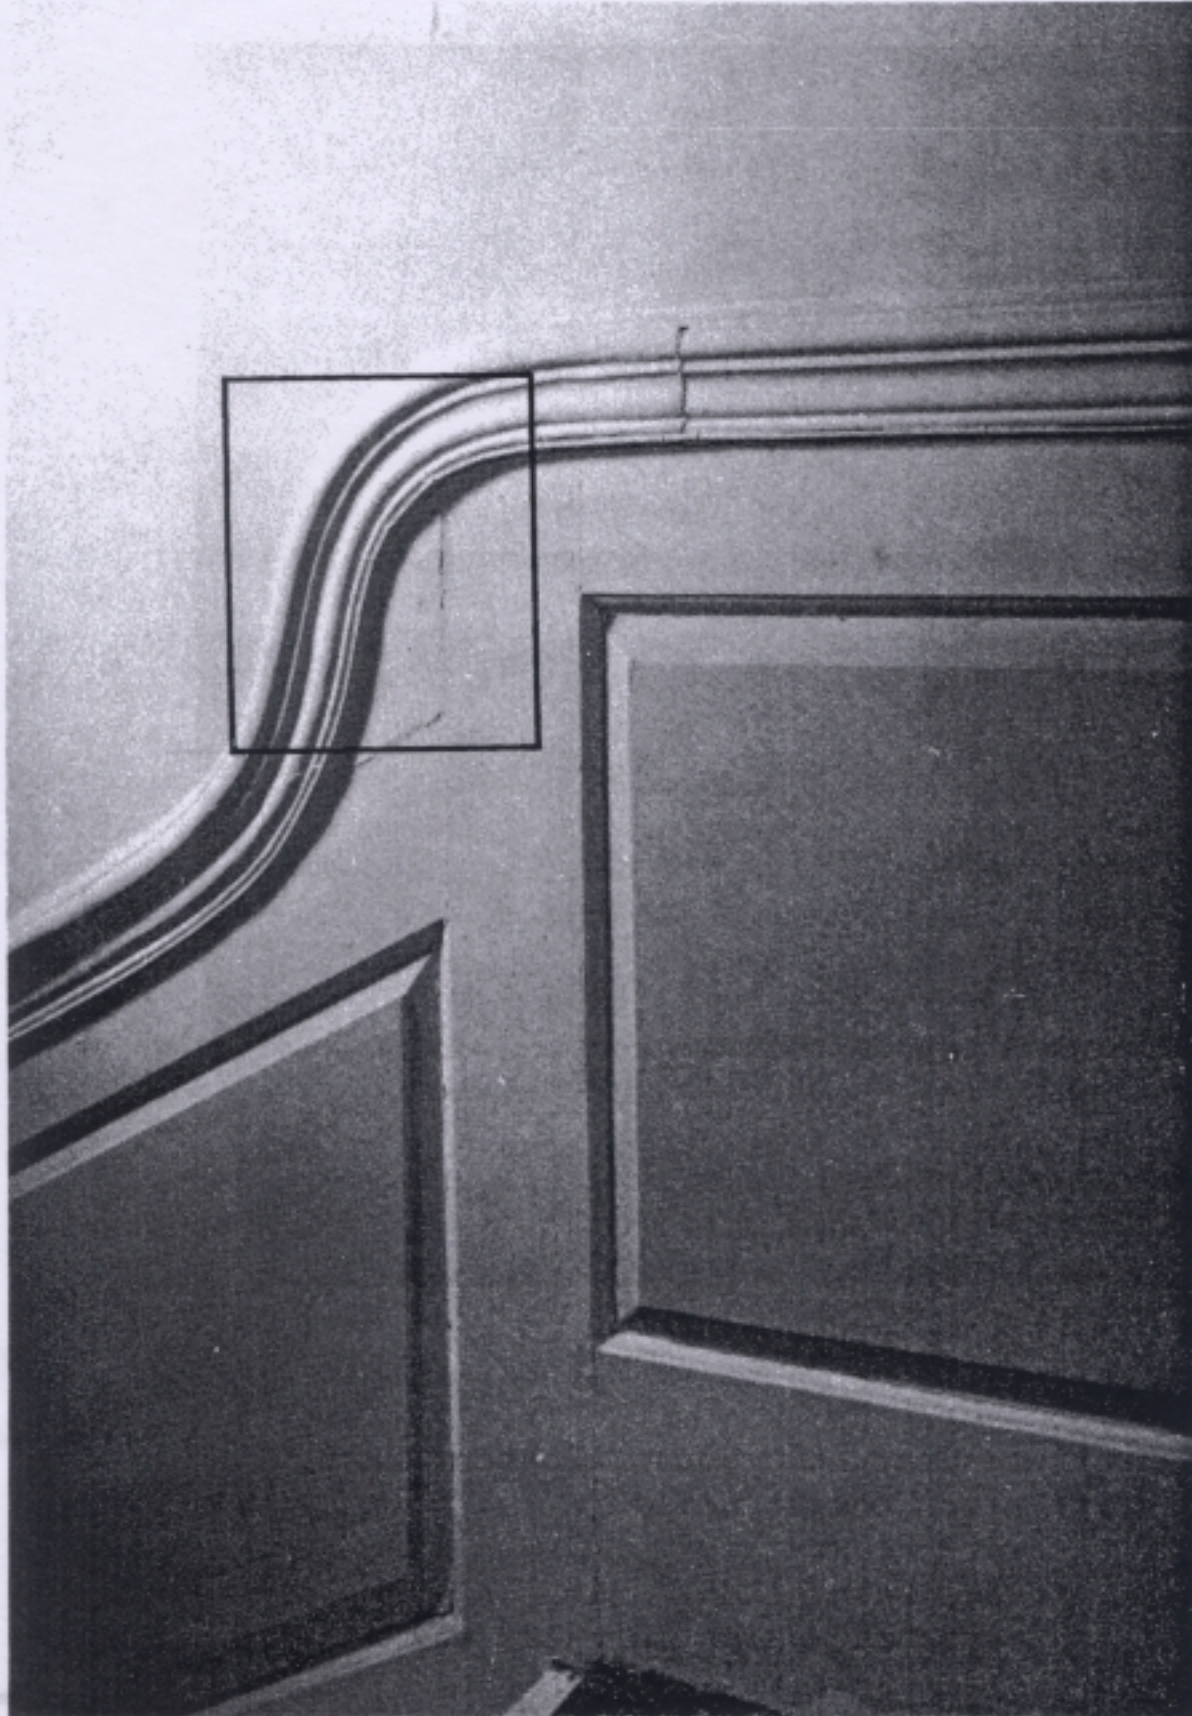
The next example is a ramped side rail in the stair hall of the S.P.N.E.A.'s Codman House property in Lincoln, Mass. The staircase had been constructed in the 1790's, and had been partially remodeled in the second half of the 19th century. There is a question as to the dating of the rail (Figure 8). The wall illustrated has plaster above the rail and wood panelling below. The opposite side of the wall (not illustrated), also has plaster above a chair rail, and wood panelling below. The presence of wrought nails and uniform paint distribution is made clear by the X-ray. The evidence, therefore, suggests that the rail is of the 1790 period (Figure 9).

Fig. 8 Codman House, Lincoln, Mass. Rectangle drawn across photo of staircase dado rail indicates area of X-ray seen on Figure 9.

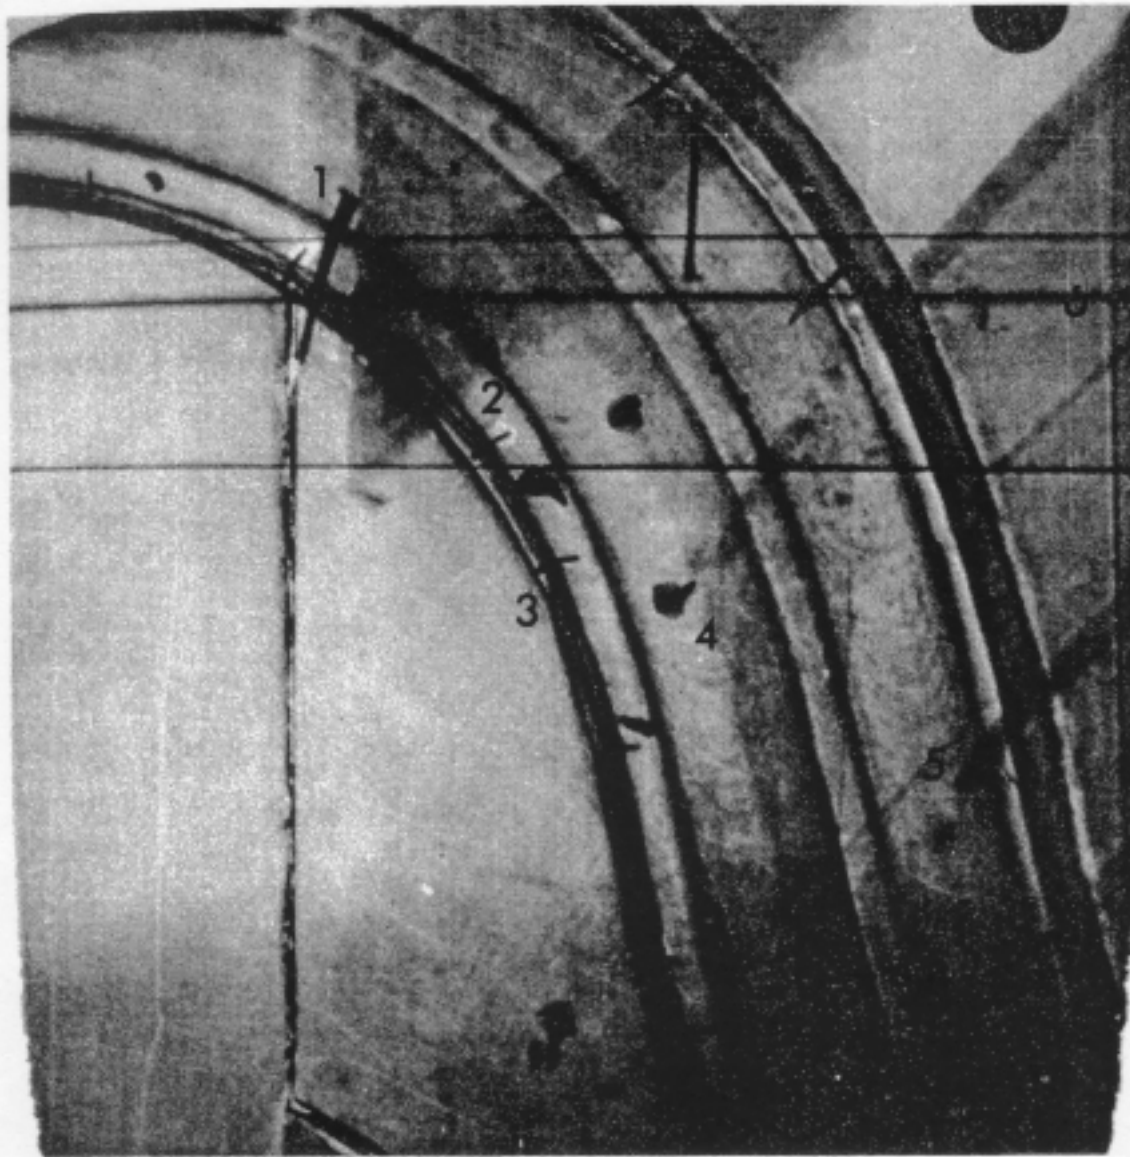
Fig. 9 Codman House, Lincoln, Mass.

- Key to X-ray:
1. Possible cut nail
 2. Lead paint chipped by staple
 3. Telephone cable
 4. Wrought nail
 5. Half rail of dado
 6. Hand-riven lath

Note: This X-ray is a reverse view of dado rail seen in Figure 8.

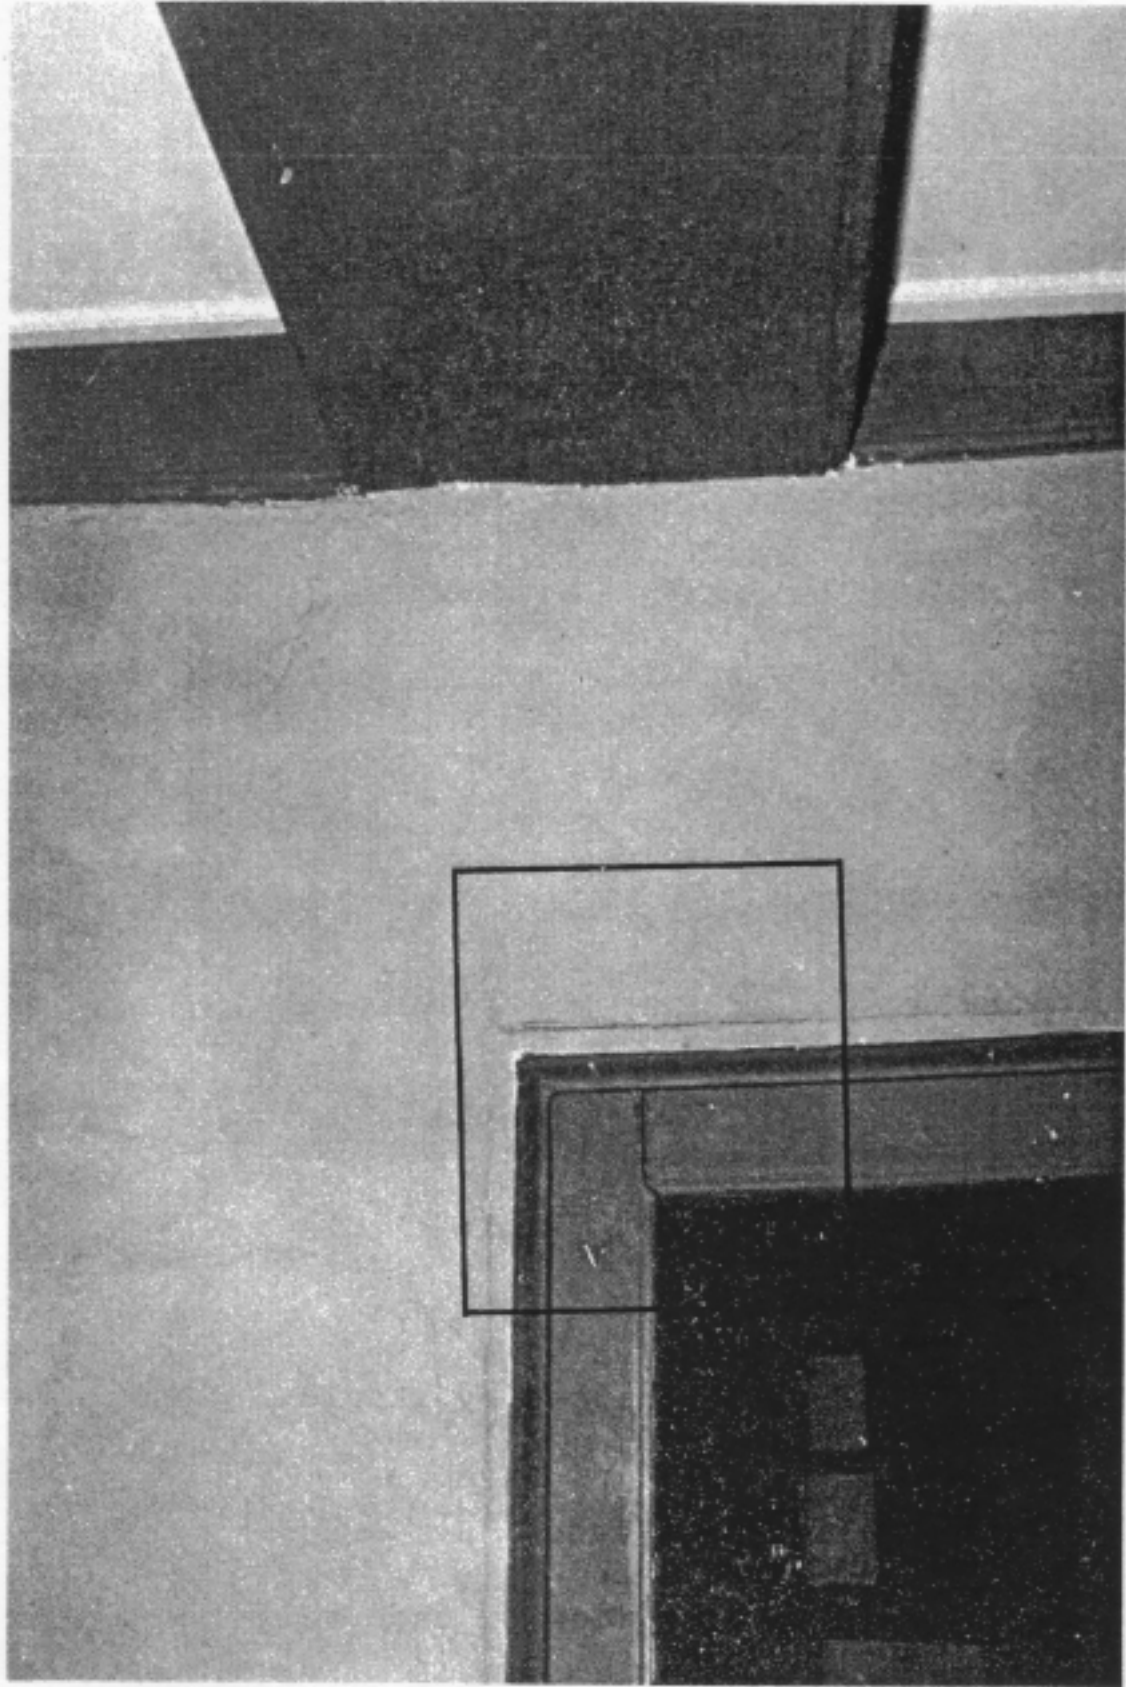
The fifth example is from the Edward Allen House, Salem, Mass. (1768). A summer beam spans 36 feet, at the middle of which there is a cross wall. The X-ray, taken at the door jamb in this wall, reveals an apparent six-inch wide stud. This stud evidently acts as a support. Lath and the door frame members are all attached to this stud. Note the presence of a large hand-wrought spike (Figures 10 and 11).

Fig. 10 Edward Allen House, Salem, Mass.
Rectangle drawn on photo across upper corner
of doorway indicates area of X-ray seen on
Figure 11.

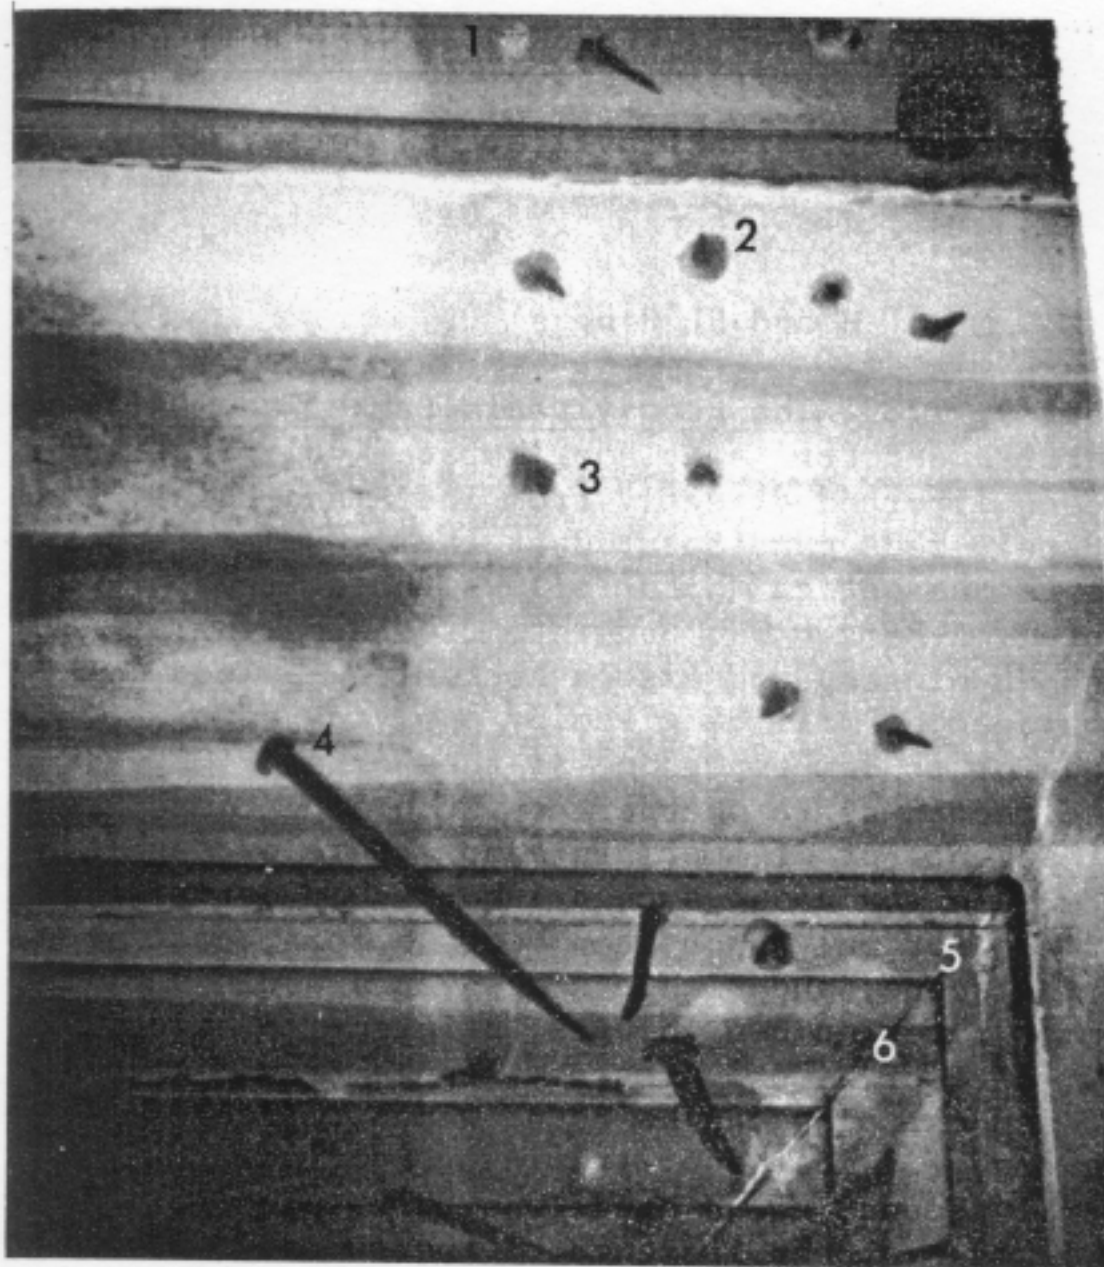
Fig. 11 Edward Allen House, Salem, Mass.
X-ray taken from opposite side of wall seen
in Figure 10.

- Key to X-ray:
1. Wide shadow of door stud (or post)
 2. Wrought nails
 3. Hand-riven lath
 4. Large wrought nail
 5. Wooden pin
 6. Doorway architrave backband
