how to date a house: **part one and part two**

by **David M. Hart**

Each detail of the appearance and construction of a home contains a clue to the structure's age. Style, orientation, frame, windows, siding, even nails can tell you something. Here's how an expert adds up all those little clues....

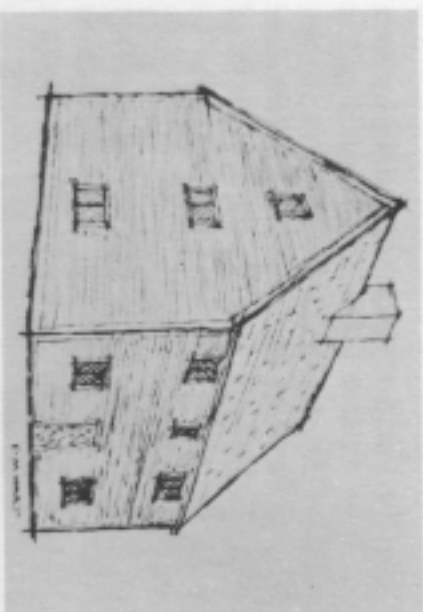
FIGURE 1

A "First Period" house, the common style up to about 1725. Typical characteristics: massive chimney, casement windows, asymmetrical plan and elevation, steep roof pitch (45°-60°), and gable overhangs.

First Period (1620-1725): This style was characterized by a steeply pitched roof (45° and steeper), gable and story overhangs, drops and pendants, massive chimney stacks, and leaded glass windows. There are few, if any, remaining examples of this type that have not been at least moderately altered but, with careful analysis, one can recreate (on paper) the house's original appearance. (See Figure 1.)

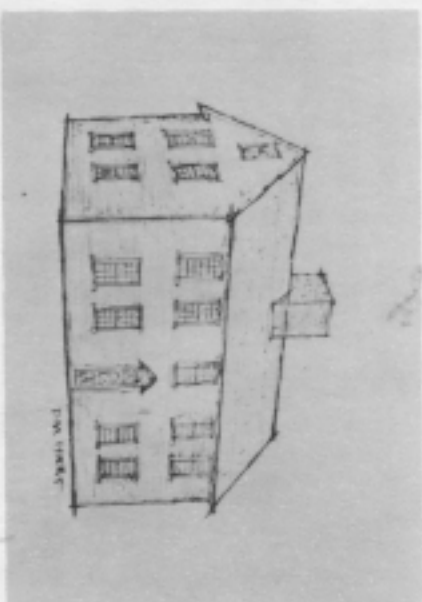
FIGURE 2

"Georgian" style, popular from about 1725 to 1790. Typical characteristics: a large central chimney, moderate roof pitch of 30°-40°, center entrance, a balanced plan and elevation, and double-hung windows.

Georgian or Second Period: This style became widespread after 1725, and continued right up through the Revolution. Typically, houses of this period have a balanced design (double-hung windows on either side of a central entrance) and are similar to what we sometimes call "center-entry colonials." This style did go through several small variations and

changes that relate to economic conditions, time and locality. (See Figure 2.)

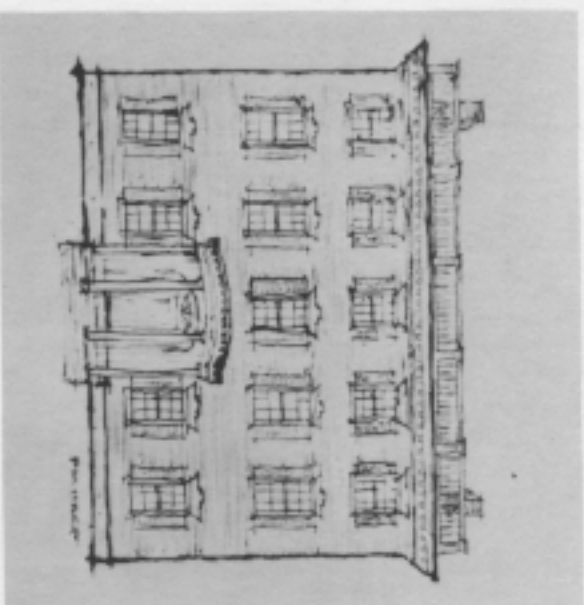
FIGURE 3

The "Federal" style, in vogue with New England housewrights from about 1780 to 1820. Typical characteristics: a low-profile roof, balustrade across roof edge, balanced elevation, and light classical trim details.

After 1790, styles changed with more rapidity. Post-colonial styles such as the Federal from 1790 to 1820, and the Greek Revival from 1820 to 1860 (see Figures 3 and 4), gave way to a flurry of romantic and eclectic styles such as Queen Anne, Shingle, Second Empire, and so on. A detailed discussion of these styles may be found in sources such as Marcus Whiffen's *American Architecture Since 1780: A Guide to the Styles*.

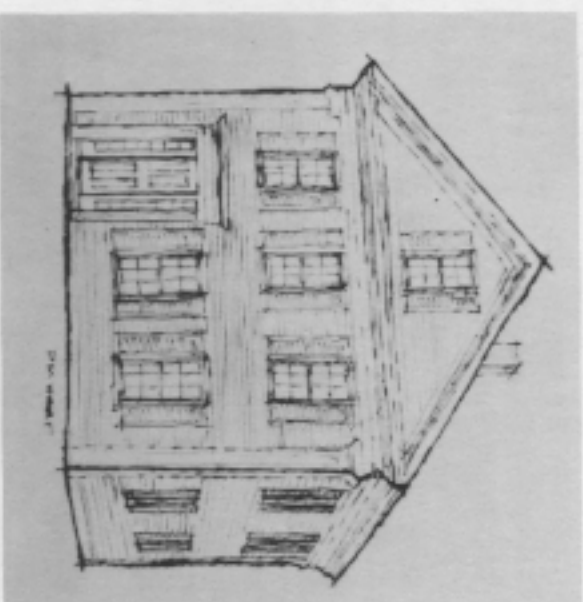
FIGURE 4

The "Greek Revival" style was common from about 1820 to 1860. Typical characteristics: a pedimented gable end facing the street, pilasters on the corners, heavy trim, and small, spindly chimneys.

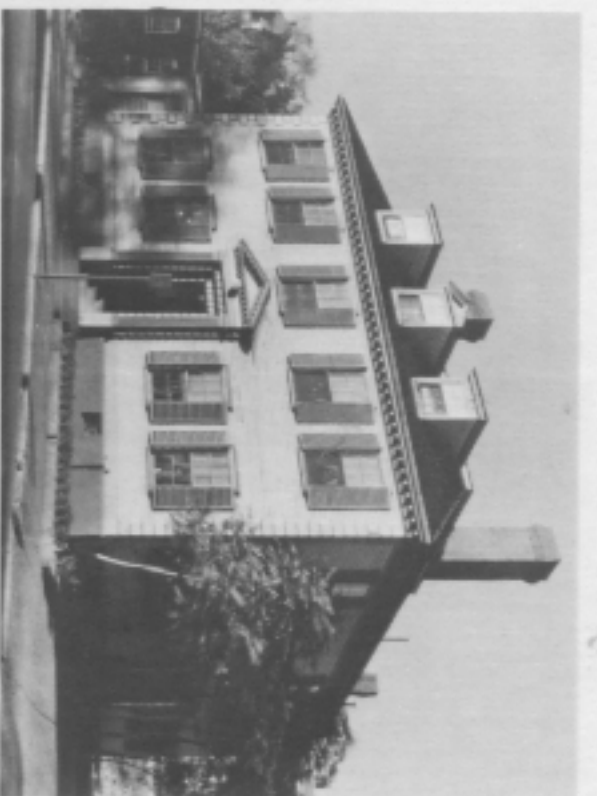
Right: A good example of a Georgian period home — balanced facade, typical entrance — which also displays a hipped roof, used commonly in the latter part of the 18th century.

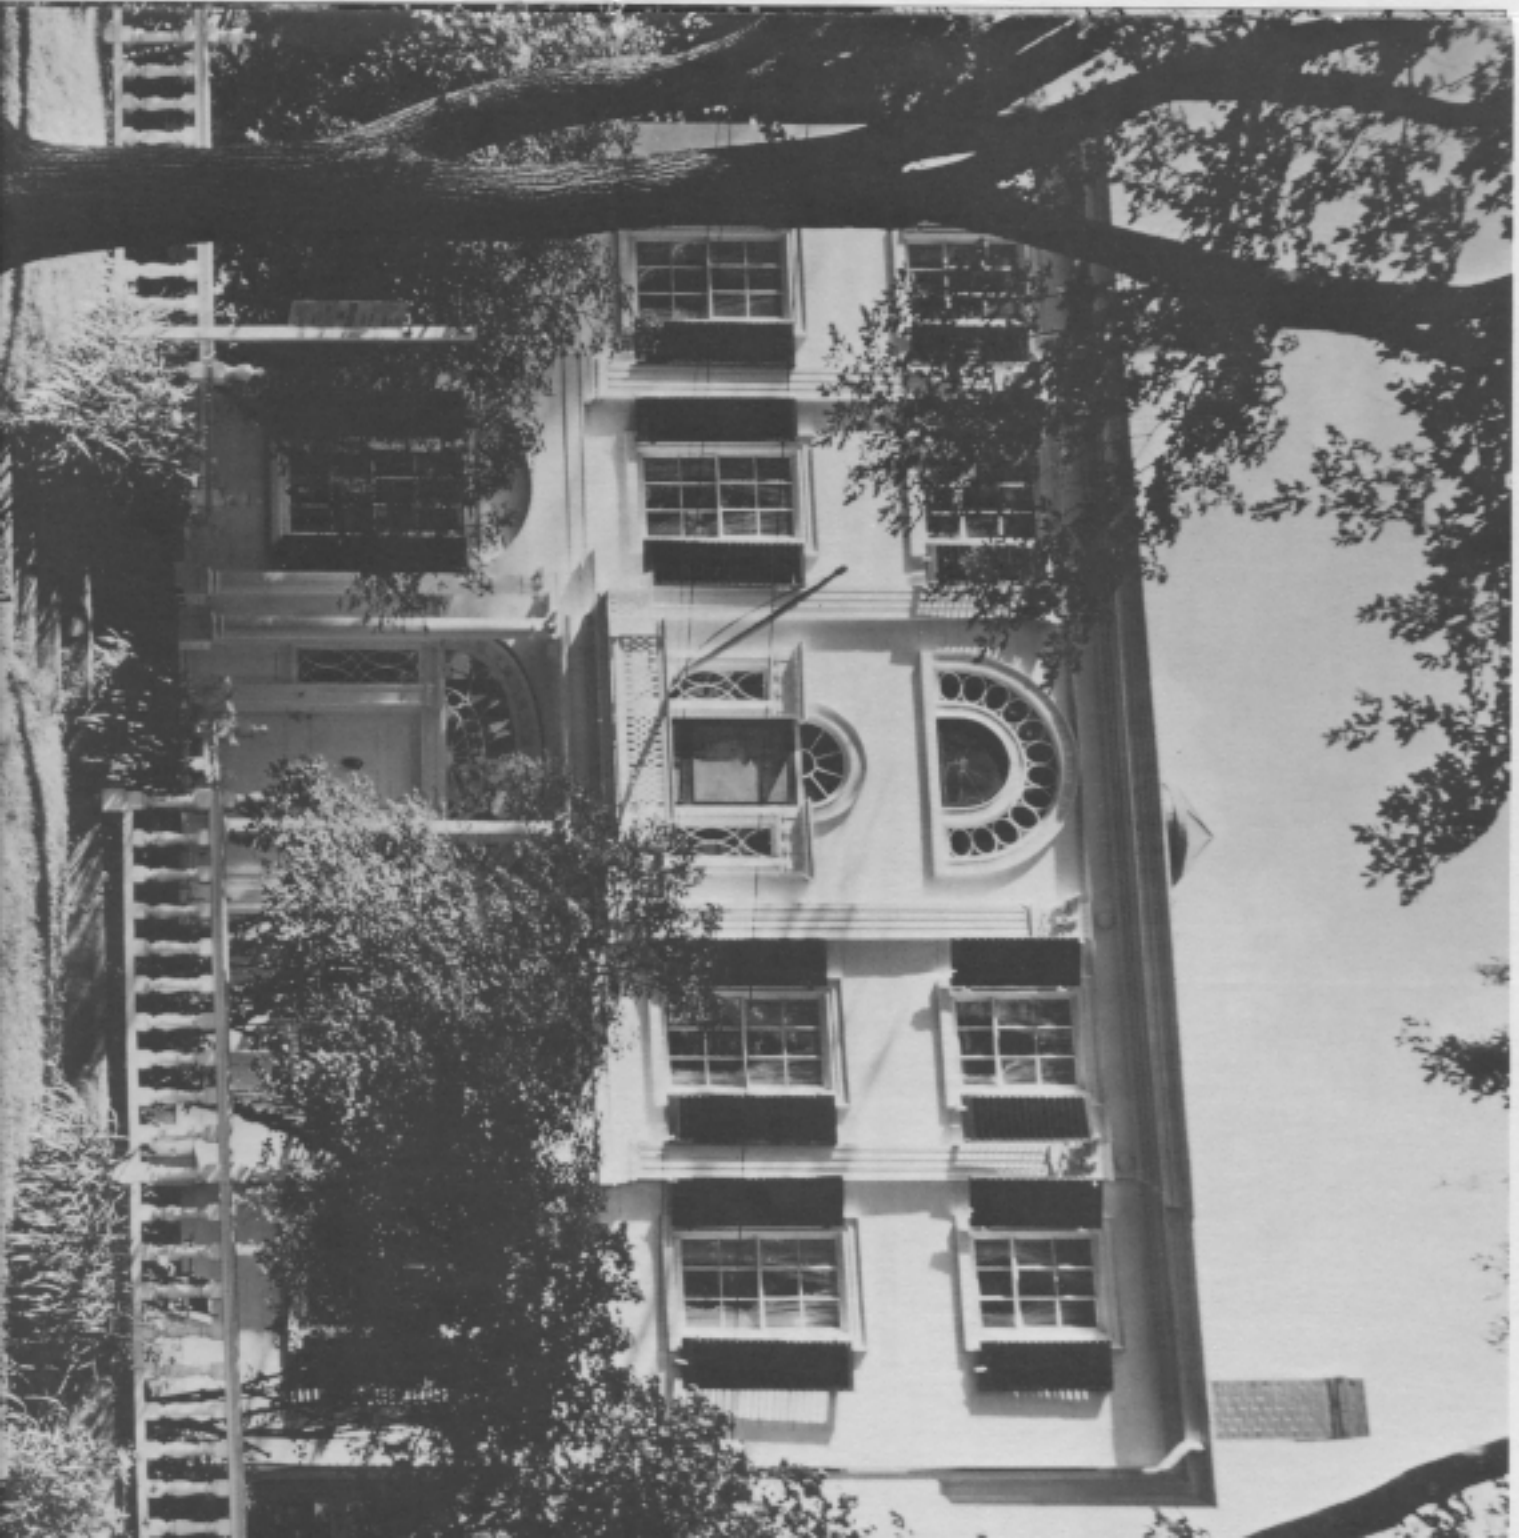
Below: This beautiful home in Wiscasset, Maine, represents high-style Federal architecture. Notice the balanced facade, three stories, low-profile roof that appears flat, and the elaborate window treatment above the entrance.

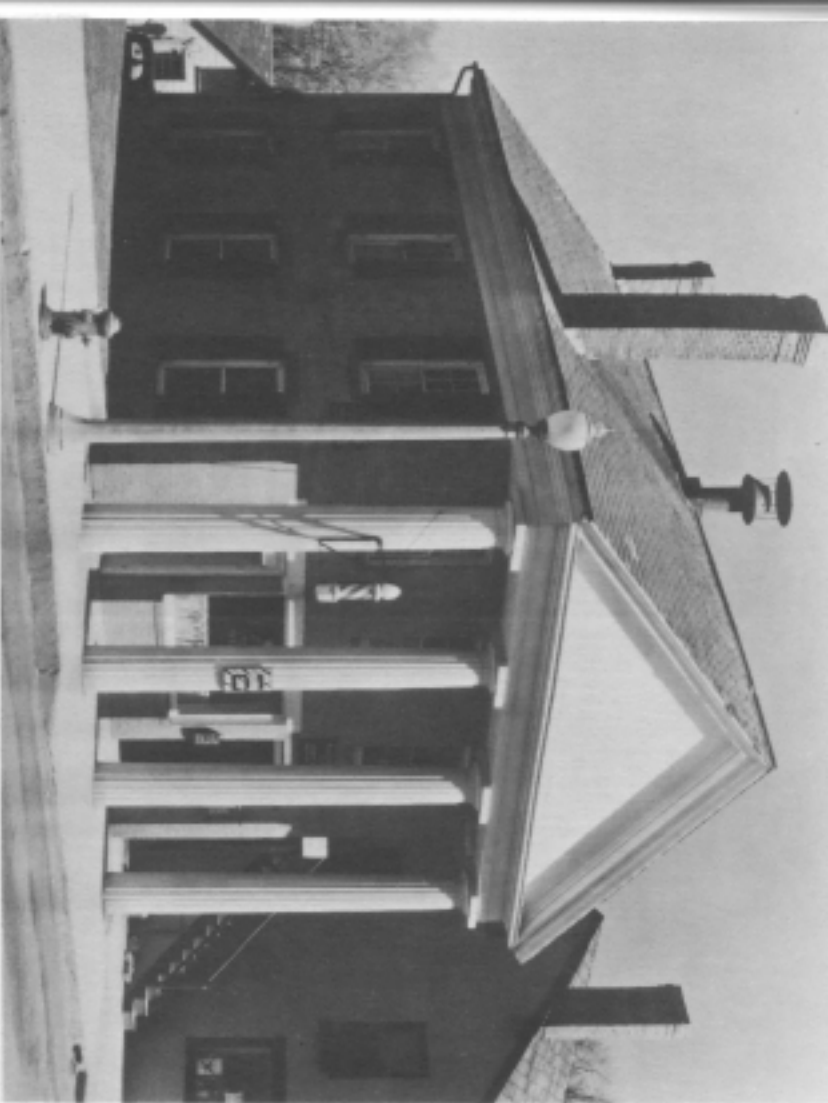
Above: This handsome typical Greek Revival structure in Concord, Massachusetts exhibits a pedimented gable end turned to face the street, a columned portico modelled after ancient Greek architecture and tall, thin chimneys.

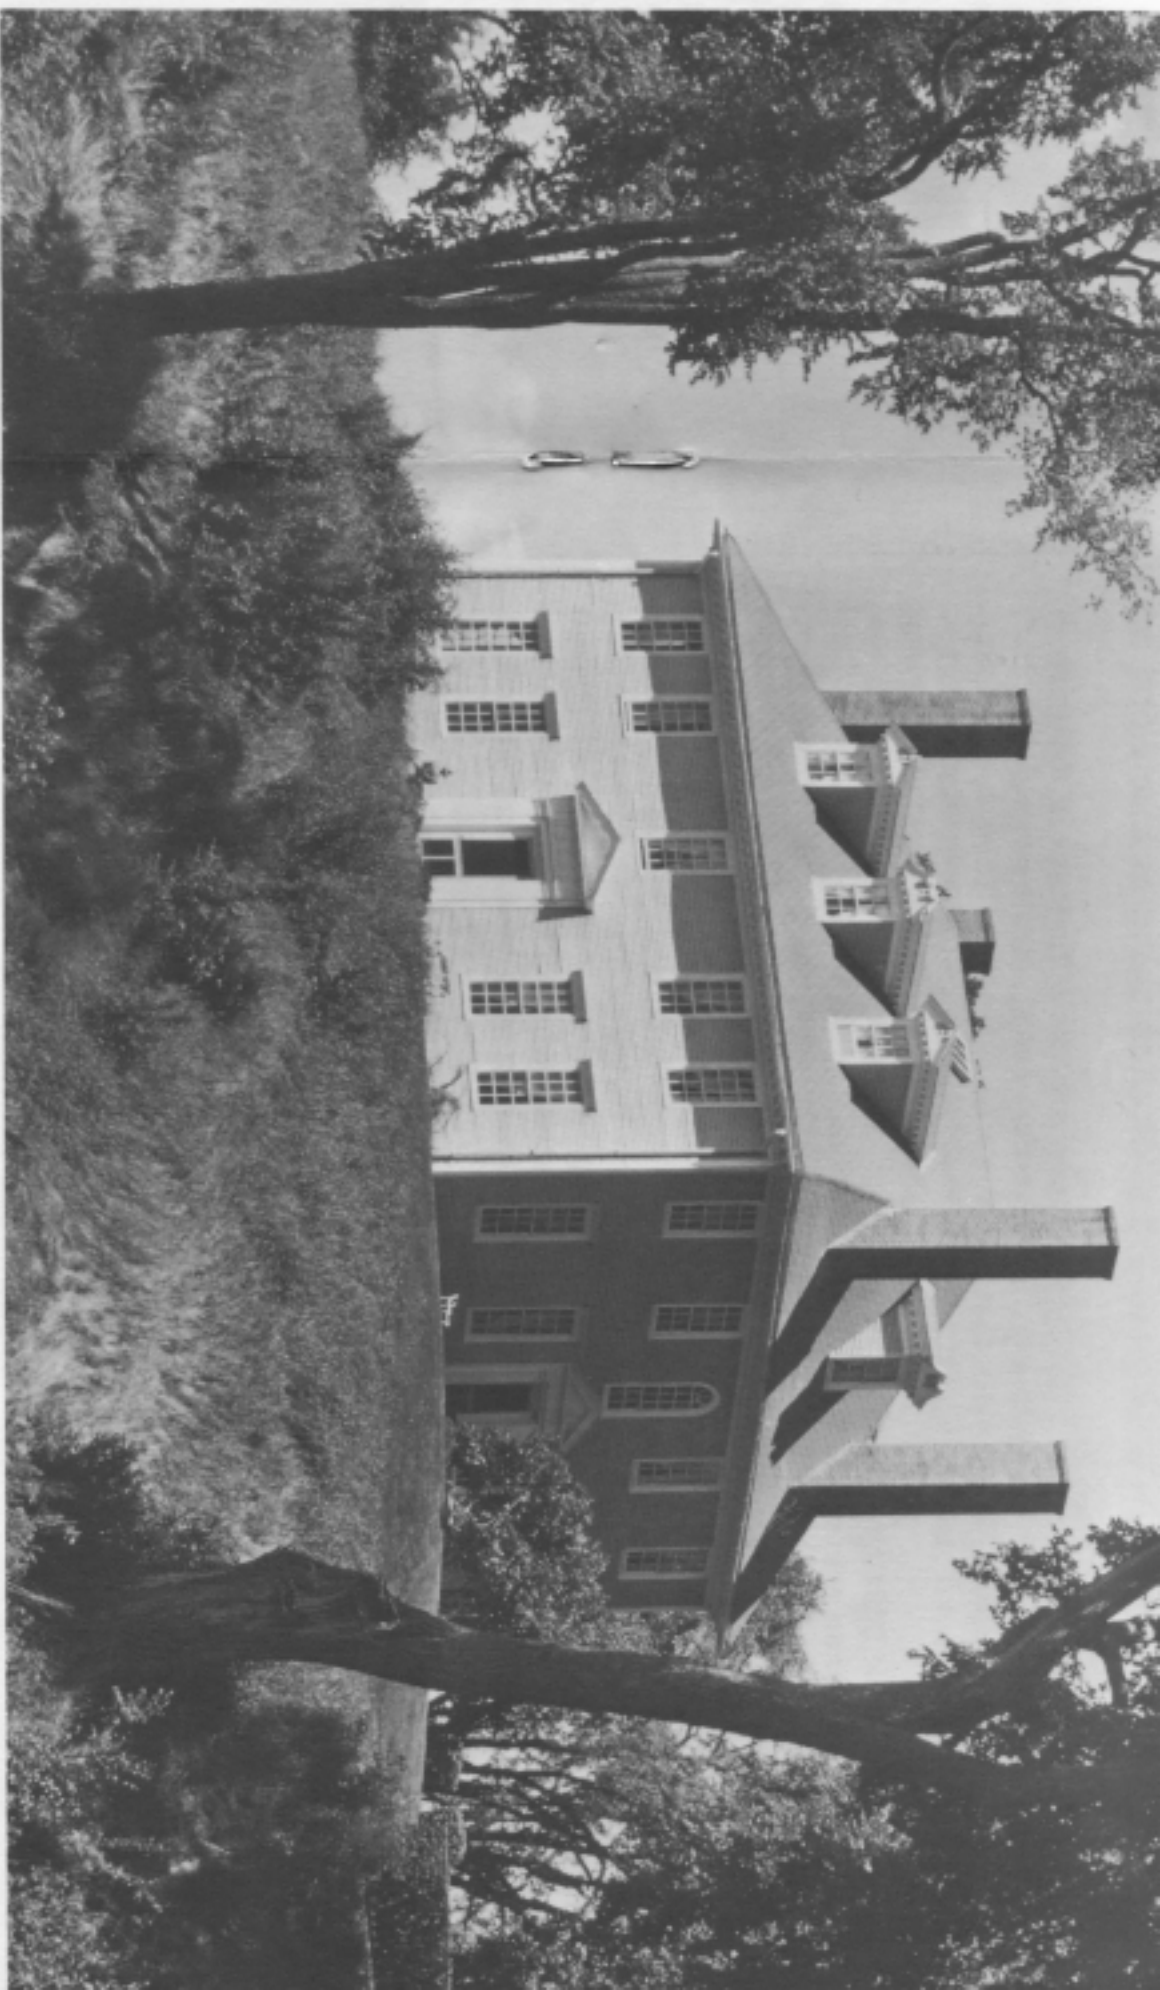
Right: Hamilton House in South Berwick, Maine is a striking example of a Georgian home built at the height of the style's development. The house, displaying balanced facade, hipped roof, dormers and four chimneys to serve the master, is owned by the SPNEA and is open to the public.

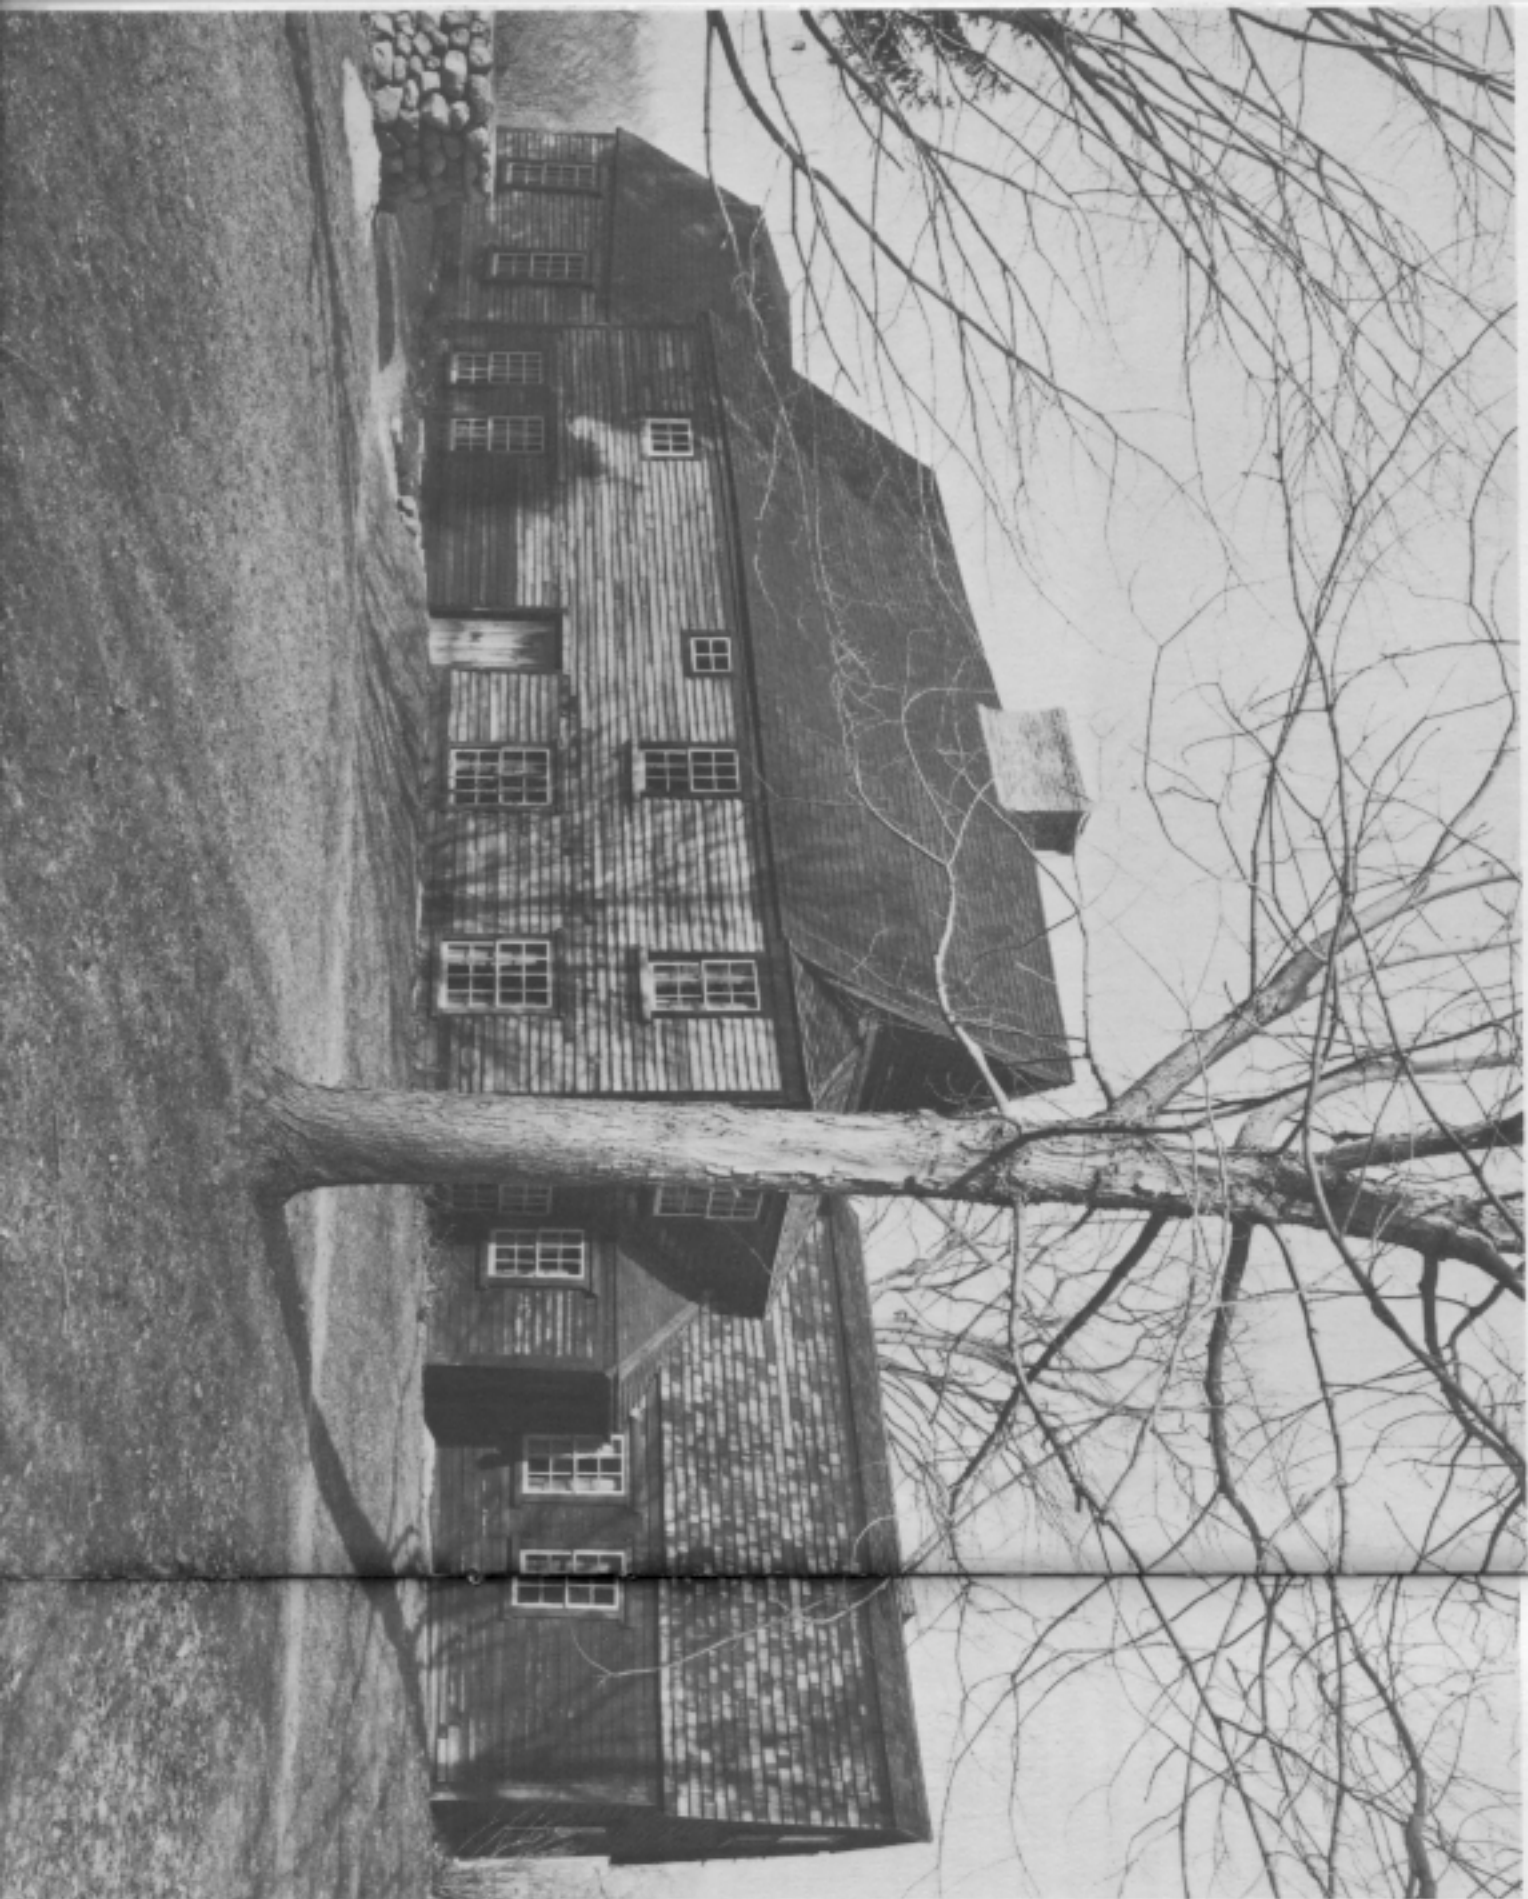
FIGURE 5

Above: Line drawing shows the characteristics of a First Period frame, which was employed by housewrights up to about 1725. The massive timbers are exposed to view on the interior, and almost always the main beams have carved chamfers.

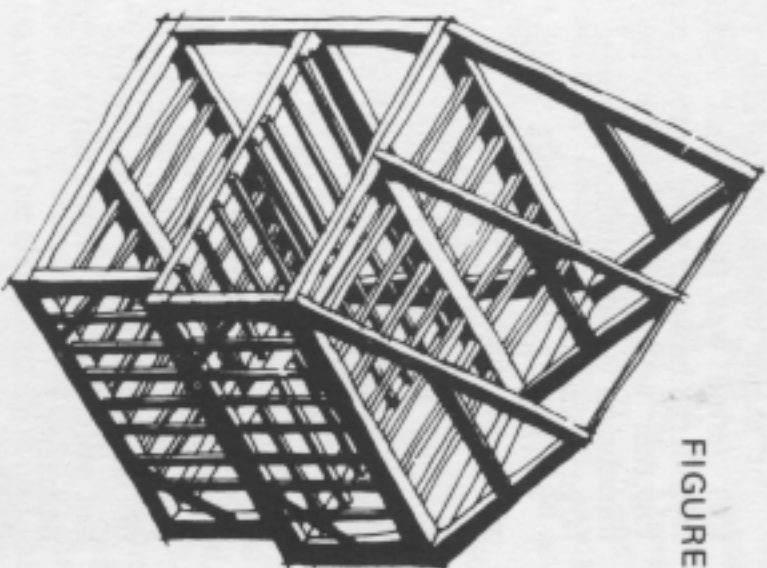
Left: The Fairbanks House in Dedham, Massachusetts, is a good example of a First Period home, framed as shown above, even though the form of the 17th-century house (section with the steeply pitched roof) is obscured by later additions. The double-hung sash are not original, of course, since they are typical of houses later than 1715.

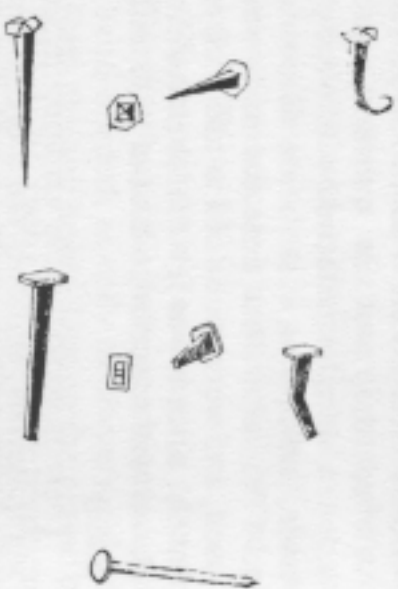
FIGURE 6

since all four sides taper to a point. Heads can vary from large "rose head" to the almost nonexistent head of a finish nail. If wrought nails were used to attach the exterior sheathing to the frame, or the interior trim, it is a good indication that the house in question was built before 1795, by which time cut nails were commonly in use. A couple of fine distinctions should be made concerning the introduction of cut nails. First, we are apt to find wrought nails in use a little later in remote districts, as new inventions did not reach these settlements overnight. Second, even though cut nails were generally much cheaper than wrought nails, early machinery was not able to handle heavy steel plates, and the larger sizes were developed later. One can often find houses with a mixture of wrought and cut nails used in their original construction; this is in itself a good hint of age, as it would indicate a transitional period of, say, 1795 to 1825.

Some subtleties are worthy of note. The first cut nails were machine-cut but hand-headed, as early machinery did not form the nail heads. During the period of 1795-1820, then, the industry produced a nail that is easily distinguished from the later cut types, assuming that the nail is in relatively good condition. About 1817 to 1820, machinery was developed which could also form the nail heads. This type of cut nail is produced even today by a few manufacturers.

Although the basic house frame was usually assembled with mortise and tenon joints, pegged with wooden pins, iron nails were used extensively in construction. This evidence is always helpful in determining the date of construction of a house. The hand-wrought nail, fashioned by a smith, was in use for thousands of years, and was prevalent right up to the 1790's, when hand-cut and machine-cut nails began to supplant them, particularly in the smaller sizes. (See Figure 6.)

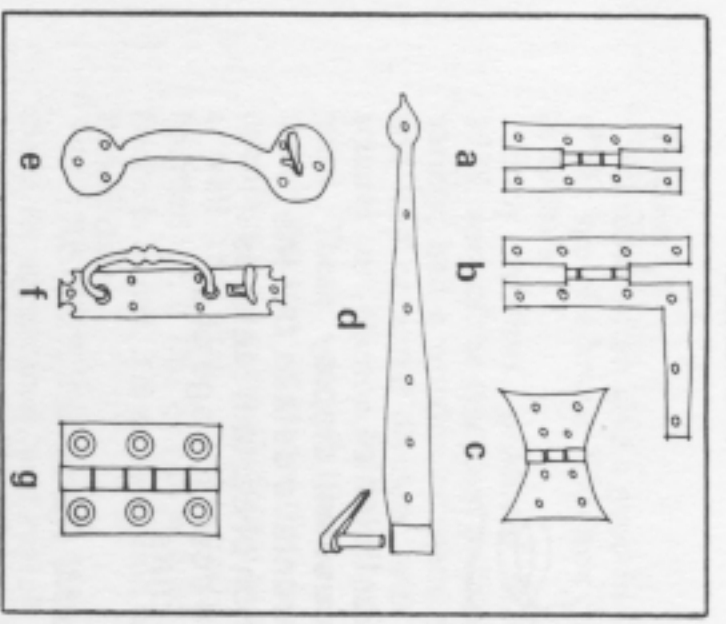
FIGURE 1

FIGURE 1: Door hardware can often help establish a date. The H hinge (a), HL hinge (b), butterfly hinge (c), and the strap hinge (d) were in use until about 1790 when the cast-iron butt hinge (g) was introduced. Wrought-iron thumb latches like the Suffolk (e) and more expensive Norfolk (f) were used extensively up to 1840. FIGURE 2: "First period" doors (a) and (b) were in use until about 1725, (b) usually in high-style houses from 1700 to 1725; variations of typical Georgian doors (c) and (d) were common from 1725 to 1790; the Federal six-panel door (e) was in vogue from about 1790 to 1830 when the four-panel Greek Revival door (f), exhibiting a wide molding (see Figure 3-d, next page), became popular.

replaced by cast-iron latches. The iron box lock was introduced in the mid-1700s, and thus one is apt to see any one of these three basic types in use up until 1840. In 1840 Blake patented the famous cast-iron latch, which continued in use right up through the 20th century. (Fig. 1-e, 1-f.)

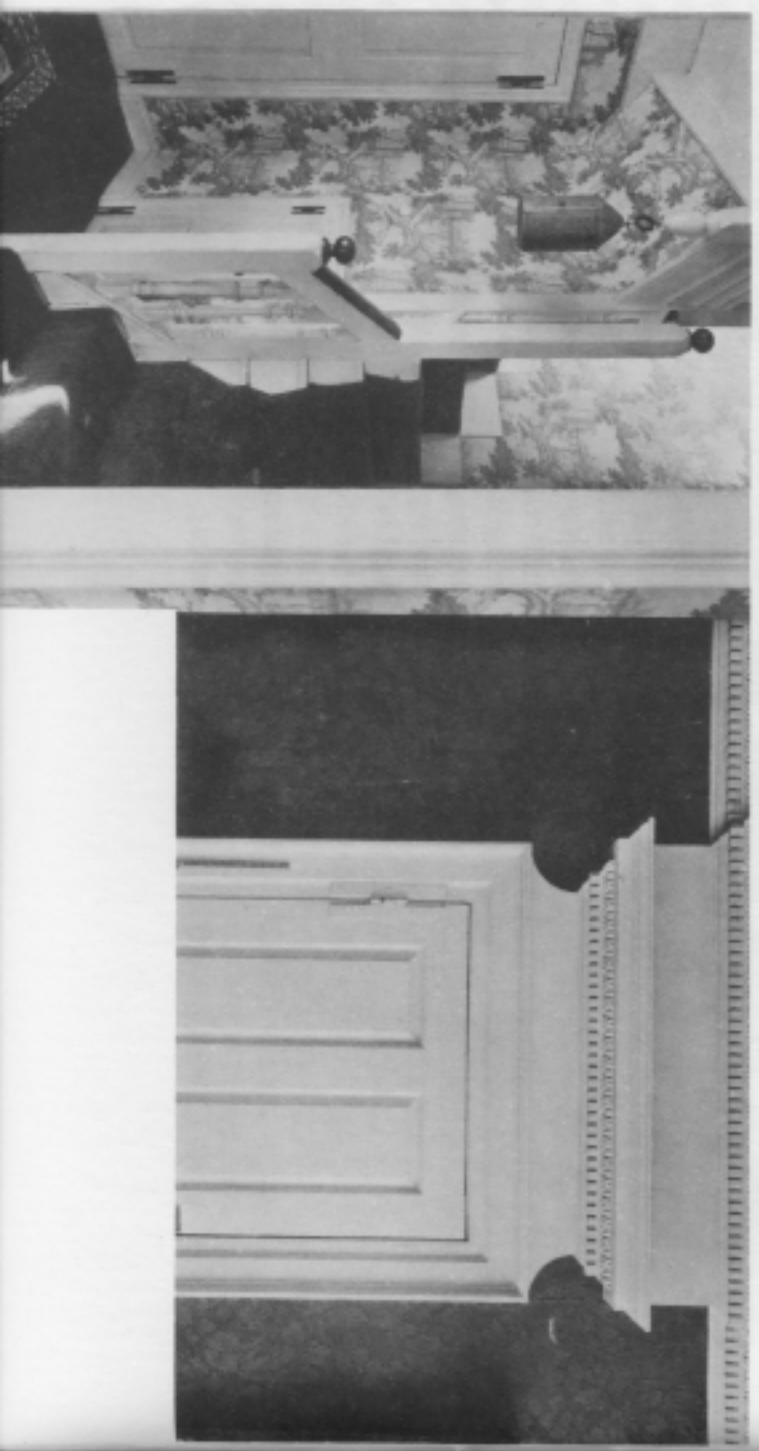
The two photographs below illustrate the wide differences between houses of the same period. Each of Georgians house — note the H hinge and simple doors — while the one at Hingham, Massachusetts house — note the H hinge and simple doors — while the one at right shows a detail of elaborate high-style finish from the Pierce-Nichols House in Salem, Massachusetts designed and built by Samuel McIntire (photo courtesy, Essex Institute).

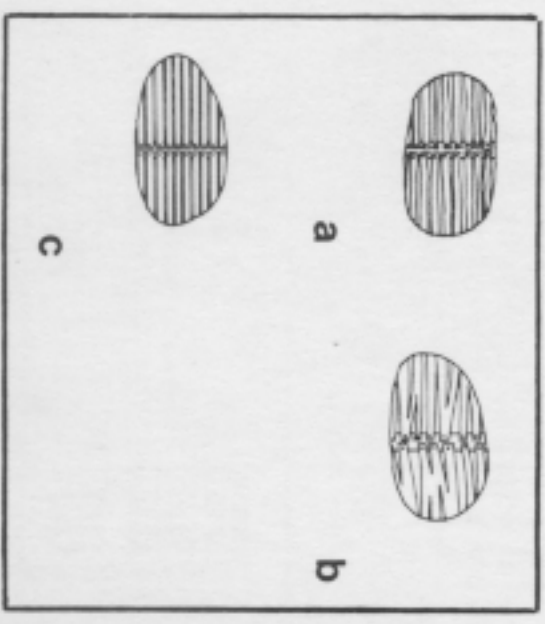
FIGURE 4

of boards sawn on all four sides, became popular because of innovations in sawmill technology. (Fig. 4.) Notice that these customs were common but not absolute, and one is able to see practically any style lath being used as an exception, at any time. In our century, expanded metal lath has almost entirely replaced wooden lath.

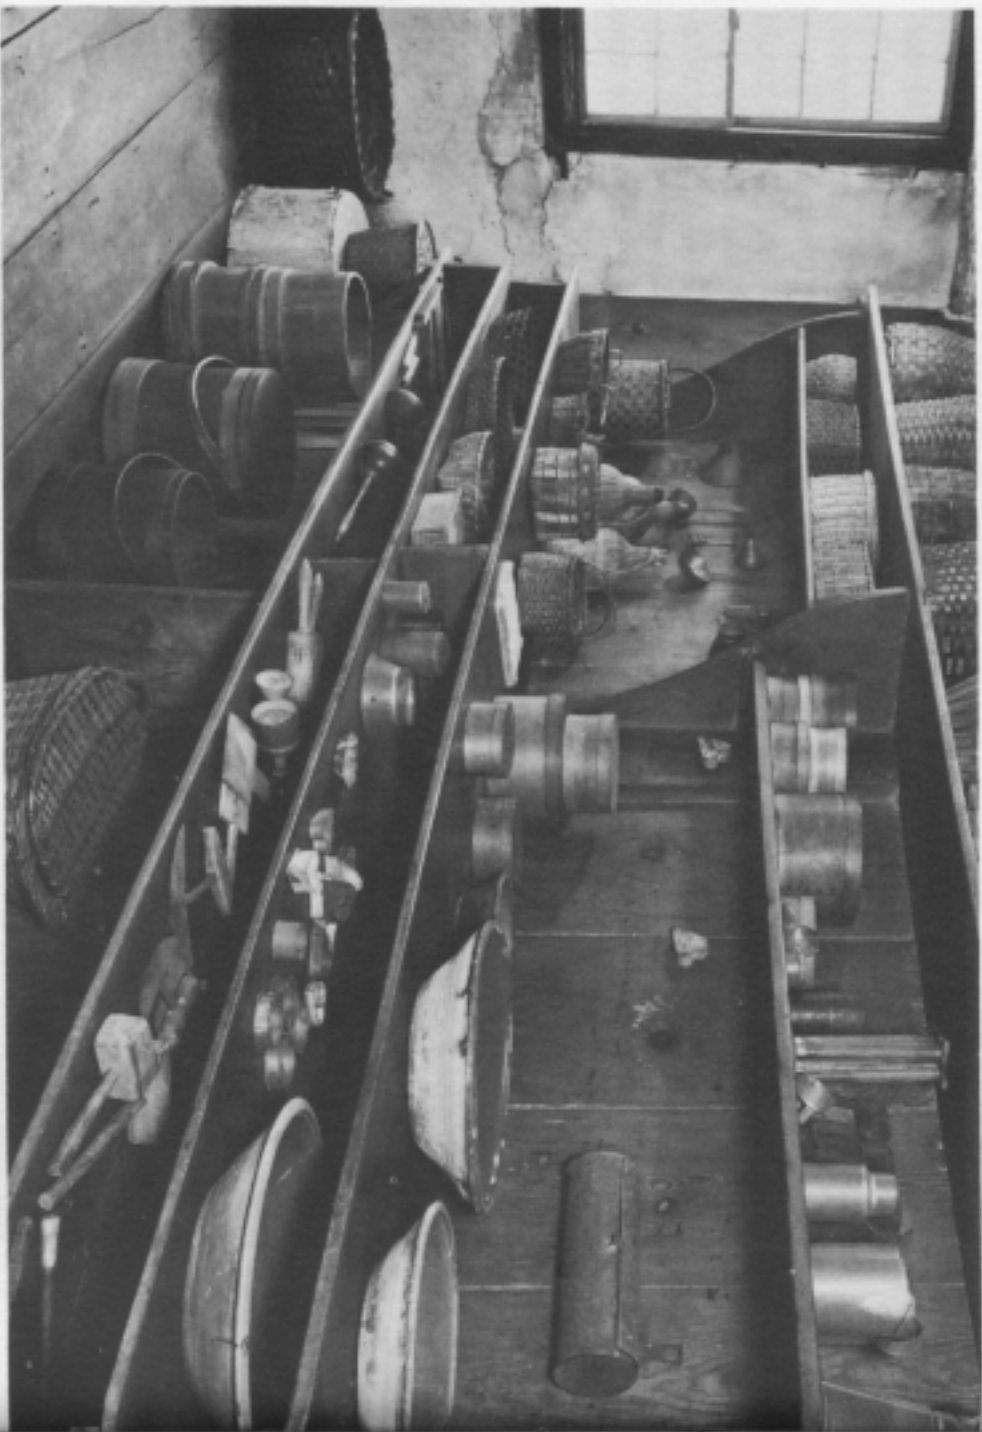
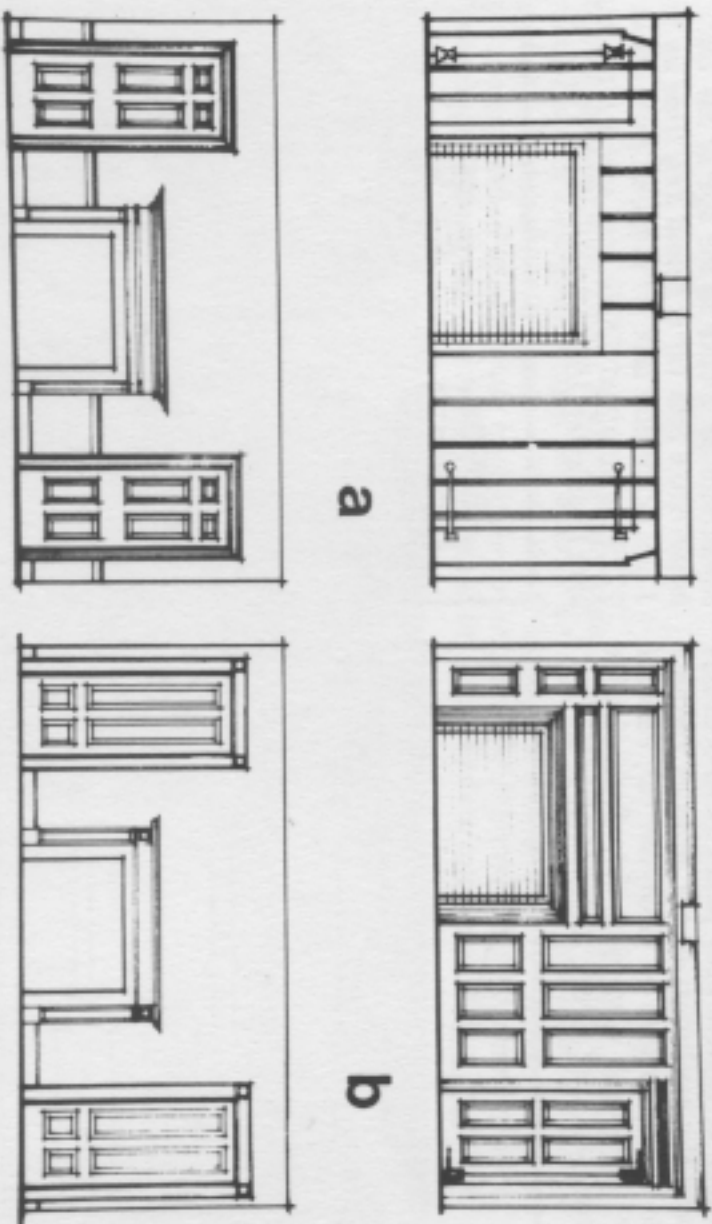
FIGURE 5

The illustrations above provide a comparison among typical fireplace wall elevations for different periods: First Period 1620-1725 (a), Georgian 1725-1790 (b), Federal 1790-1830 (c), and Greek Revival 1820-1860 (d).

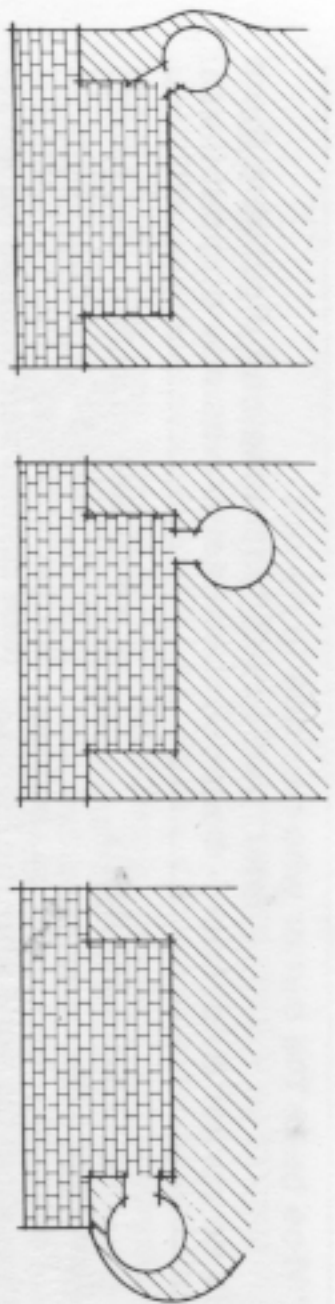
FIGURE 6

The drawings above show three ways in which the bake oven was commonly positioned in the kitchen fireplace prior to the mid-18th century, by which time the oven had moved out to one of the fireplace jambs, as shown in Figure 7, at left.

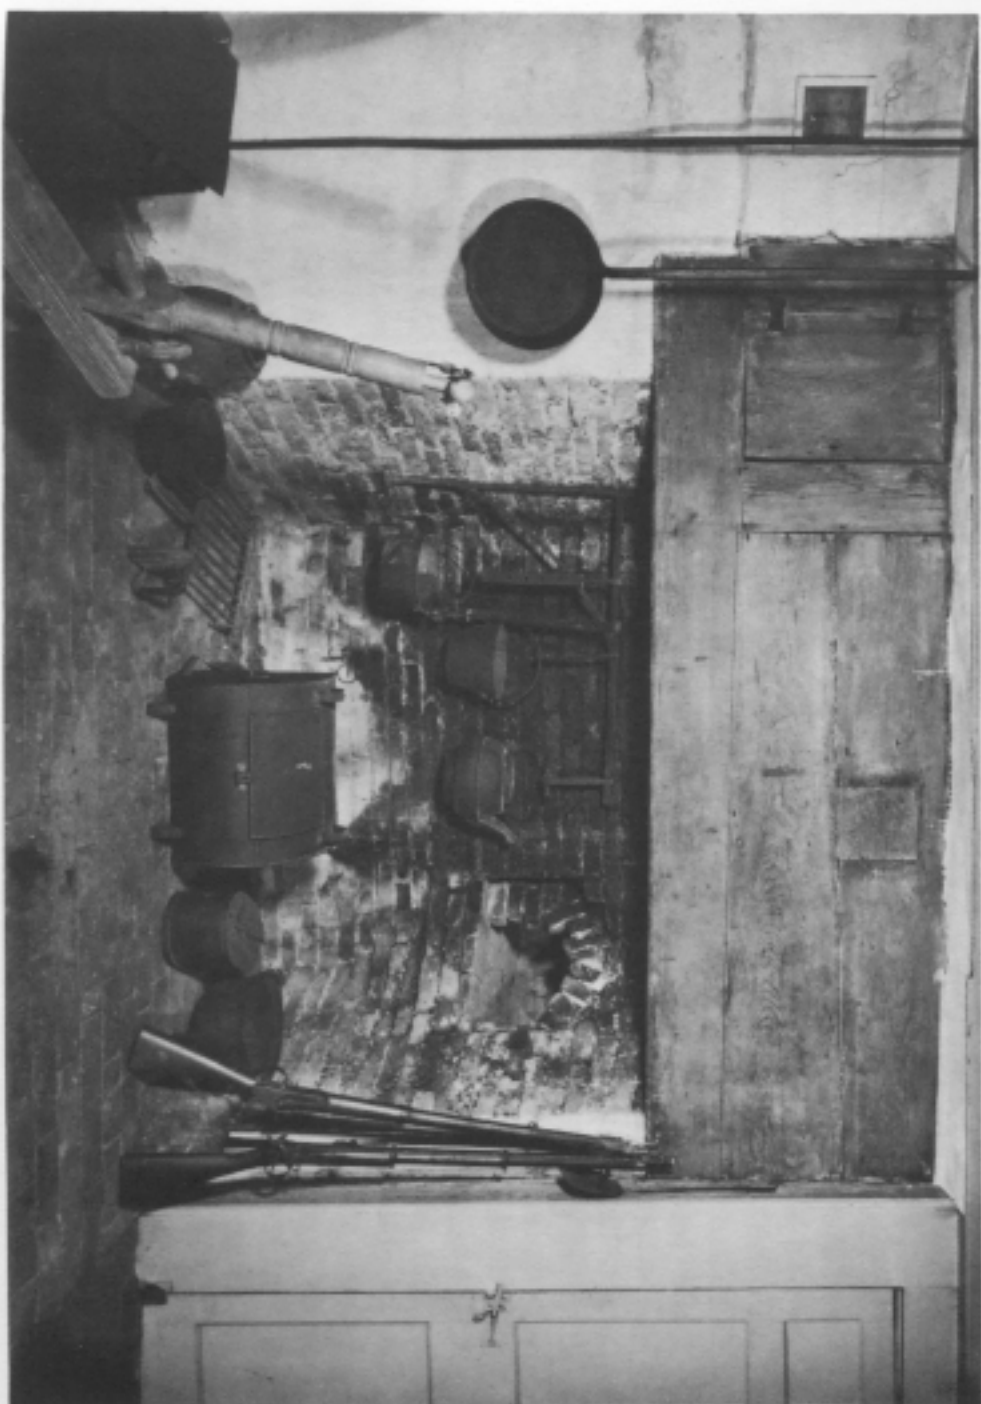
Below is a good example of a First Period fireplace in the Coffin House in Newbury, Massachusetts. Finding the bake oven within the fireplace wall dovetails with other evidence supporting the dating.

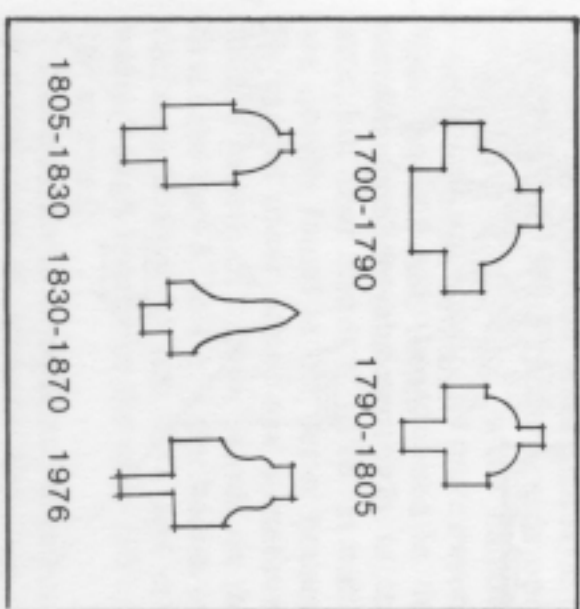
FIGURE 8

Above are cross-sections showing the progression of window muntin bars from a wide, flat profile prior to 1790, to the narrower, deeper profile of the mid-19th century. These can be compared to the profile of the muntin bar commonly available today.

The general trend of muntin bar configuration was from a wide flat profile in the early 18th century to a narrow, deep profile by the mid-19th century. Prior to 1790, the muntin was characterized by a wide (1 1/4") profile which narrowed to about 3/8" about 1790-1805. The bar then typically became deeper and changed configuration throughout the 19th century, as illustrated. Again, the high-style

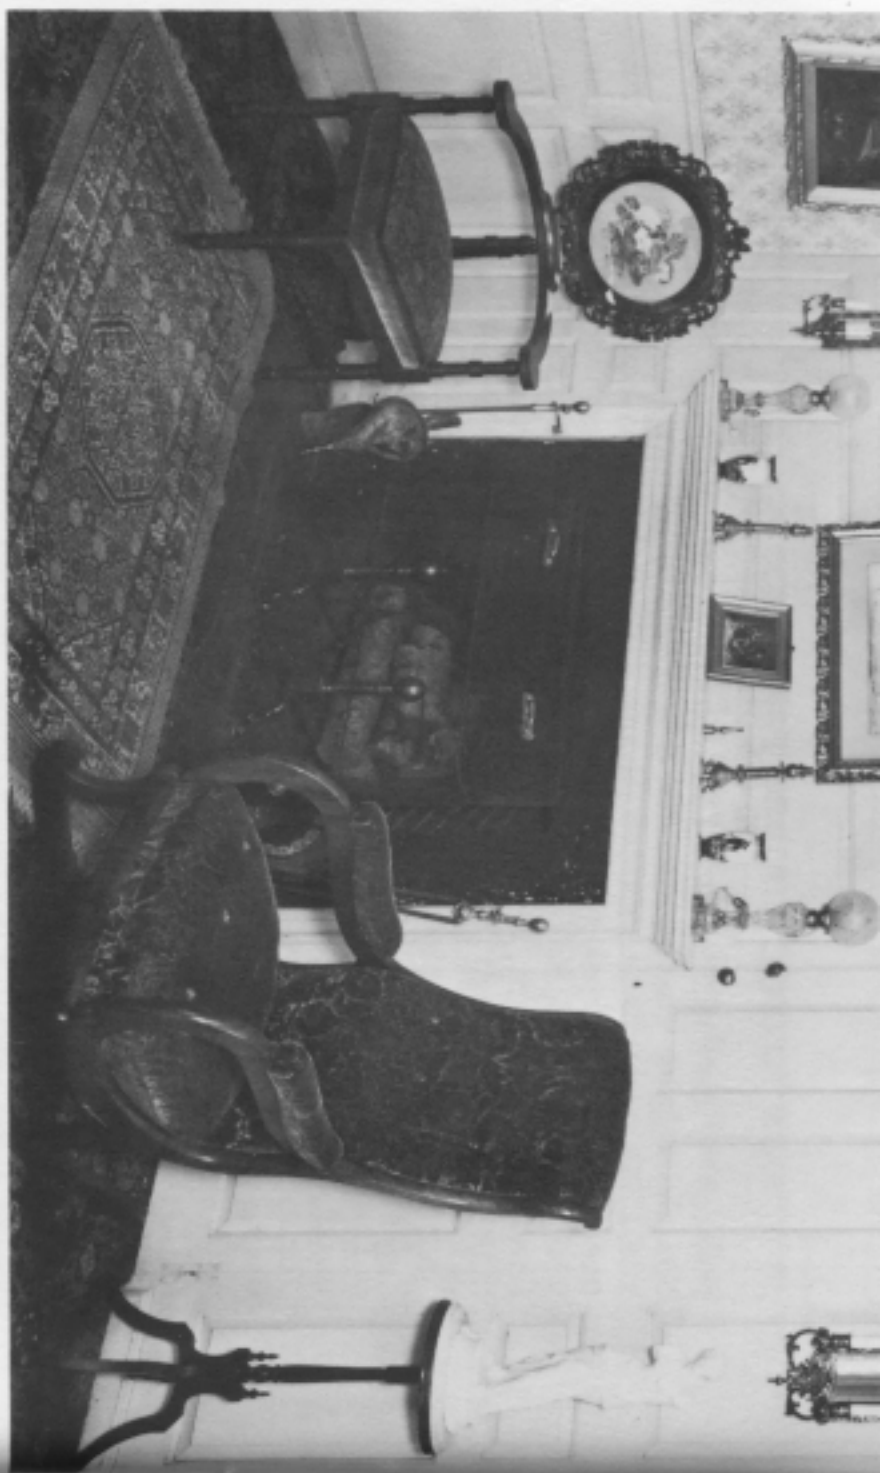
Above: The Marrett House in Standish, Maine, owned by SPNEA, offers a good example of a Georgian fireplace wall elevation: a small opening surrounded by wide, projecting architrave molding and typical paneling details.

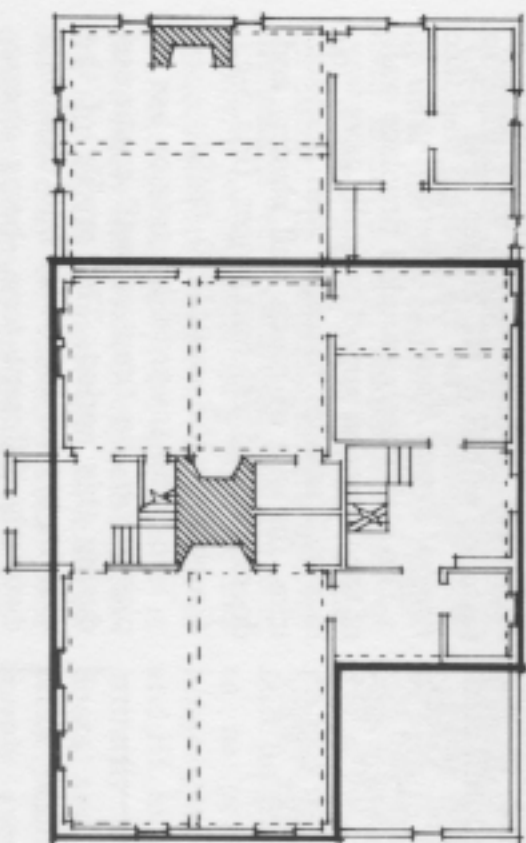
FIGURE 9

Left: The value of a measured floor plan is shown in this illustration. A confusing combination of eight first-floor rooms is greatly simplified by picking out the early portion of the house (dark outline). The same house is shown in a measured elevation below, with dotted lines showing what was probably the original house.

When one is examining a house, it is important to have a measured floor plan of all floors. One look at the plan can indicate areas to be examined further, and usually gives clues as to construction sequence. These plans, in conjunction with a careful examination of the house and associated documents, should make the construction information much clearer. ■ ■

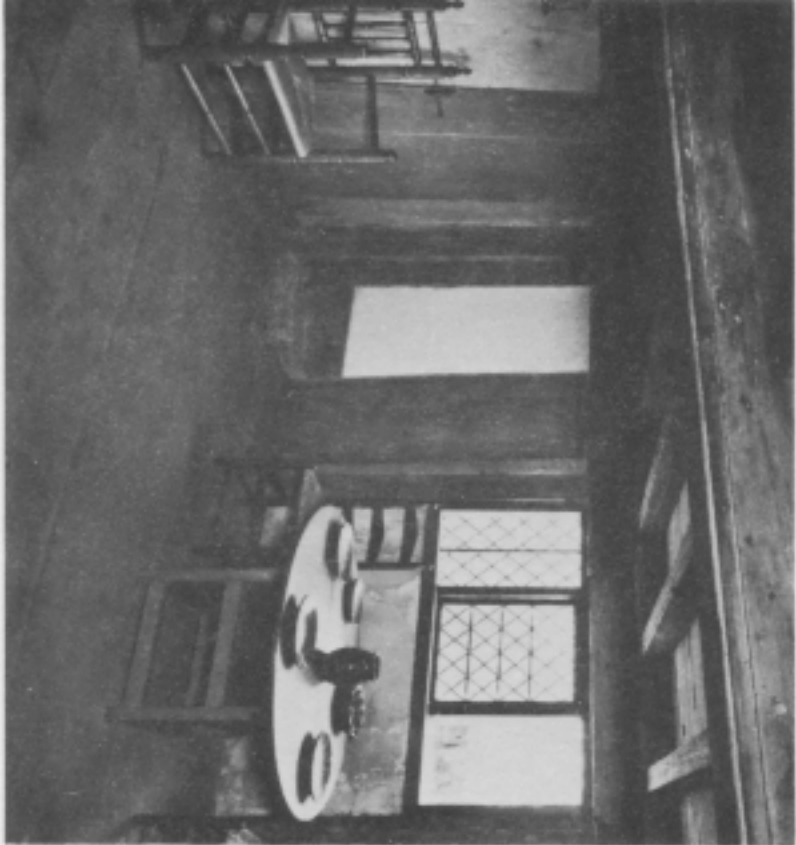
Although not always good indicators of age, windows can sometimes give clues. Here is a typical First Period window photographed in the Richard Jackson House, c. 1664. This is the oldest dwelling in the state of New Hampshire.

Early windows, produced before c. 1725, were of the casement or fixed glass variety, had a wooden or metal frame, and lead or metal dividers, with small squares or diamond-shaped panes of glass. These windows are very rare today, but the evidence for casement openings is occasionally found hidden in a wall that has subsequently been boarded up. If this type of window or its frame is found, it is an indication of First Period date.
