X-RAY ANALYSIS OF THE NARBONNE HOUSE

David M. Hart, Designer
Topsfield, Mass.

In addition, an X-ray analysis was carried out to determine certain structural conditions hidden from view. Specifically, the examination was made in hopes of finding evidence in three areas. First, the existence and configuration of exterior wall bracing; second, the possibility of finding original window framing; third, the possibility of evidence between the two house frames that would indicate whether the south frame once had an exterior wall. The equipment used was Picker Corporation's Portashot System, which is a portable X-ray generator and Polaroid film and processing unit for on-the-job analysis of results.

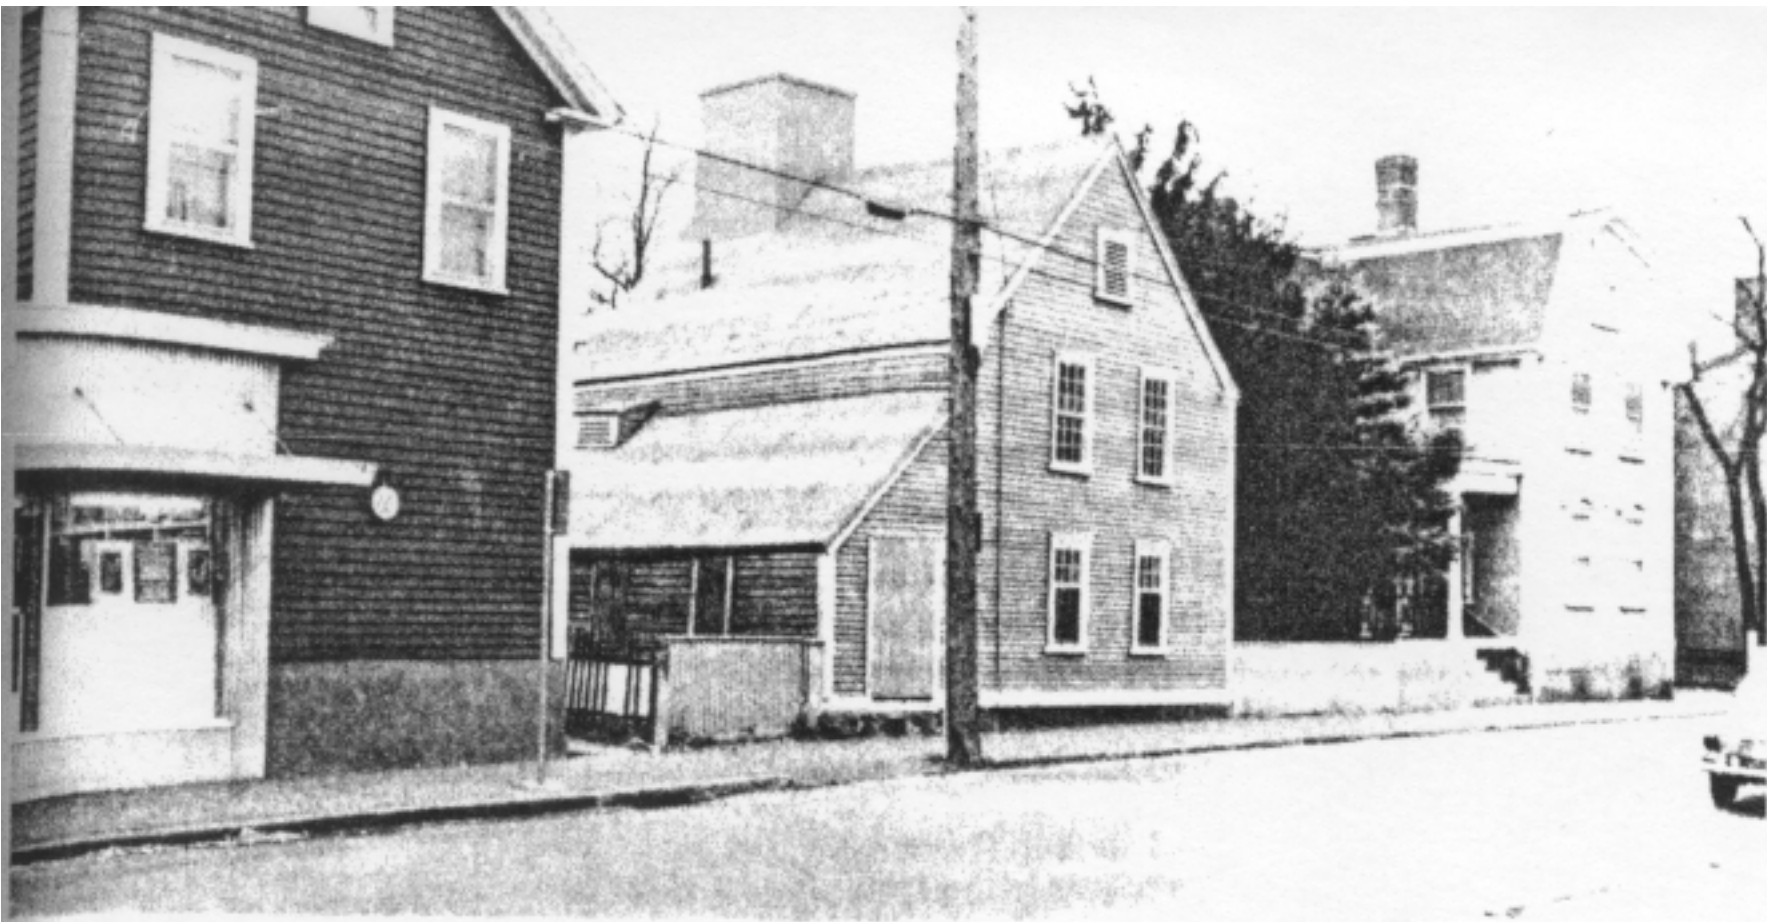
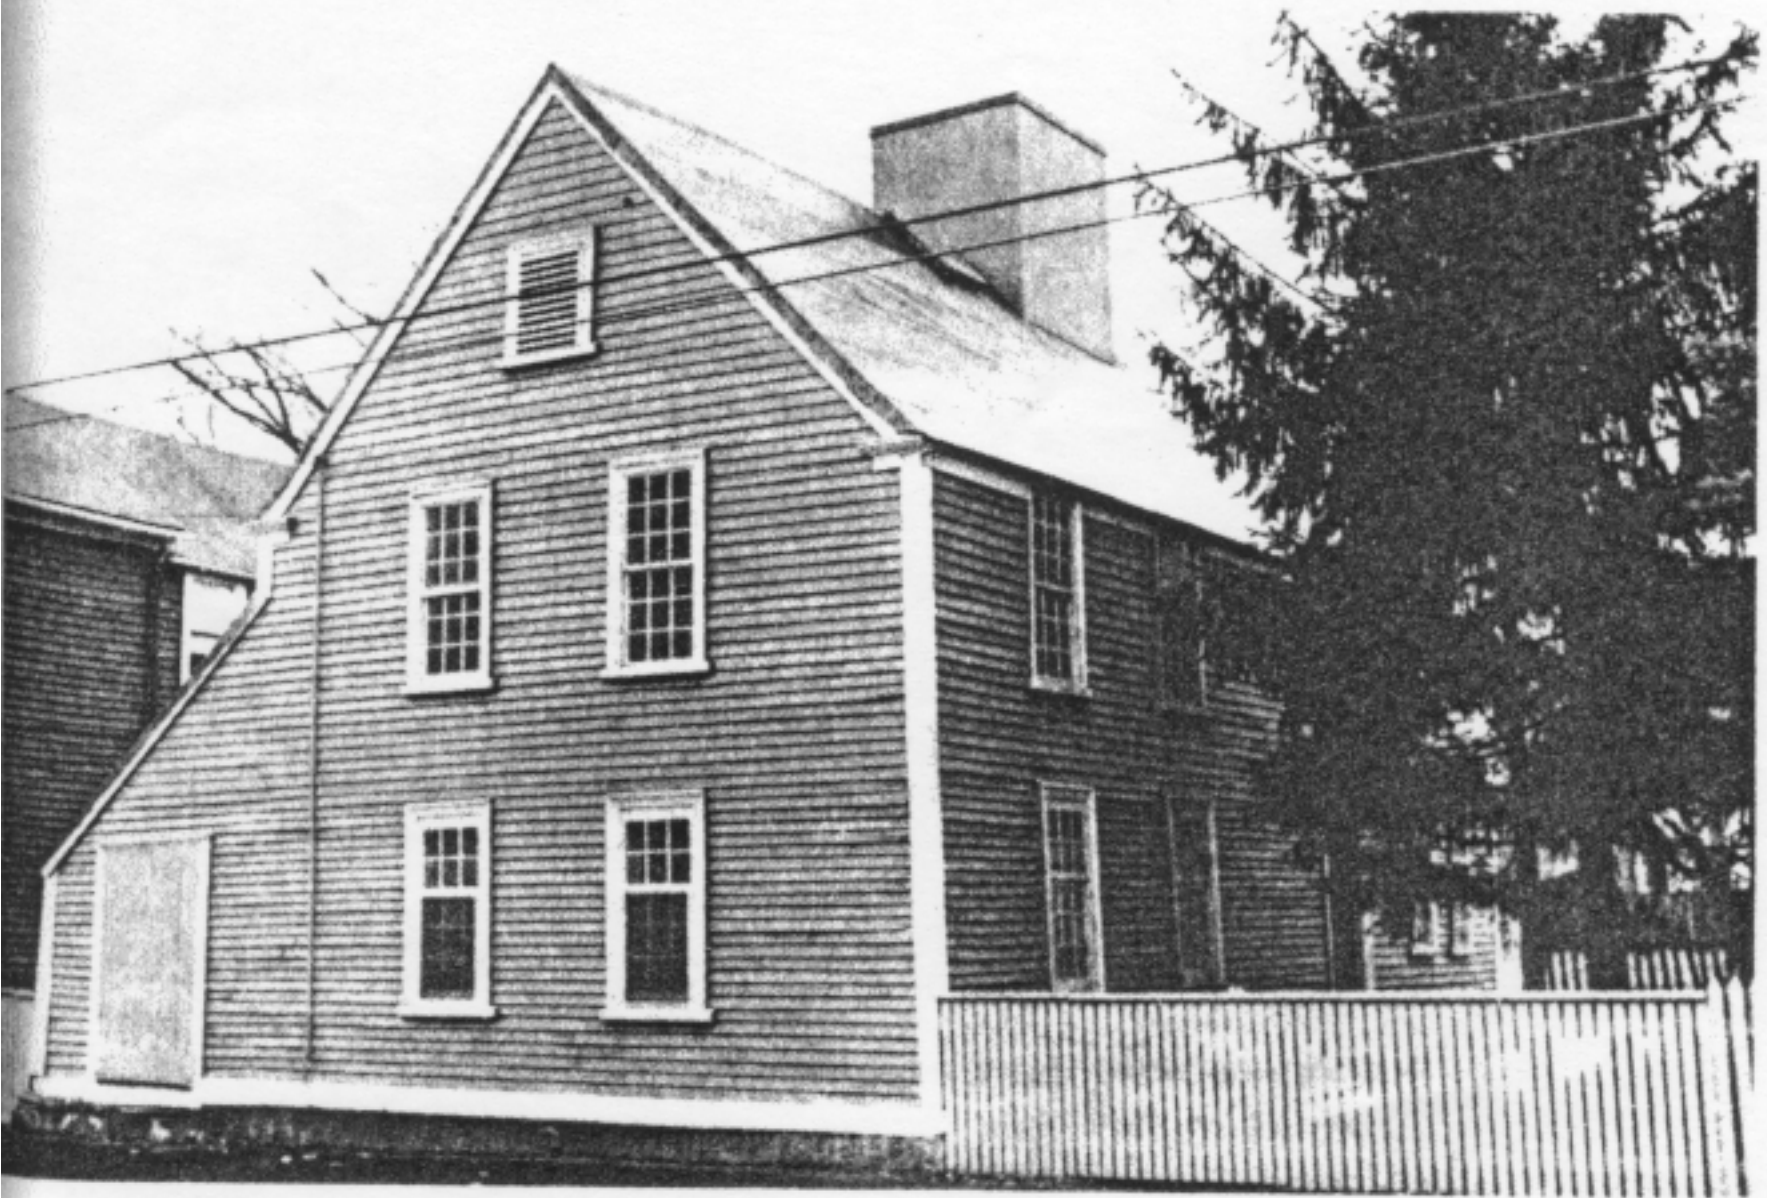
Fig. 1 and 2 Two views of Narbonne House from Essex Street, showing later shed addition to east.

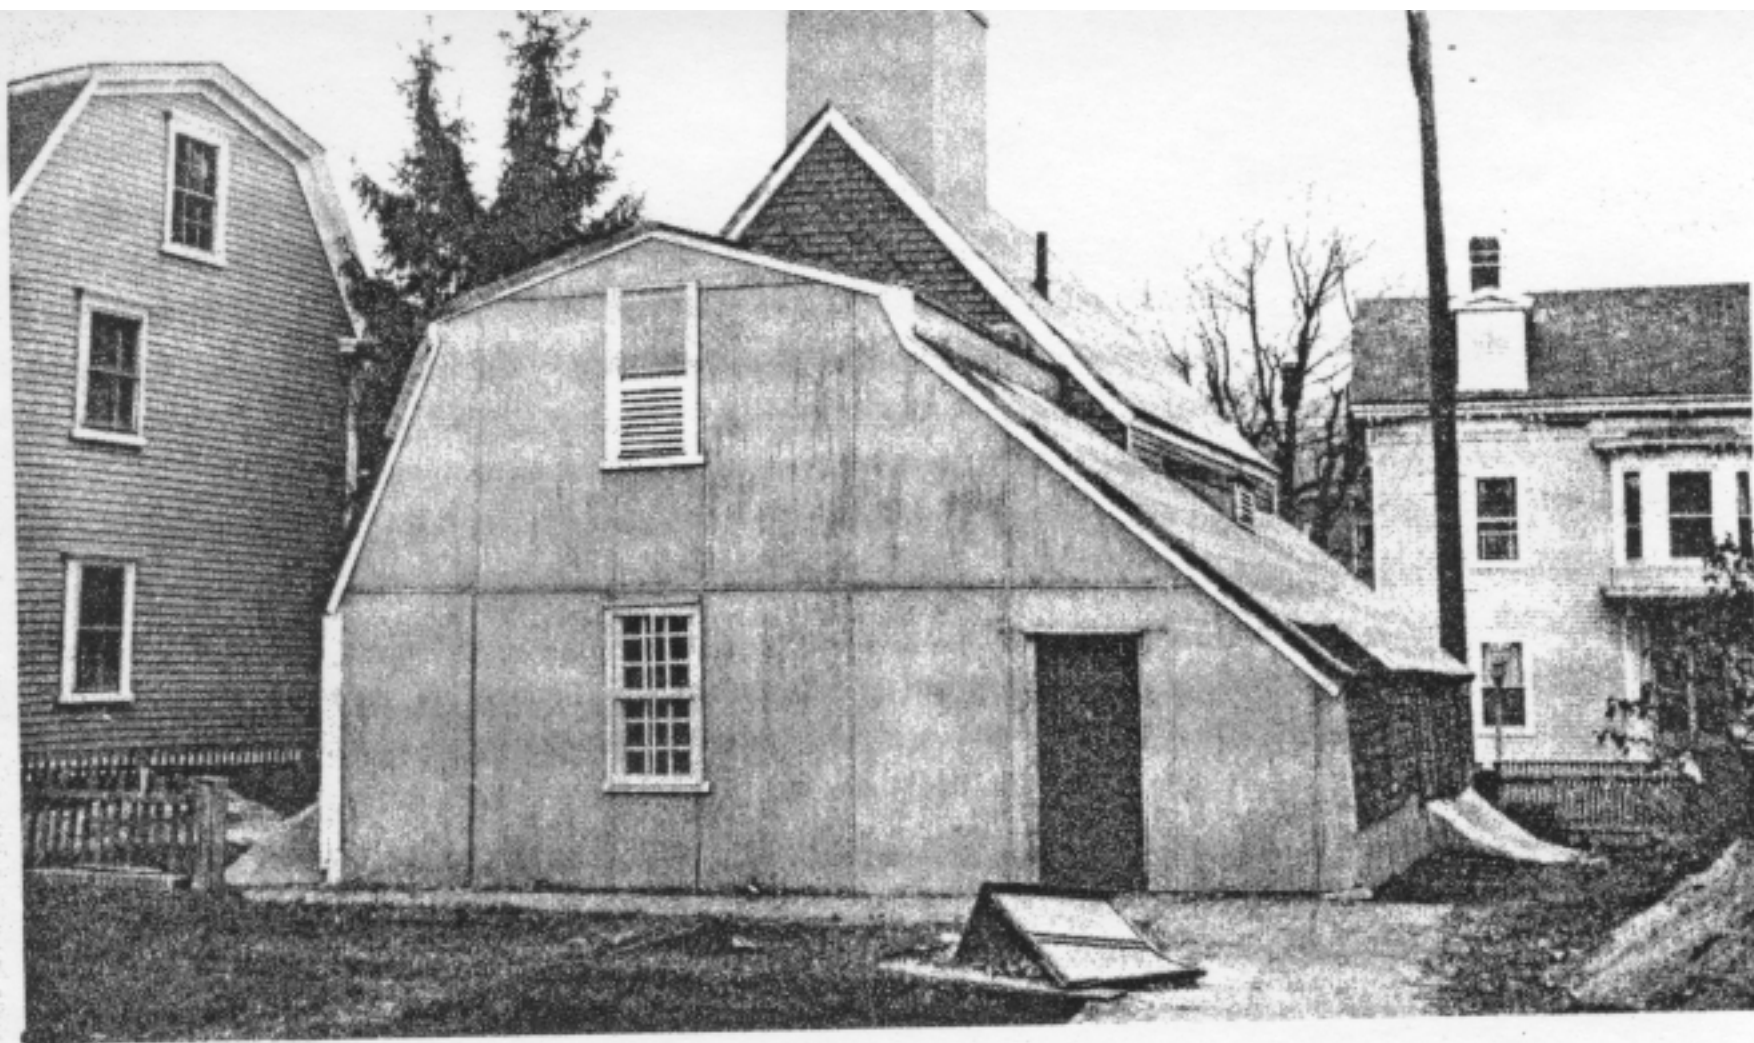
Fig. 3 Narbonne House from rear yard. Chimney and gambrel - shed gable end are temporarily covered with plywood to prevent further deterioration of materials.

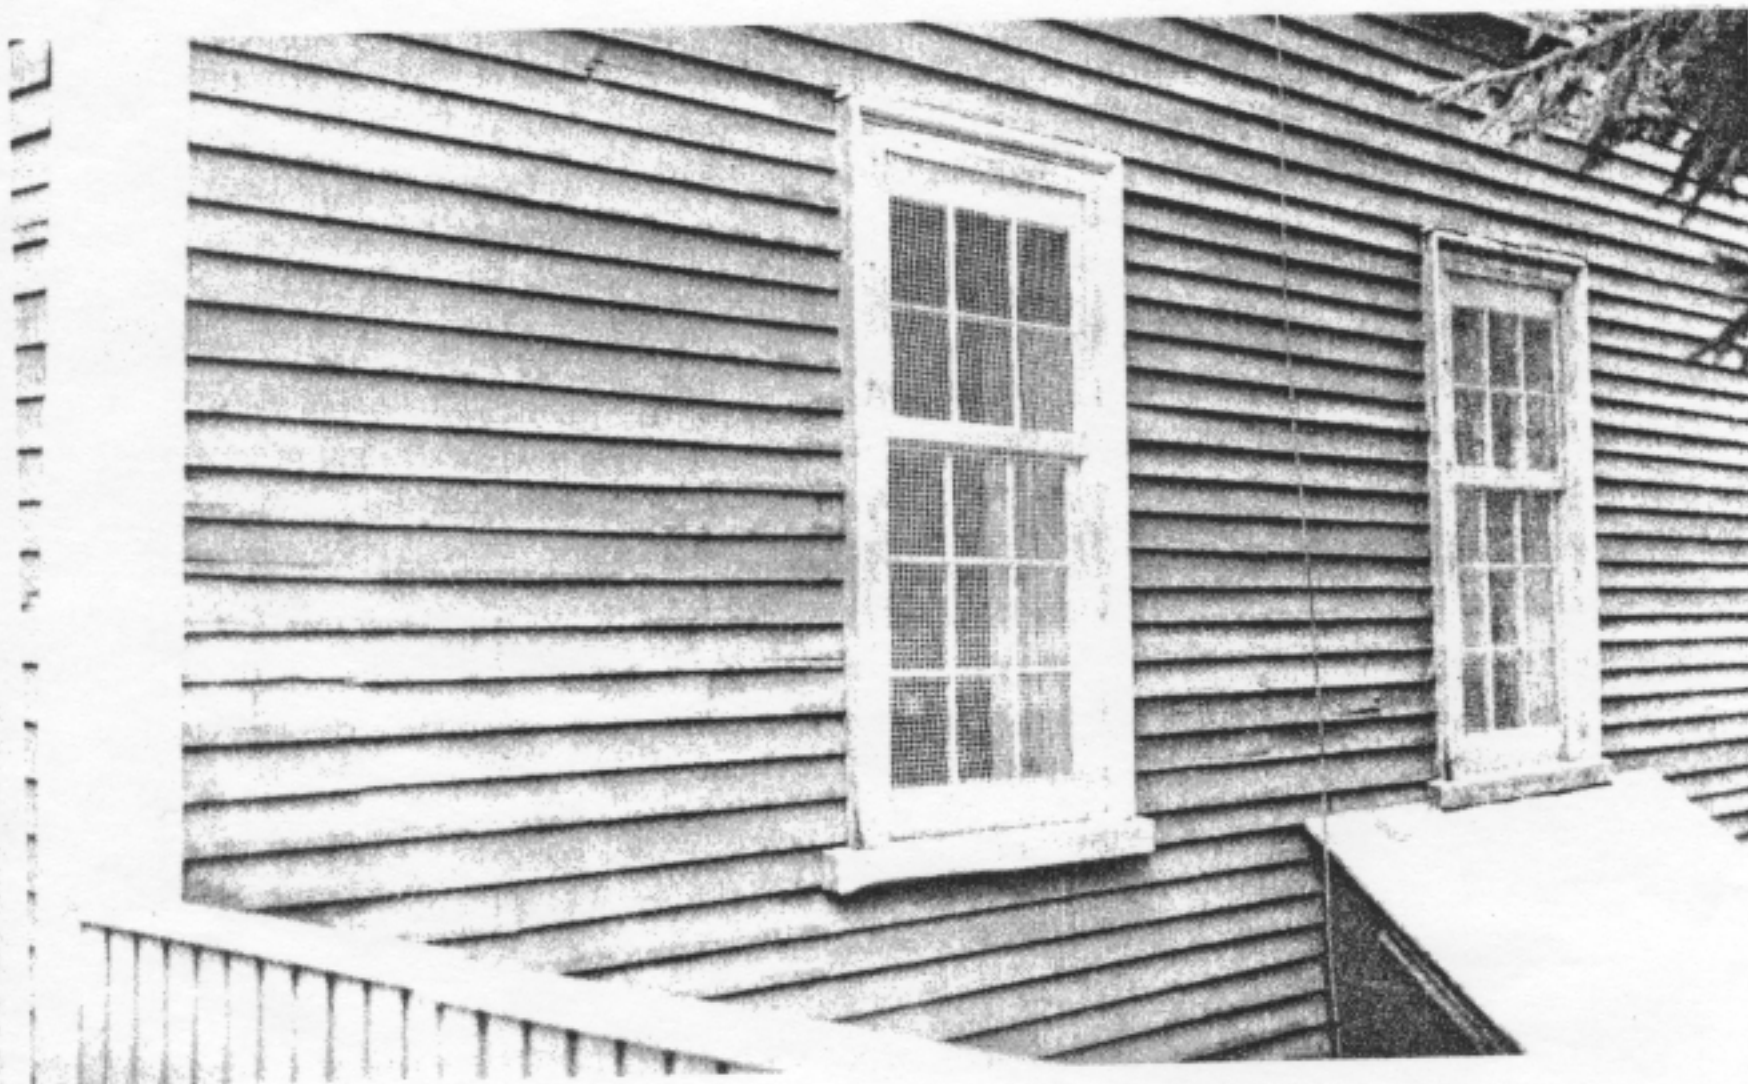
Fig. 4 Exterior view of north-west corner. X-ray examination for brace and original window frame started in this area.

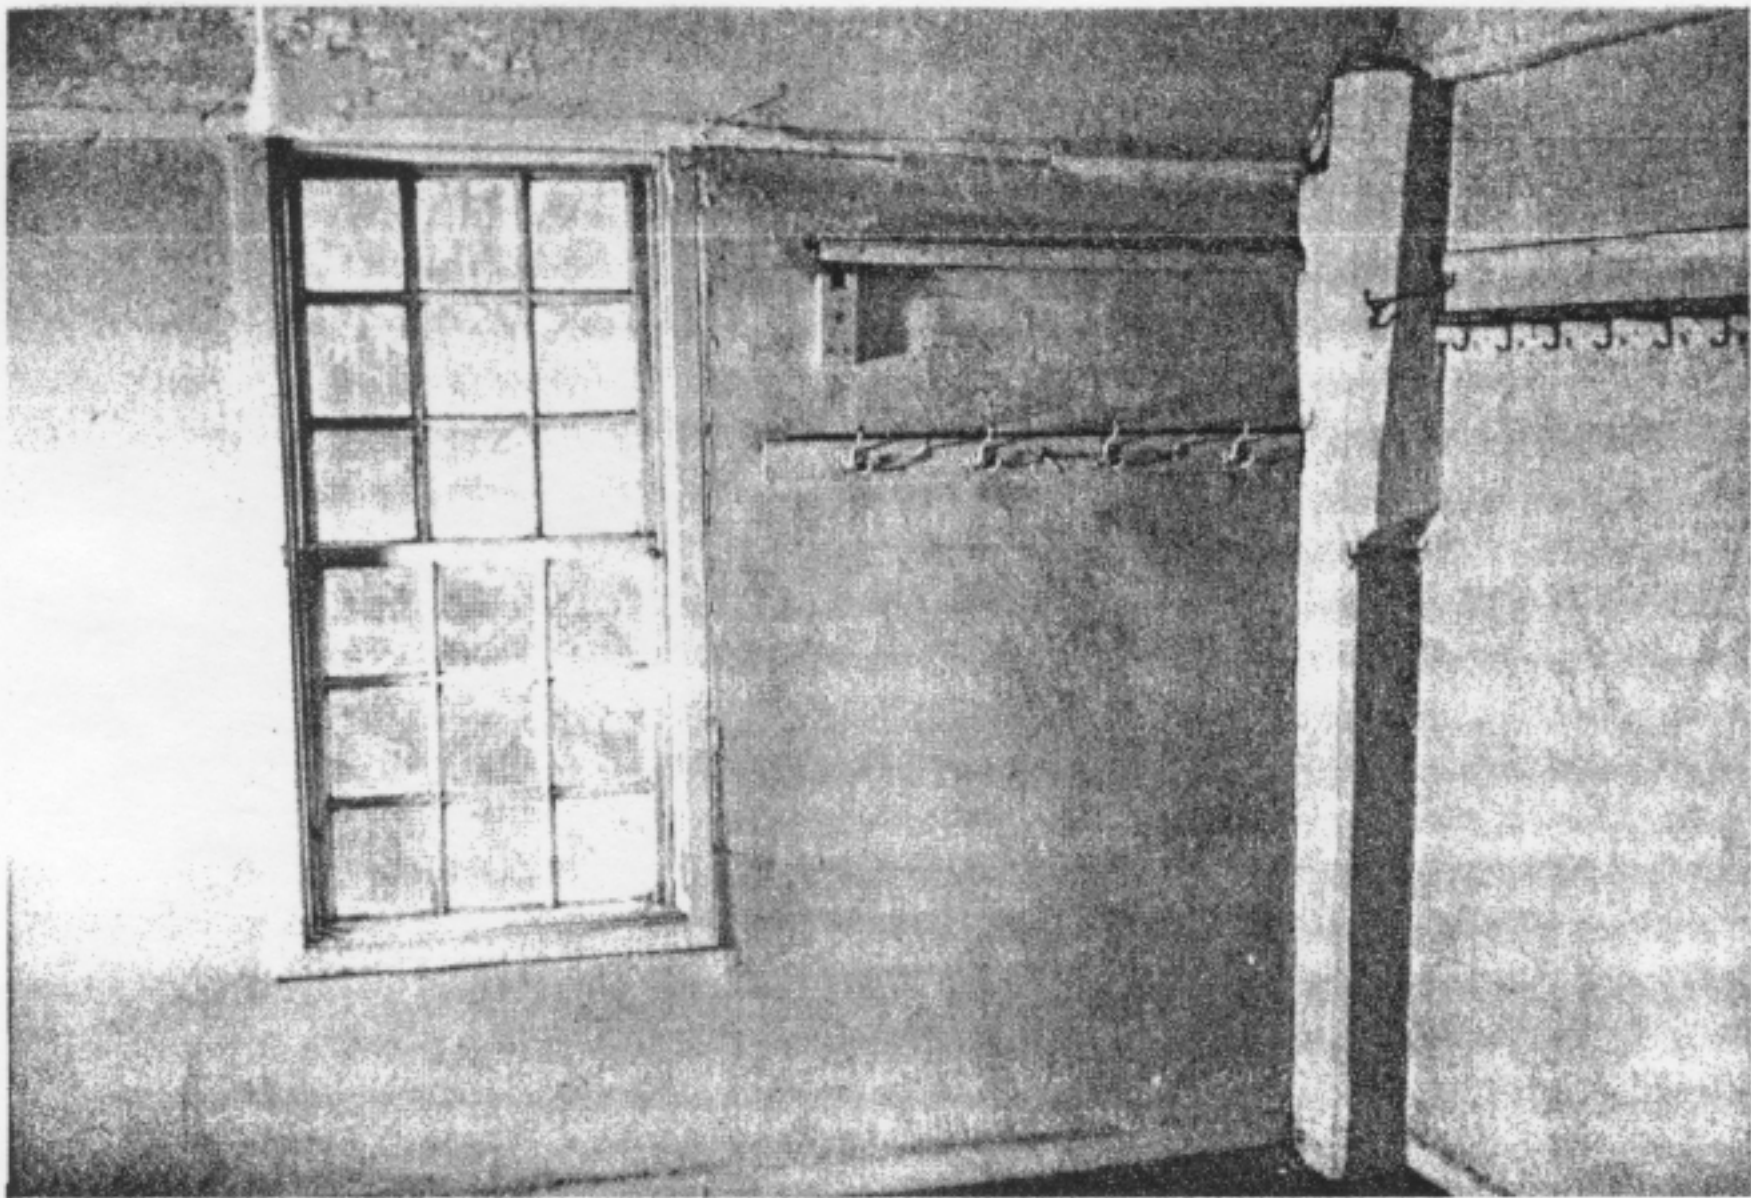
Fig. 5 Narbonne House, Interior view of north-west corner, second floor.

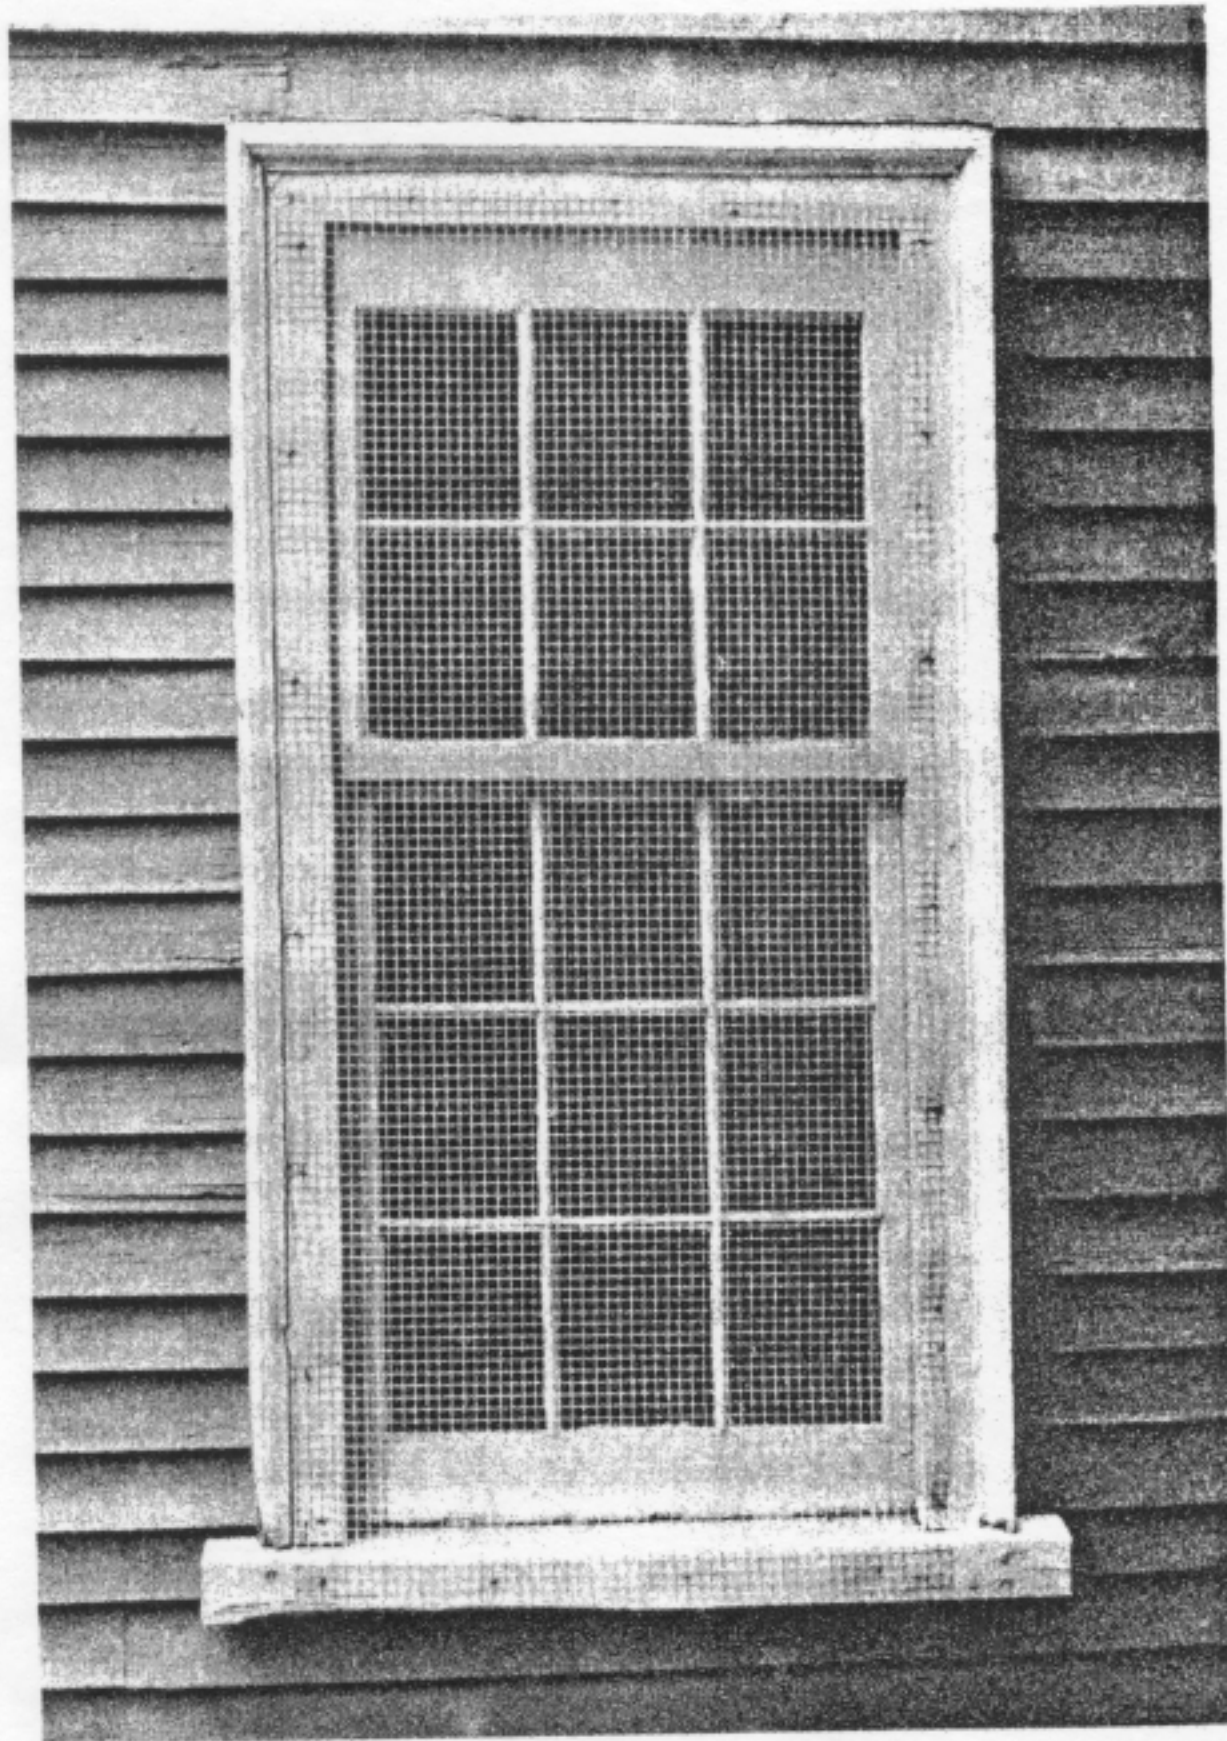
Next, the window itself was examined by X-ray, particularly around the lower corner of each side (see Fig. 13-17). Here again, there was no evidence of either a window frame that could date to the original, or any evidence of notches in the surrounding sheathing that would indicate an earlier frame. The possibility of the early frame being used as a base for the present frame is not entirely discounted, however, as there could be additional evidence that is obstructed, or not clear to us at this time.

Fig. 13 Exterior of window located in wall that was examined for original window evidence.

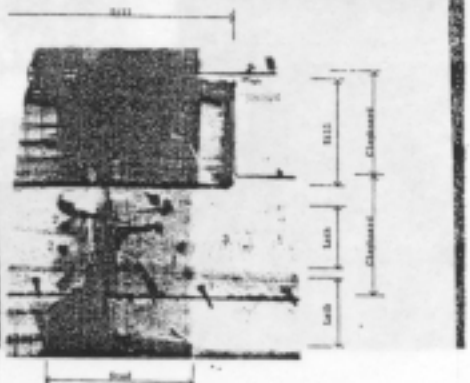
Fig. 13. Window frame, Salem, Mass.
 2-view of present window frame, lower right side.
 Key to 2-view: 1. Clapboard siding, cut
 2. Mesh nails, wrought
 3. Precast concrete
 There are 4 for every mesh and several nails to the steel, setting in the concrete.

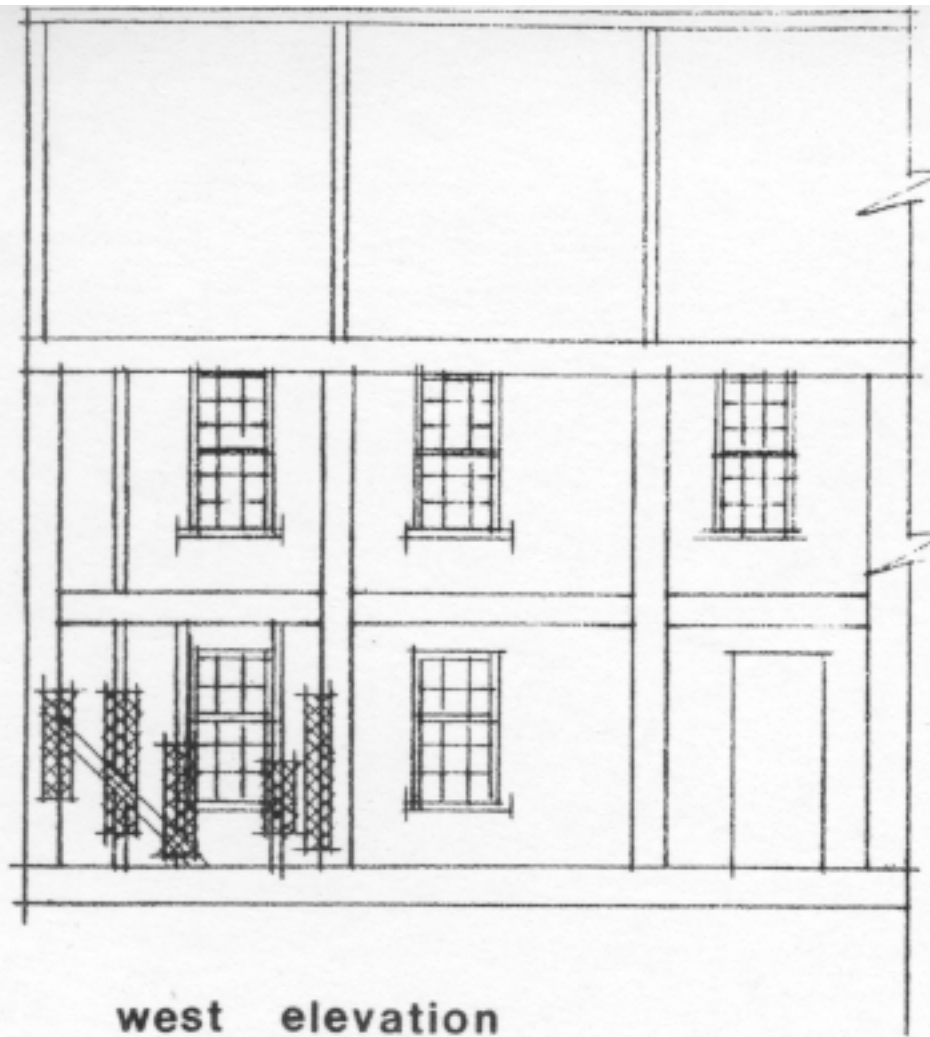
Fig. 17 Composite drawing; cross-hatched areas are those that were examined for evidence of original window frame.

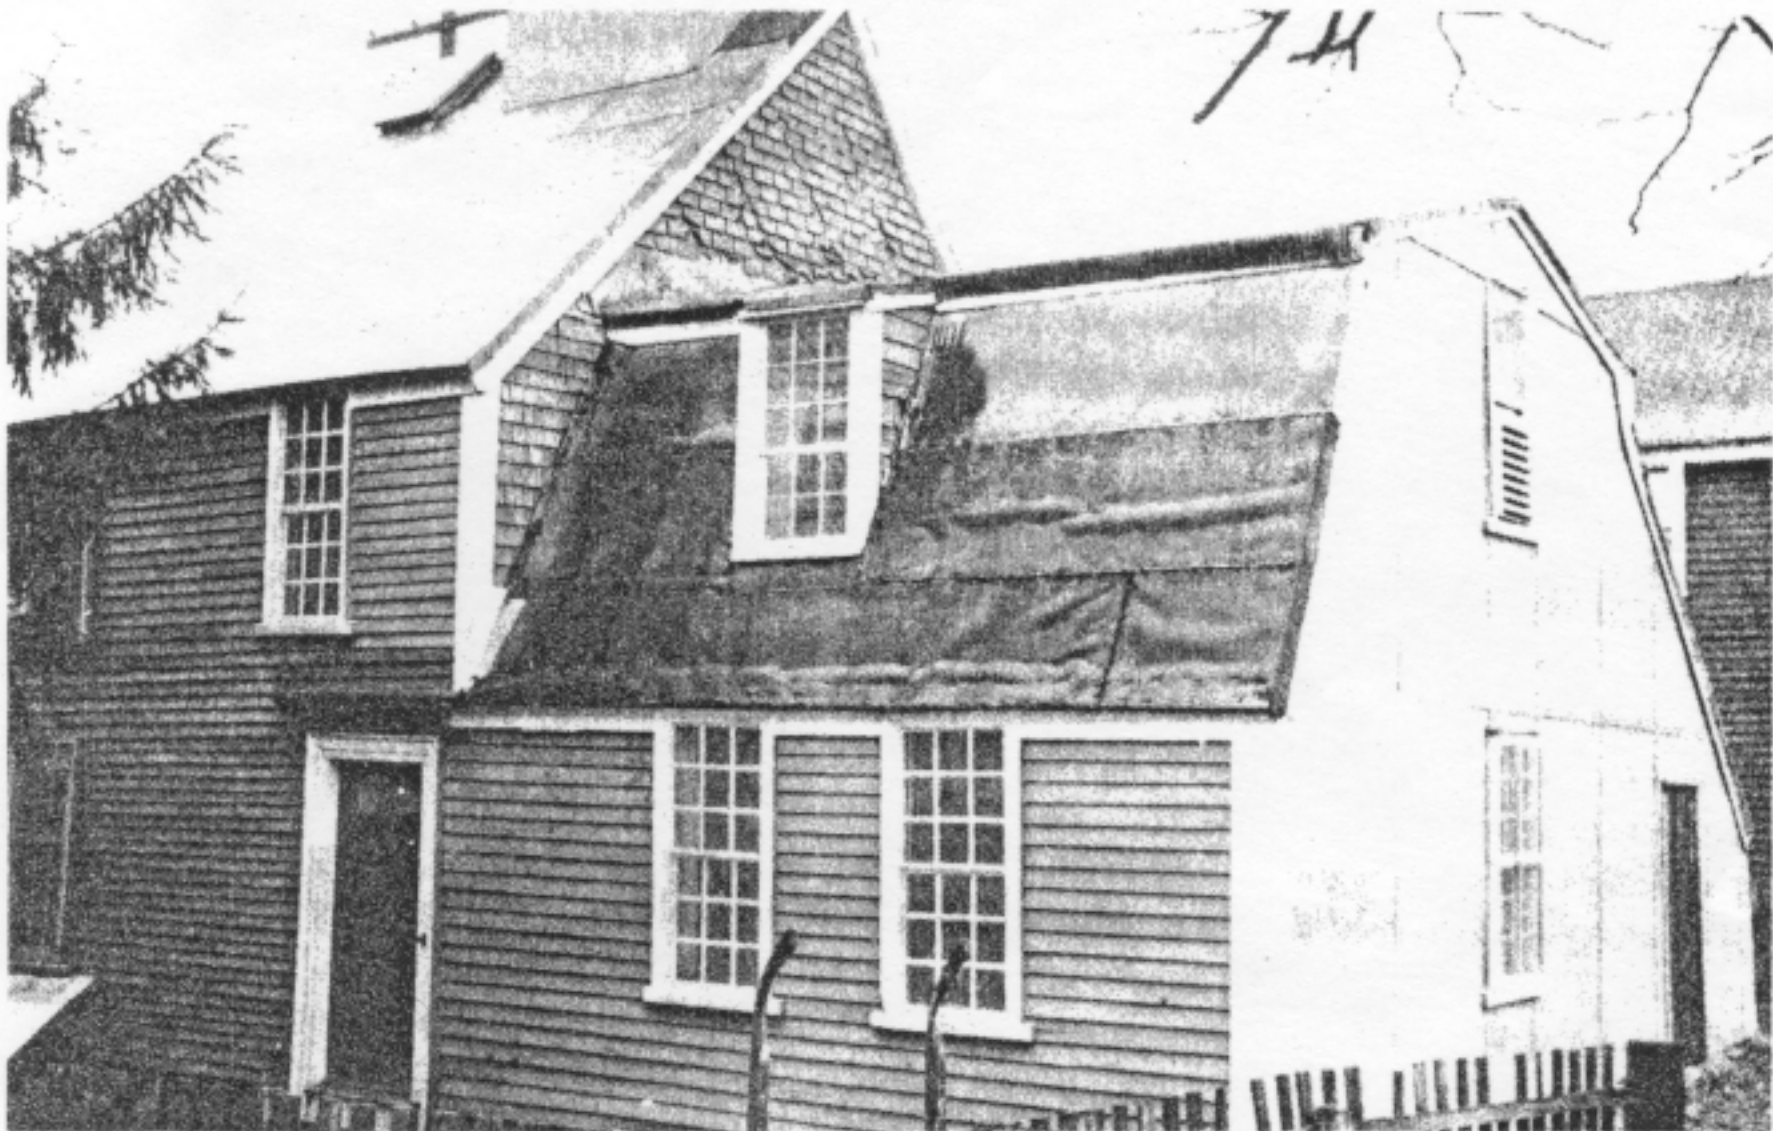
The last phase of investigation was that area between the two house "halves." The north portion is known to have been built about 1675. Figure 18 shows that north portion and the later gambrel addition. Through structural research, it has been determined that there was an earlier addition to the south, but it undoubtedly has been removed. On the basis of style alone, the present gambrel addition would seem to date from the 1720's at the earliest. At the present time, there is unfortunately no documentary evidence to indicate just when this addition was made.

Fig. 18 House from side yard, showing attachment of gambrel addition to north portion.

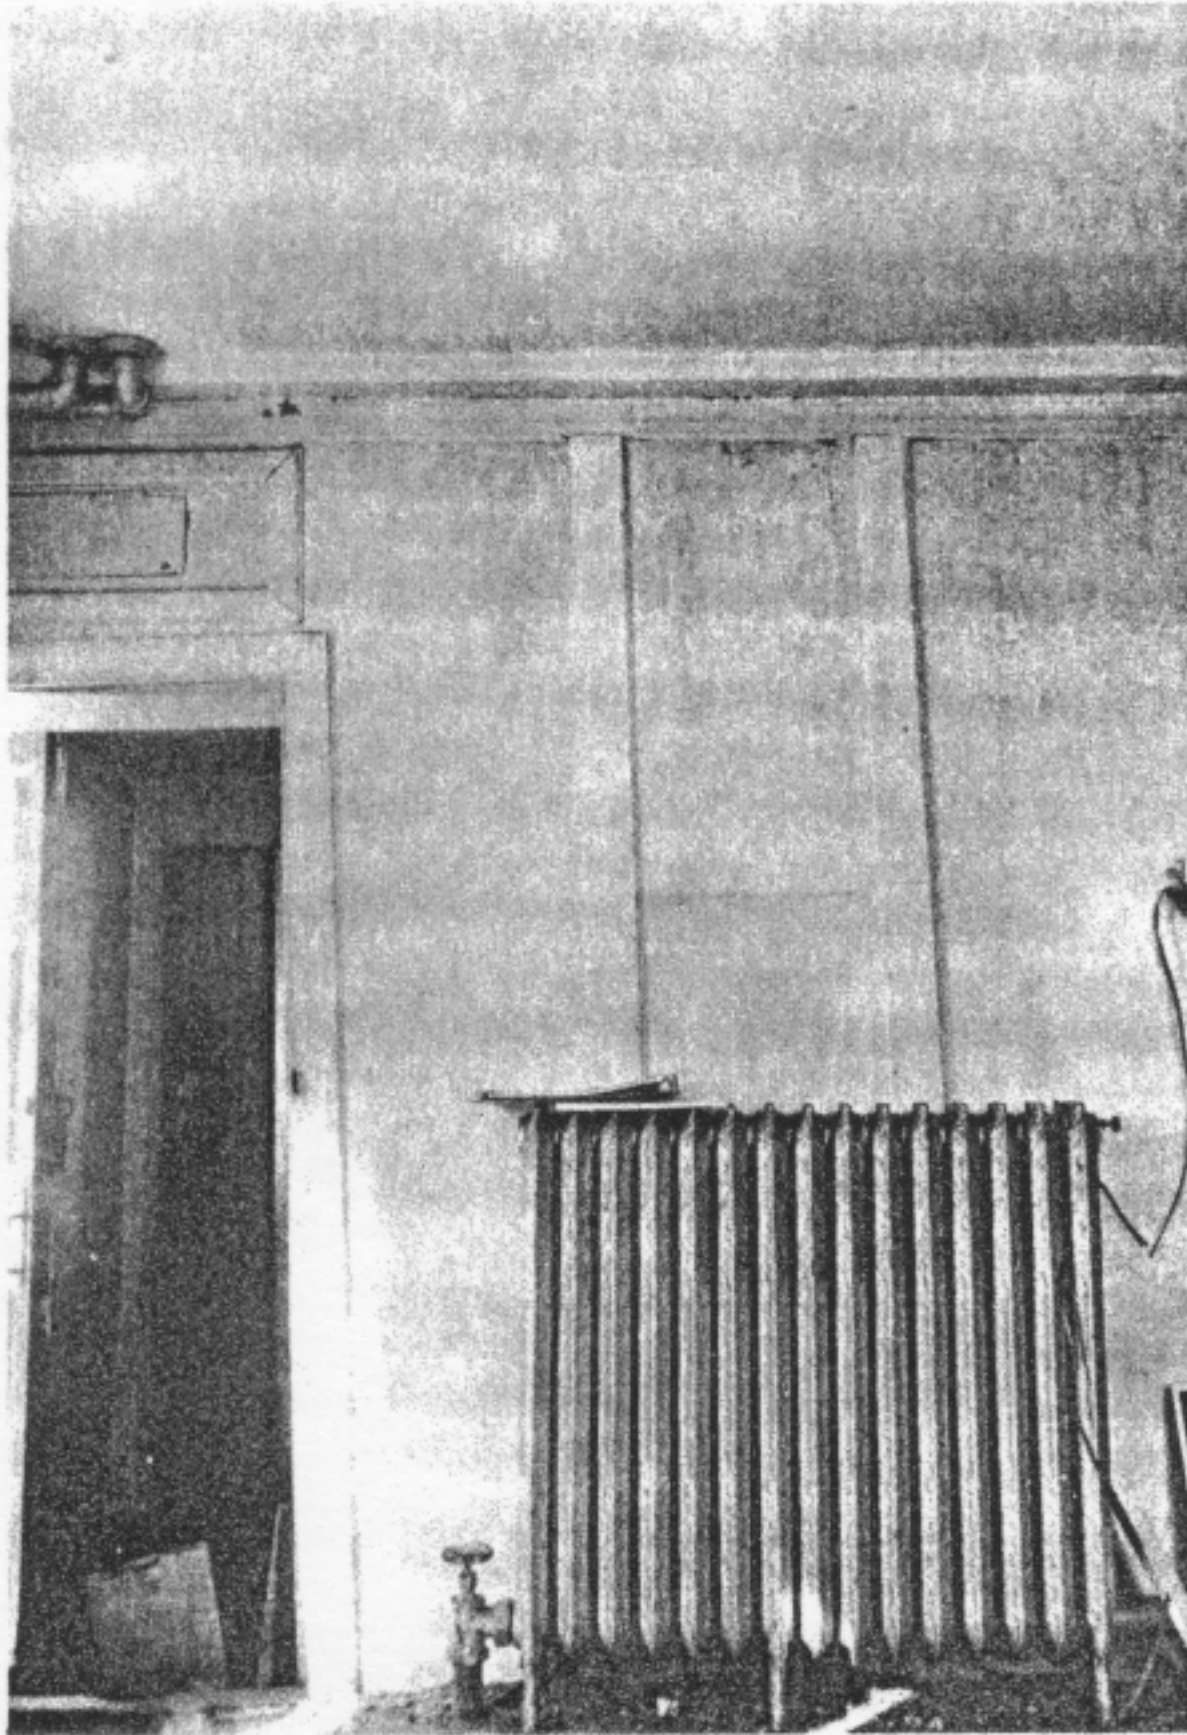
Fig. 20 South parlor, first floor. Area examined for evidence of stud mortices is directly above radiator.

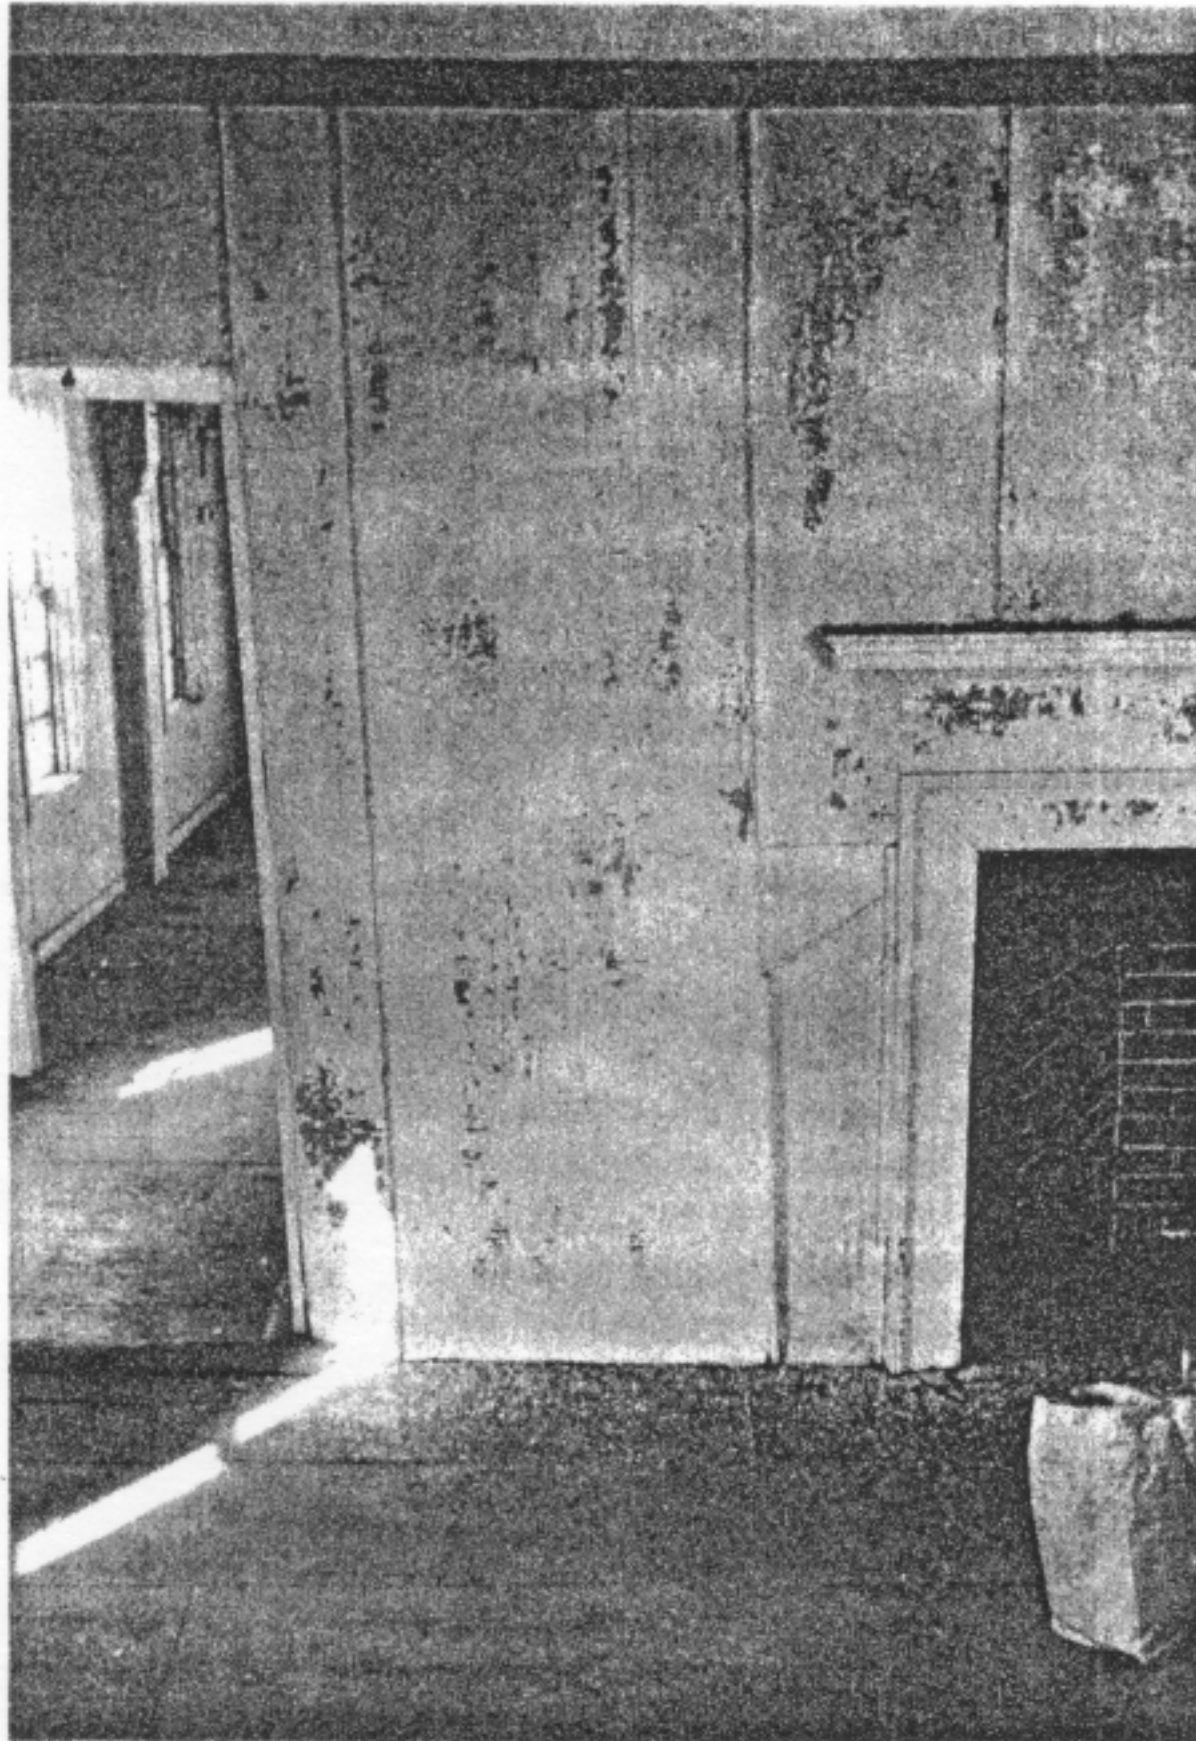
Fig. 21 South chamber, second floor. Area examined for evidence of stud mortices is floor just to left of fireplace.
